# Annual Environmental Management Report Boggabri Coal Pty Limited

March 2008

<b>Name of Mine</b>	Boggabri Coal Mine		
<b>Mining Titles/Leases</b>	CL368		
<b>MOP Commencement Date</b>	1 January 2006	<b>MOP Completion Date</b>	15 November 2011
<b>AEMR Commencement Date</b>	1 January 2007	<b>AEMR Completion Date</b>	31 December 2007
<b>Name of Leaseholder</b>	Boggabri Coal Pty Limited		
<b>Name of Mine Operator</b>	Downer EDI Mining Pty Ltd		
<b>Reporting Officer</b>	Thor Berding		
<b>Title</b>	General Manager		
<b>Signature</b>	<hr/>		
<b>Date</b>	26 March 2008

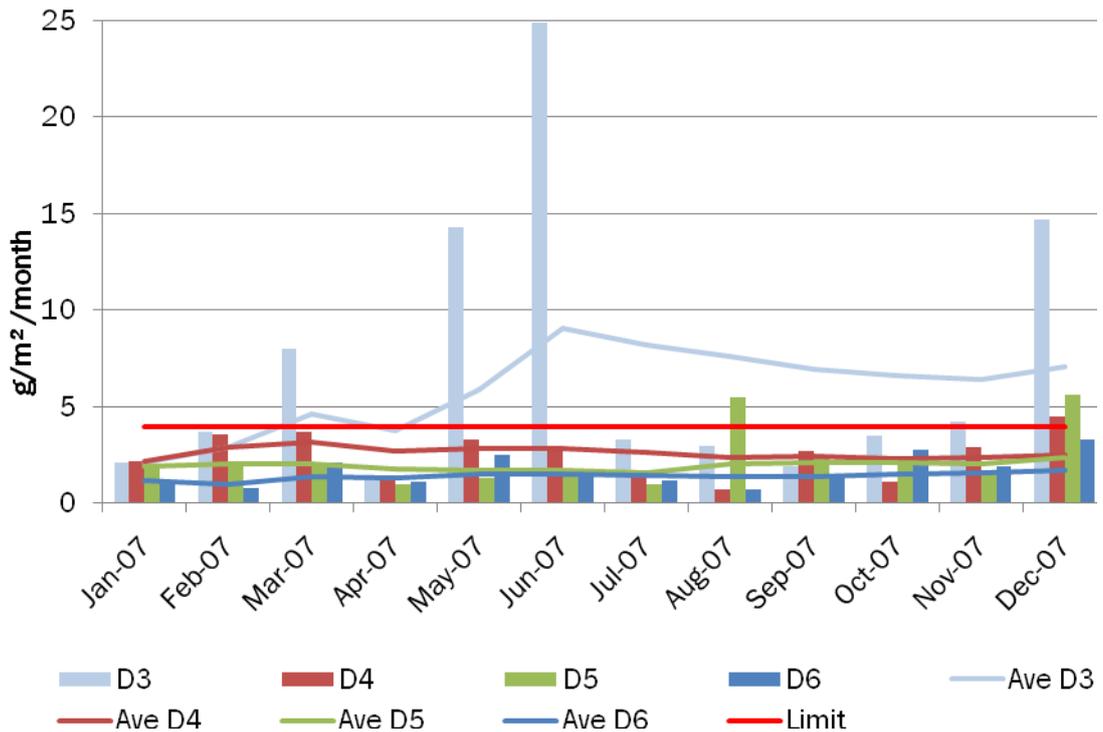
**Figure 18 Dust Monitoring Sites East of the Boggabri Mine**

Notable features of Figure 14 above are the high readings recorded at site D3, located near the start of Goonbri Road; a gravel road that can generate large volumes of dust from normal vehicle traffic. This source cannot be disregarded when assessing dust gauge exceedences as the road is closer than the mine to the D3 monitoring site.

Another two gauges will be located between the mines and monitoring site D3 to investigate the origin of the dust at site D3, (mine or road traffic). It is possible that these additional gauges could form the platform for a change of location for this monitoring point if it continually has higher readings than the additional gauges.

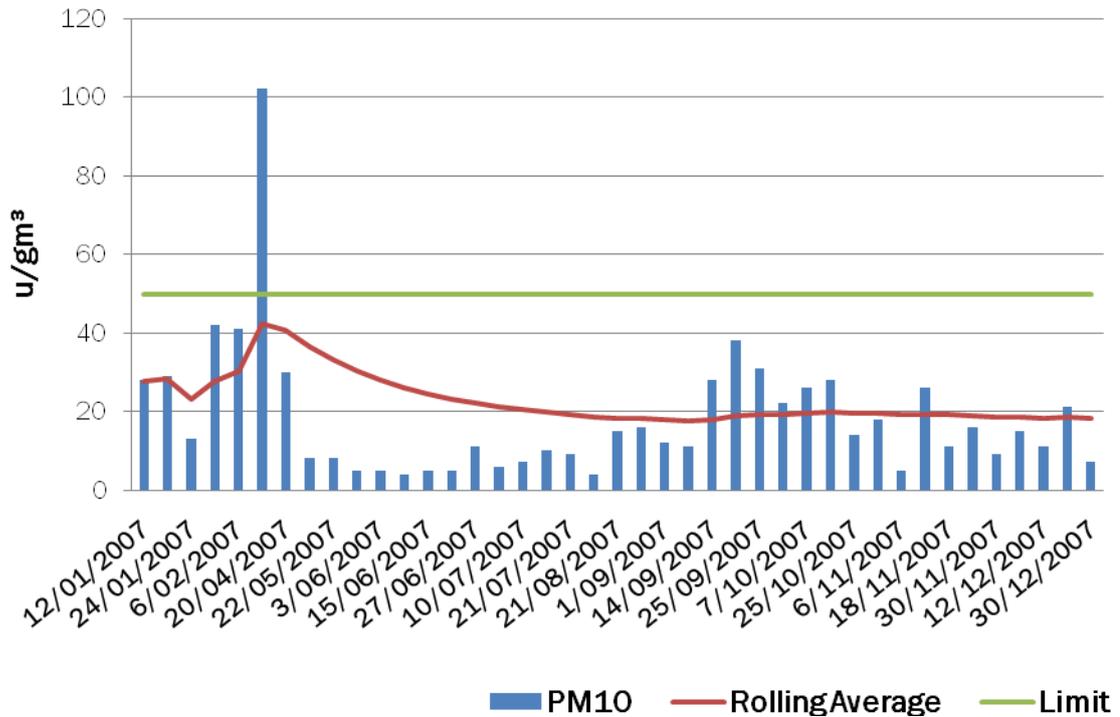
**Figure 22 PM<sub>10</sub> Results 2007**

The PM<sub>10</sub> monitor had to be repaired early in 2007. Because of this there were no readings recorded between the 6<sup>th</sup> February and the 15<sup>th</sup> of April. Note the high result obtained for the 15<sup>th</sup> April (102 µg/m<sup>3</sup>). This was the first reading taken after the site had been repaired and is therefore not considered to be an accurate reading.

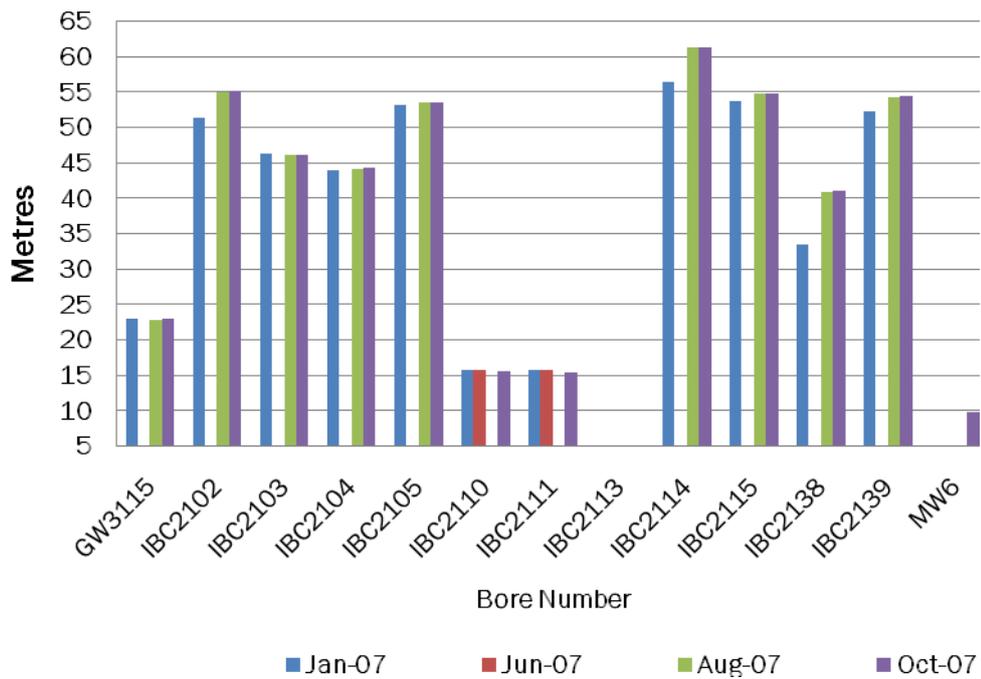
**Figure 23 Bore Hole Standing Water Level**

The temporal variation in standing water levels in the monitored piezometers are illustrated in Figure 19. The majority of the piezometers show a decreasing trend in groundwater levels. The exceptions are IBC2103, IBC2104 and IBC2105. IBC2103 and IBC2104 are installed in coal seams other than the Merriown seam and the third piezometer is located at a greater distance from the current mine work area. Drawdown has been observed since mid 2006 when mine works began progressing to the north.

The largest fluctuation in standing water level was observed at IBC2138, the closest piezometer to mine workings. This piezometer is located immediately up gradient (northwest) of the mine workings and a fluctuation in standing water levels of 11.1 m was observed. The smallest fluctuations (0.5 m) in standing water levels are observed at GW3115 (approximately 2.5km west of mine workings), which is located away from the ground water flow path.

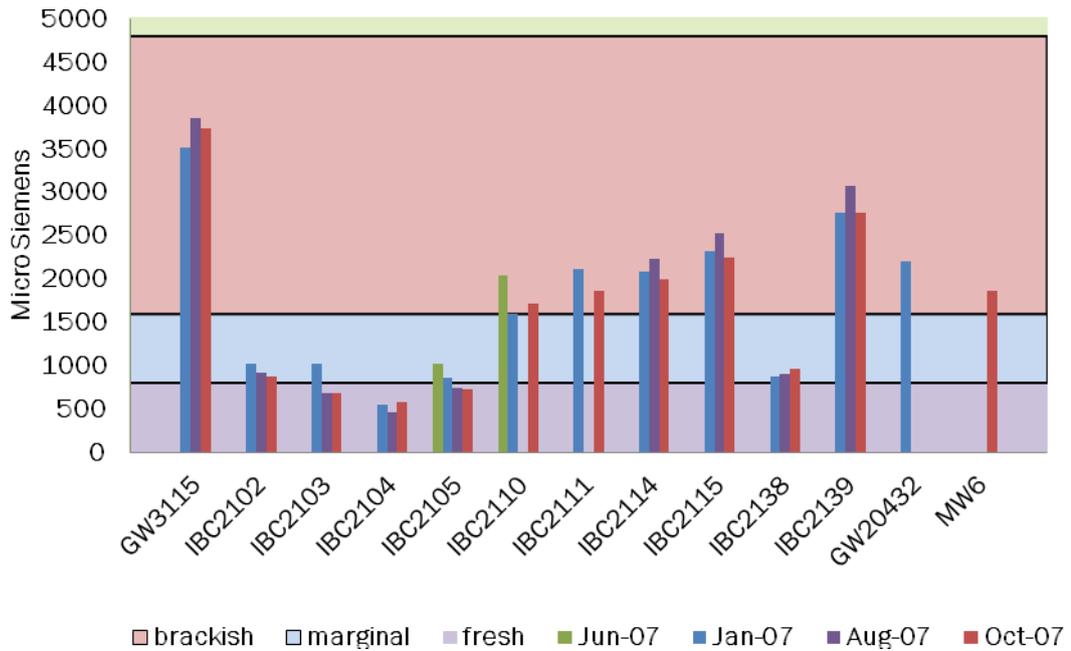
**Figure 25 Bore Hole Electrical Conductivity**

The standard deviation of measured EC is generally within 20% of the mean, and no significant trends were observed for any of the bores. The monitoring in August 2007 indicates elevated EC comparing to previous monitoring. This is most likely the result of the decline in standing water levels at that time, which has been followed by a decrease in EC and the stabilisation of standing water levels.

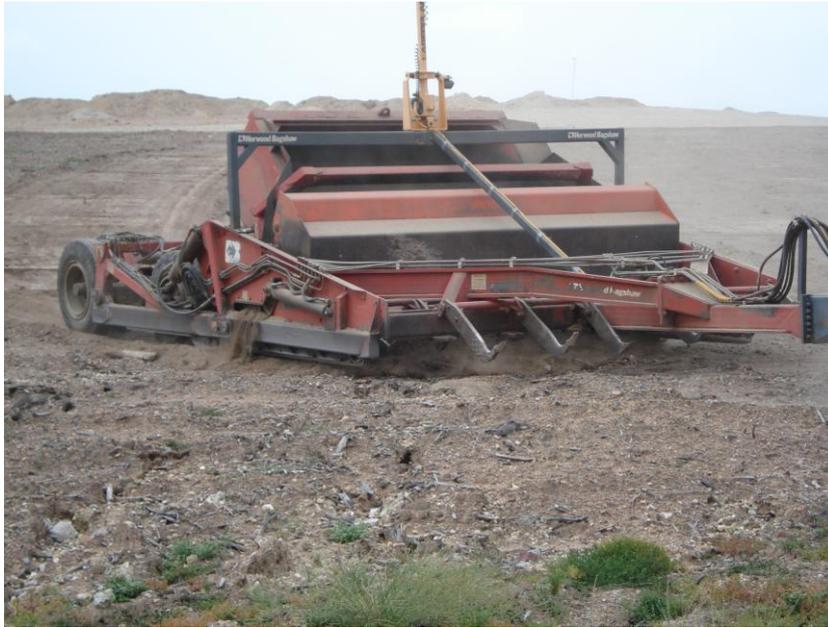
In November 2007 the washouts on the batter were repaired using a laser bucket. The area was then hilled for tree planting using a savannah plough to make the hills approximately 350mm high and 5m apart. The laser bucket was used to rip in between the hills to a depth of 300mm. The area was then aerially sown with superbrew seed mix comprising Bisset Creeping Blue Grass (10%), Bare Fine-cut Rhodes (70%), Green Panic (10%) and Premier Digitaria (10%). at a rate of 60kg per hectare

**Figure 29 Laser bucket Repairing Washouts on Batter**

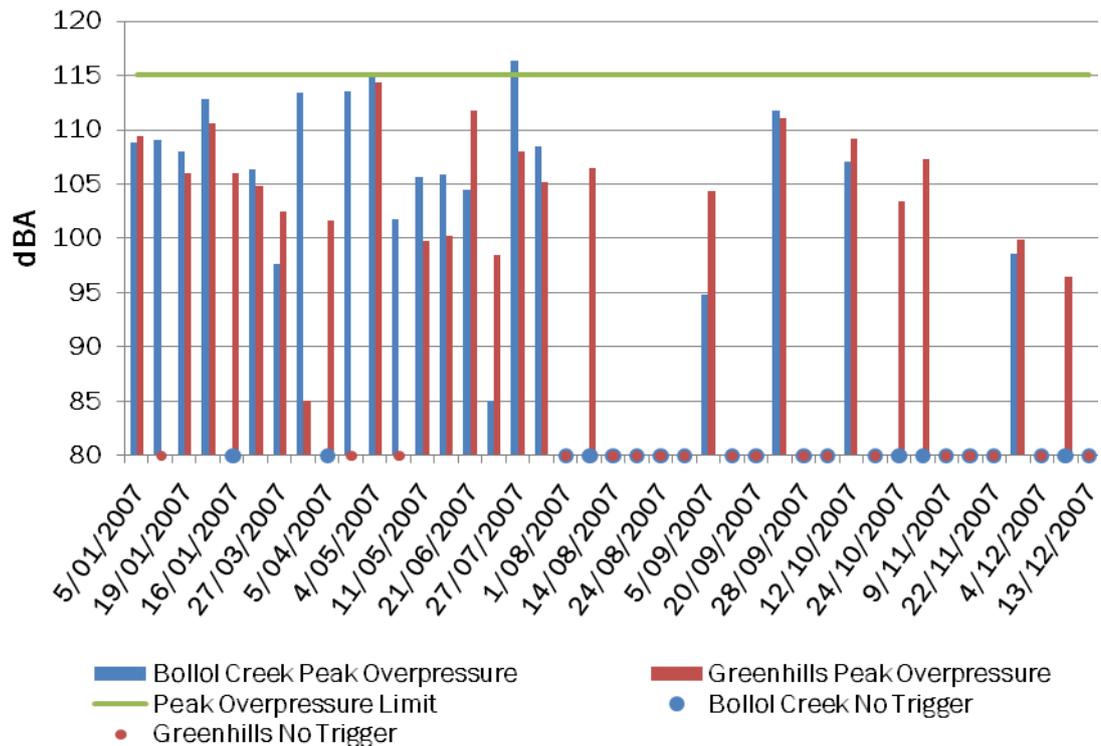
**Figure 37 Peak Overpressure Summary 2007**

During the reporting period there has been one blast that has exceeded the acceptable limit for peak overpressure of 115dBA. A reading of 116.4 dBA was recorded on 27 July 2007 at “Bollol Creek Station”. This reading is not classed as an exceedence of peak overpressure as overall monitoring results have been well over the 95% acceptance limit.
