MUSWELLBROOK COAL COMPANY LIMITED

Annual Environmental Management Report

Environmental Department
Muswellbrook Coal Company
2013-2014

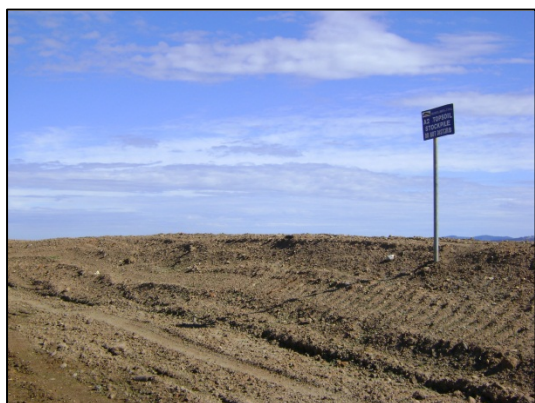
Figure 1 – SIGNPOSTED TOPSOIL STOCKPILE

Topsoil is generally stripped, stockpiled and strategically placed for ease of recovery or direct use on rehabilitation. All topsoil stockpiles are signposted (refer to **Figure 1**), and inspections are undertaken by MCC's Environmental Staff to assess vegetative cover and weed infestation. Weed control was required on some topsoil stockpiles during this monitoring period principally for Galenia and Paterson's Curse. Areas where the noxious weed Mother-of-Millions was found to occur were not disturbed and the soil taken directly to the overburden emplacement area and buried. This may cause a loss of some topsoil, but it is considered a better option than spreading the noxious weed across the rehabilitation.

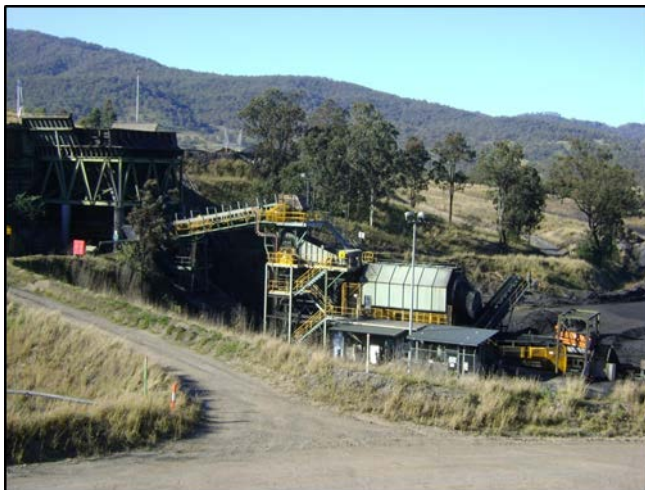
After crushing, the No.2 belt conveyor system has two self-cleaning electromagnets positioned across the coal stream to remove any ferrous materials. Coal passes under a belt ash analyser. If the analyser detects high ash coal, it is directed to a high ash stockpile in the CPP area. Low ash coal is directed to a bypass bin of 300 tonne capacity. The cut point of the diversion depends upon product specifications of purchase contracts. Product coal from either the bypass or washed product bin, is hauled by an 85 tonne truck to product stockpile (Refer to **Section 2.8 Ore and Product Stockpiles**). There was a total of 715,977 tonnes of coal that was directed to bypass over the AEMR reporting period.

Figure 4 - COAL CRUSHING PLANT - coal is placed into a receival bin then fed into a rotary breaker

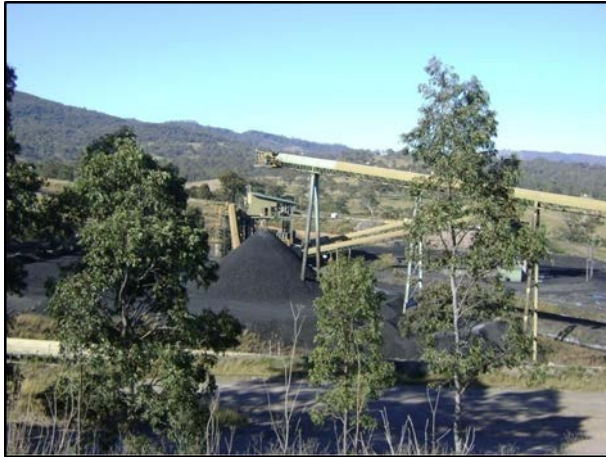
disposal at a low level in the mining void. **Figure 5** displays a photo of the CPP. During the reporting period, there was a total of 674,640 tonnes of coal washed.

Figure 5 - COAL PREPARATION PLANT - crushed coal is reclaimed and processed in the CPP

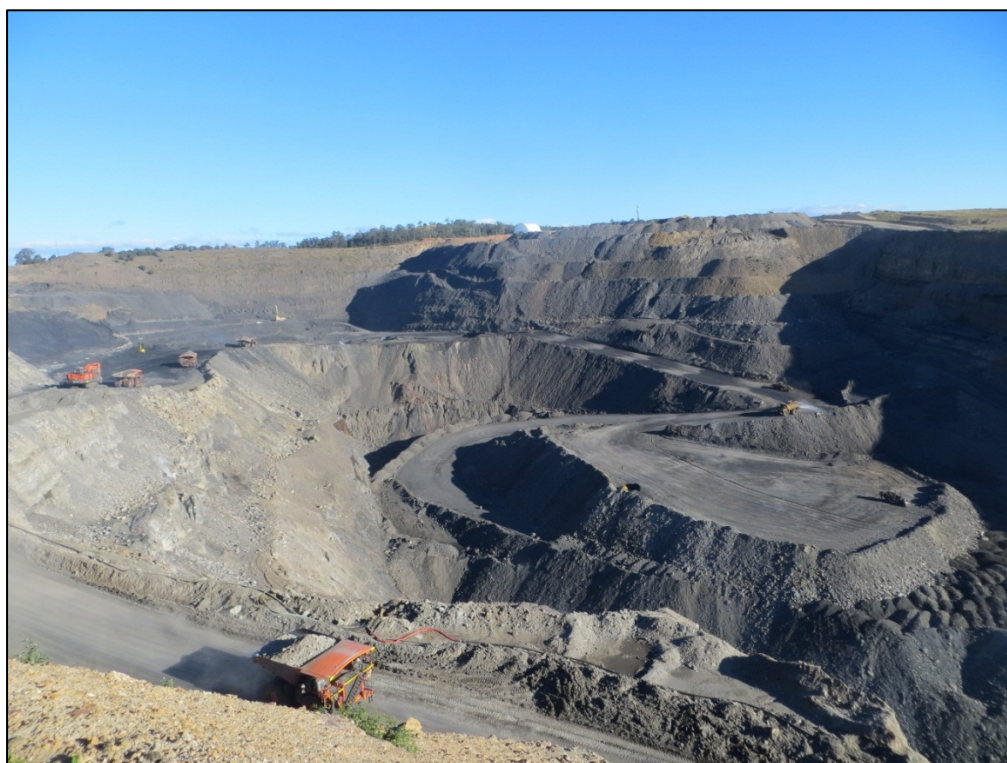
Figure 6 - No.1 OPEN CUT EXTENSION IN-PIT EMPLACEMENT (June 2014)

Overburden from the No.1 Open Cut Extension was placed in the existing No.1 Open Cut and No.2 Open Cut voids. There was no out of pit emplacement of overburden material during the reporting period. **Figure 6** displays in-pit emplacement in the No.1 Open Cut Extension and **Table 7** provides production and waste generated over the reporting period.

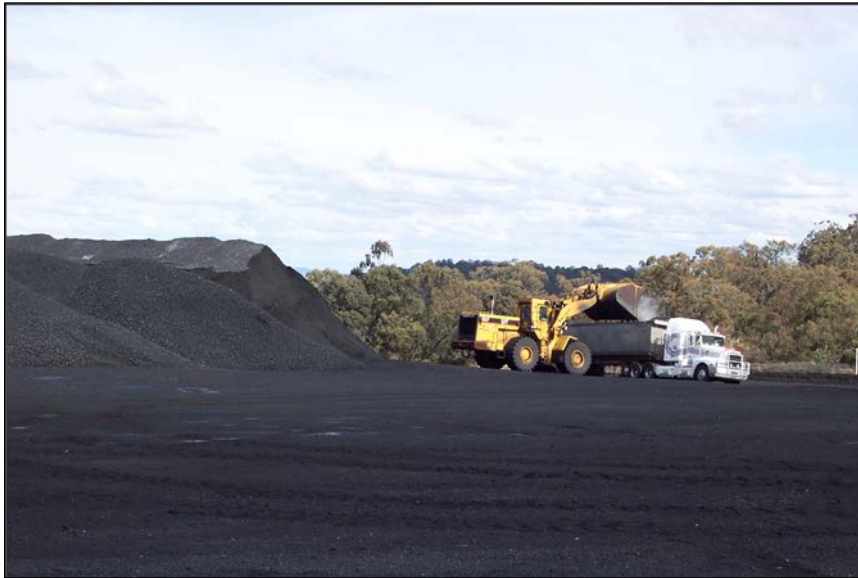
Figure 7 - PRODUCT COAL STOCKPILE

Product coal is hauled from the product bin by an 85 tonne truck to the stockpiles. There are five product stockpiles with a total capacity of 250,000 tonnes. Product coal is trucked off site (refer to **Figure 7**) via Muscle Creek Road and the New England Highway to the Ravensworth Coal Terminal (RCT) for train loading. This coal is then transported to the port of Newcastle.

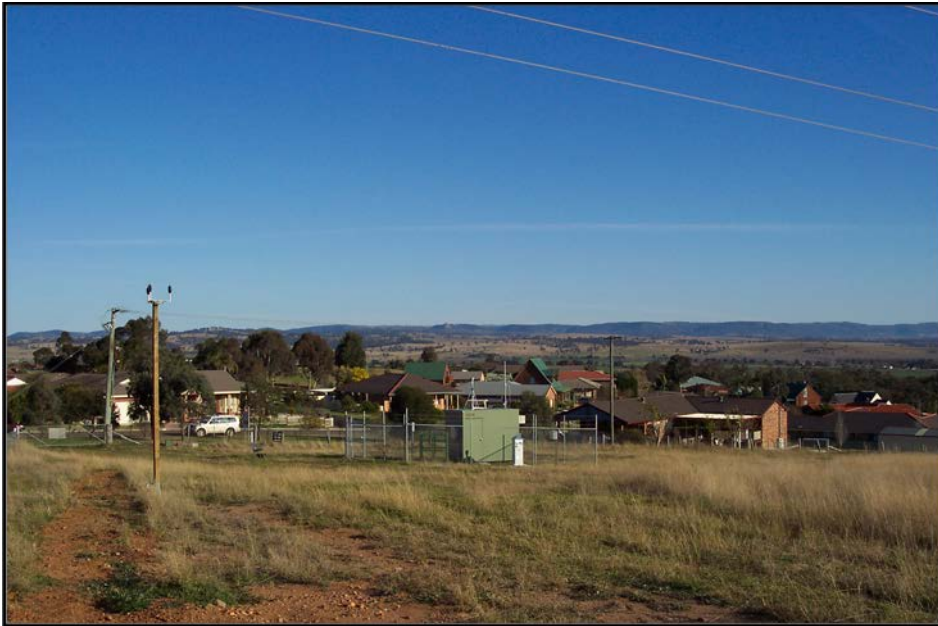
Figure 9 - SITE 1 RTEMs LOCATION (*Queen Street, Muswellbrook*)

There are four RTEMS sites surrounding MCC mining operations. Site locations are displayed in **Figure 8**, and the monitoring equipment situated at each site is provided in **Table 11**. Photographs of each site are displayed in **Figures 9-12**.

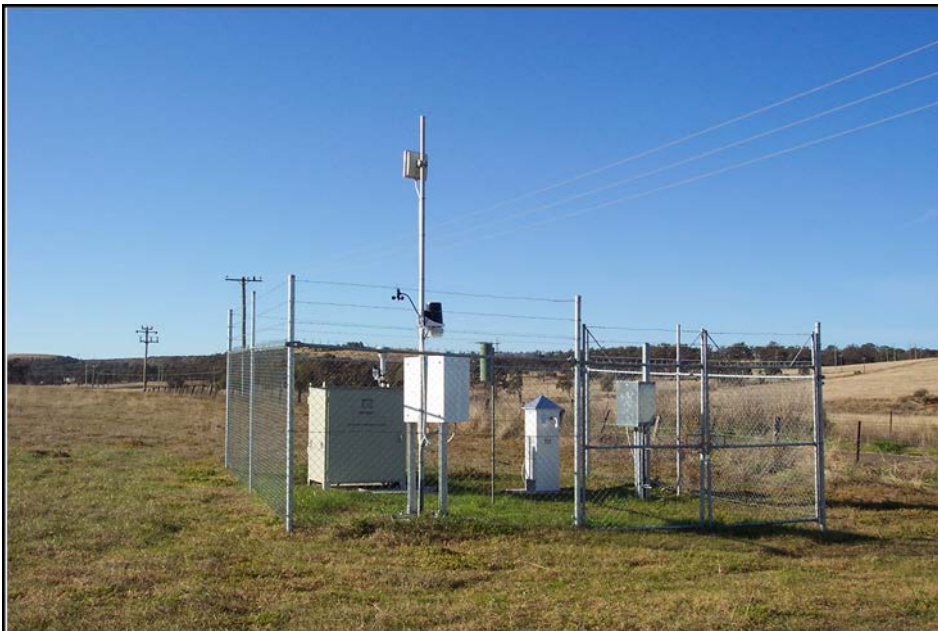
Figure 10 - SITE 2 RTEMs LOCATION (*Sandy Creek Road, Muswellbrook*)

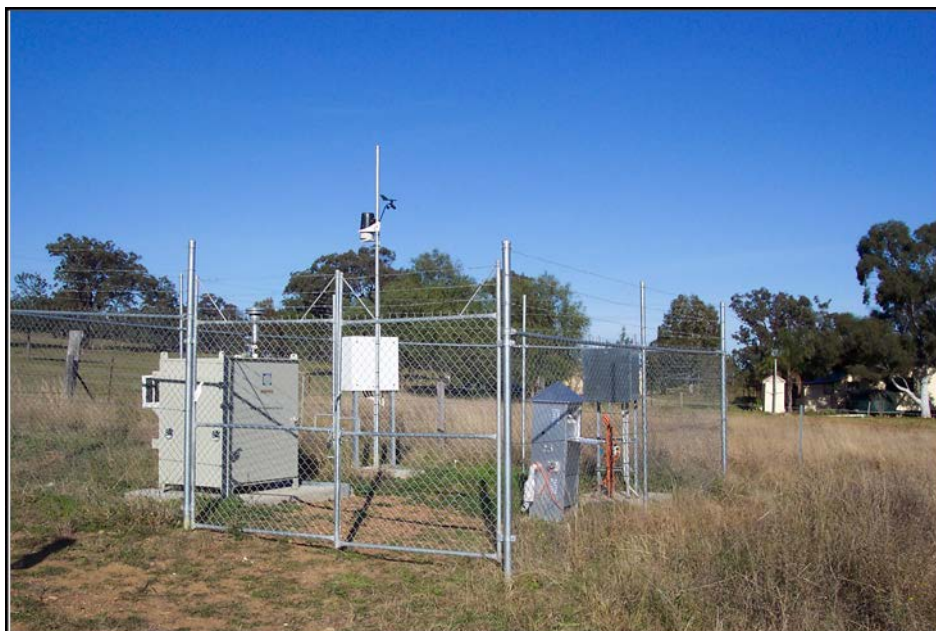
The TEOM at Site 3 was replaced by a BAM unit in November 2013

Figure 11 - SITE 3 RTEMS LOCATION (*Intersection of Sandy Creek Road and St. Helier's Road, Muswellbrook*)

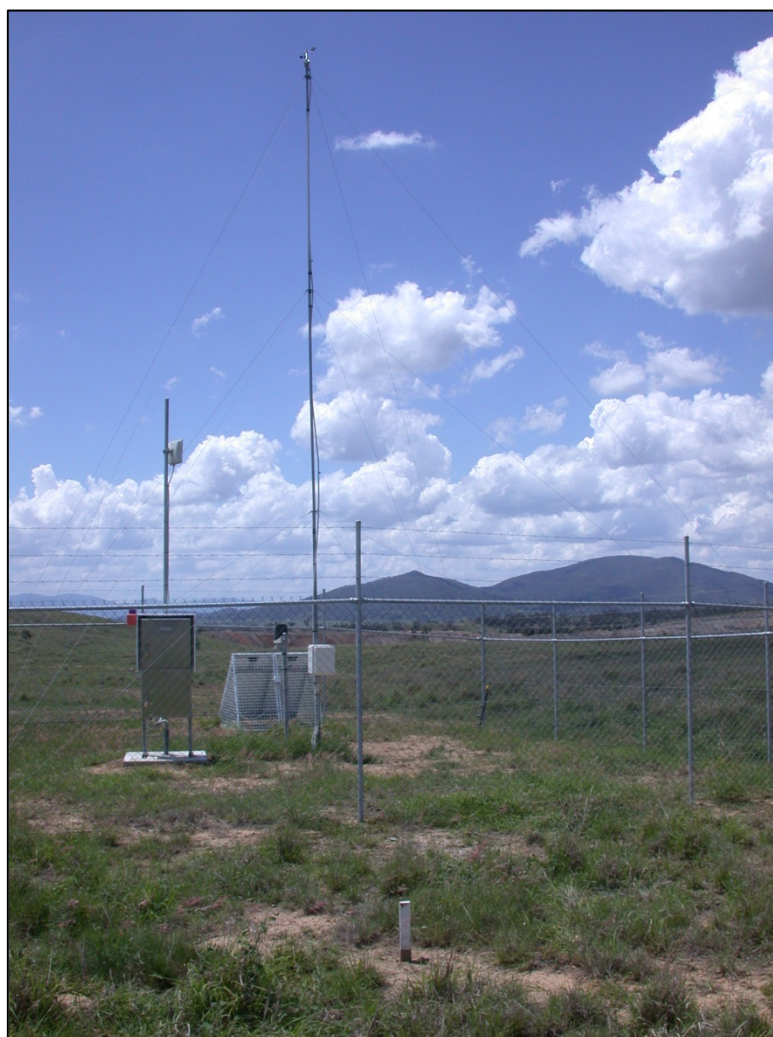
Figure 12 - SITE 12 RTEMS LOCATION (*old overburden emplacement west of the No.1 Open Cut Extension*)

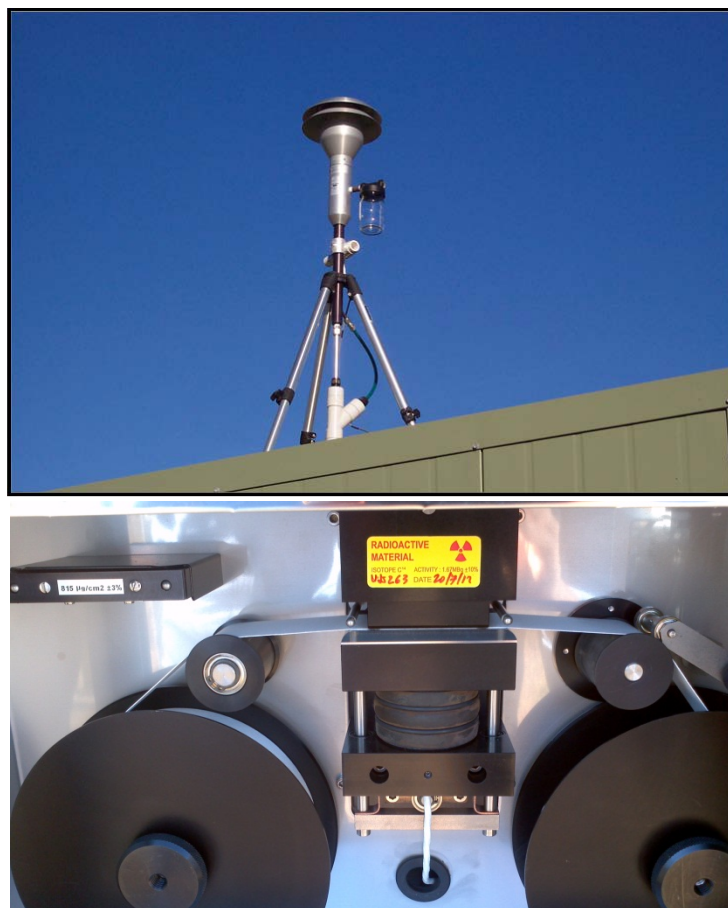
A picture of a TEOM sampling inlet and the BAM's filter/beta gauge are provided in **Figure 13**. TEOM and BAM locations are displayed in **Figure 8**. An example of the Real Time PM₁₀ data display is provided in **Figure 14**.

Figure 12 - TEOM PM₁₀ MONITOR (top) and BAM PM₁₀ MONITOR

In November 2013, a BAM monitor unit was installed to replace one of the TEOM's which had failed. This monitor was recommended as a suitable replacement by the air quality consultants used by Muswellbrook Coal Company. The BAM monitor continuously monitors fine suspended particulates (PM₁₀). It is located at the Site 3 Real Time Environmental Monitoring Station and the data collected by the BAM is transmitted to Muswellbrook Coal by telemetry on a real time basis.

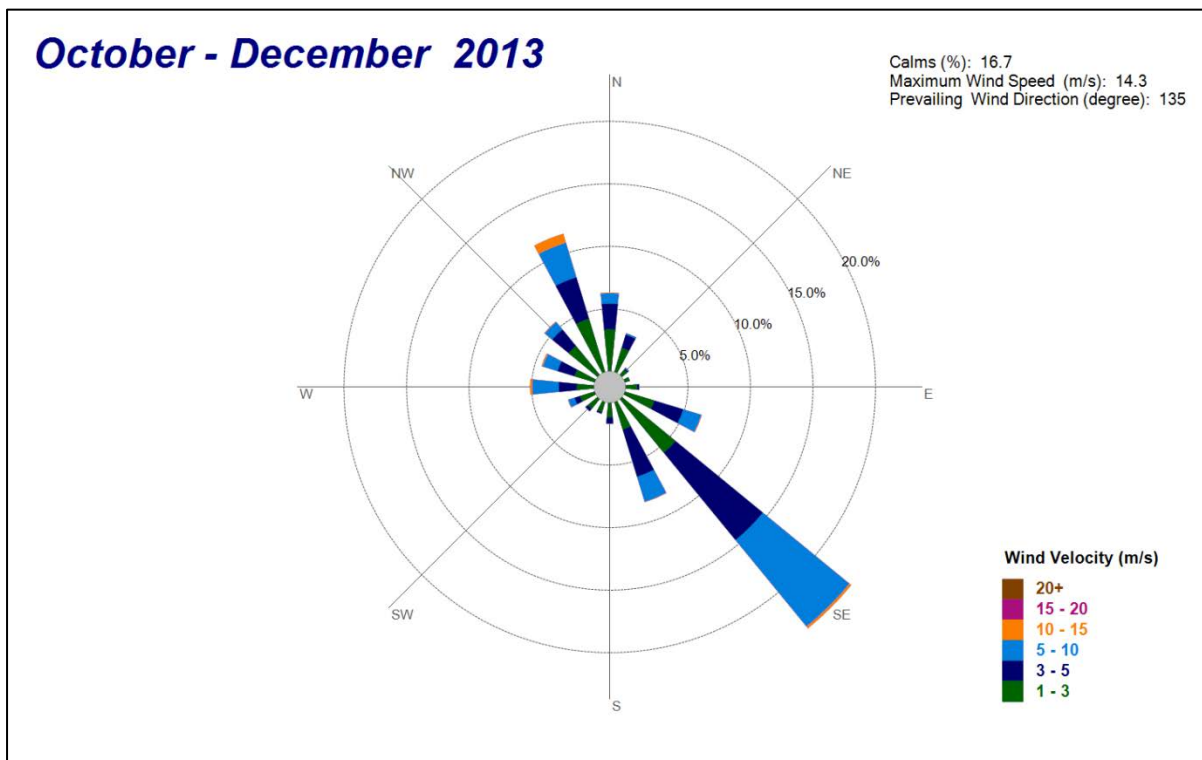
Quarterly wind roses are provided in **Figures 17-20**. Prevailing wind directions were from the northwest during the cooler months of the year (July-September 2013) and south-easterly in the warmer months (October-December 2013 and January-March 2014). April-June 2014 indicated a fairly even split in wind patterns from both the northwest and the southeast. These results are generally consistent with the predominant wind patterns in the Hunter Valley.

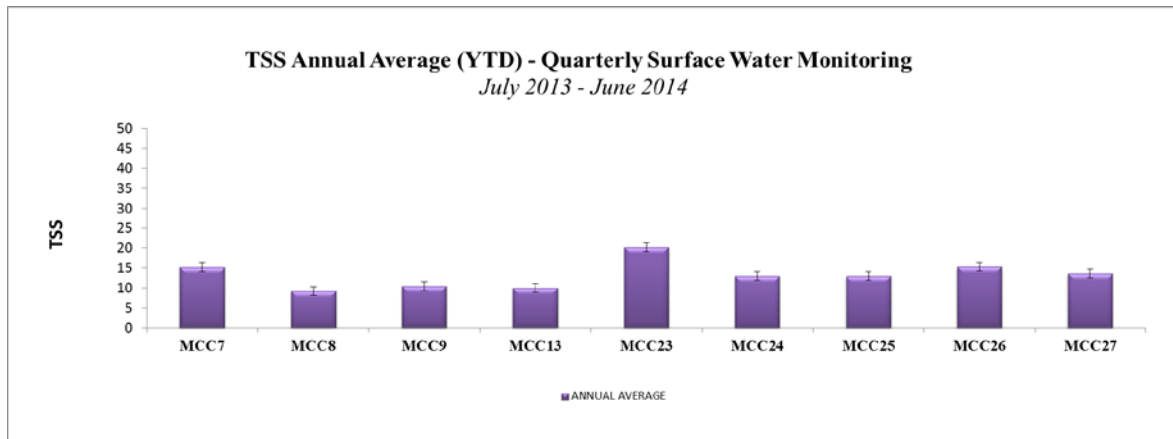
Annual average TSS results for quarterly surface water monitoring sites (MCC7, MCC8, MCC9, MCC23, MCC24, MCC25, MCC26 and MCC27) ranged from 9.3 mg/L to 20.3 mg/L. The minimum and maximum TSS recorded during the reporting period were 5 mg/L and 55 mg/L, respectively. TSS for all quarterly monitoring sites was well below the recommended guidelines of less than 120 mg/L for ecosystems and undisturbed surface water.

Figure 41 - QUARTERLY SURFACE WATER MONITORING ANNUAL AVERAGE TSS CHART

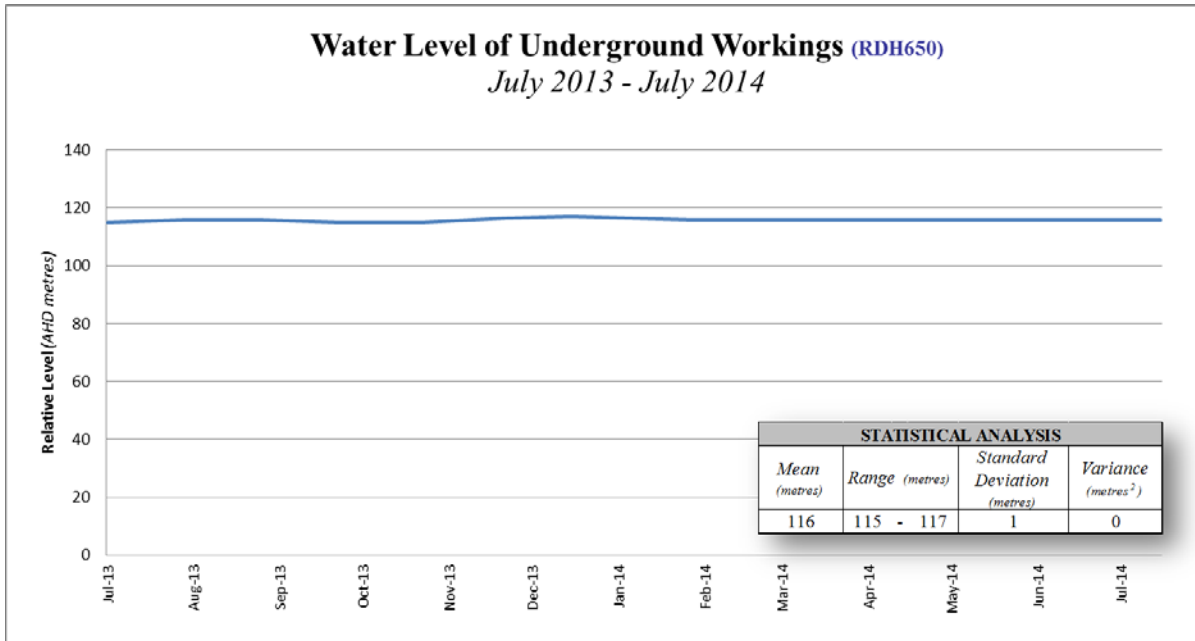
Figure 42 - RELATIVE LEVEL FOR UNDERGROUND WORKINGS (Lewis Seam RDH650)

Historical ground water results are provided in **Appendix 3**. Relative level, pH and Electrical Conductivity sampling results for Borehole RDH529/RDH650 are shown in **Figures 42-43**.

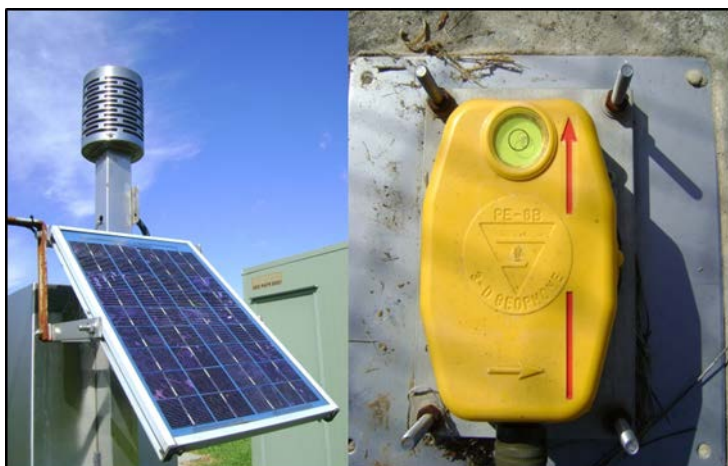
Figure 51 - BLAST MONITOR (microphone and geophone) AT QUEEN STREET (B1)

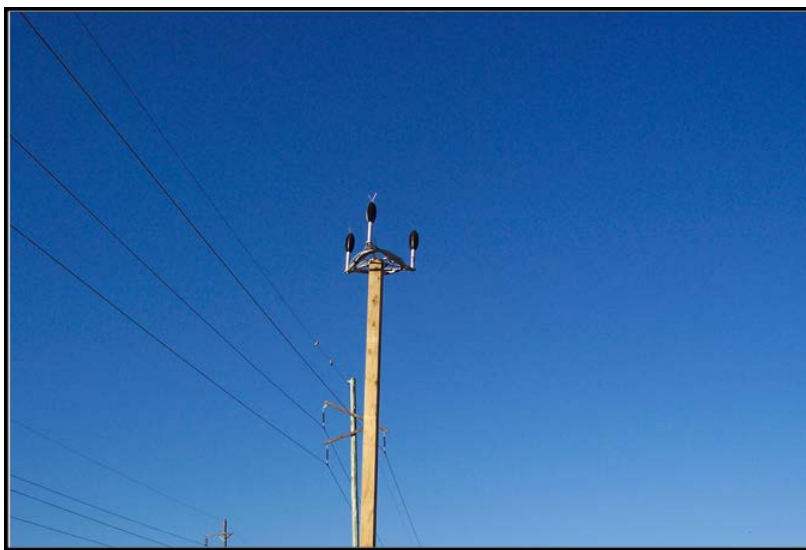
Figure 54- REAL TIME NOISE MONITORING MICROPHONE ASSEMBLY

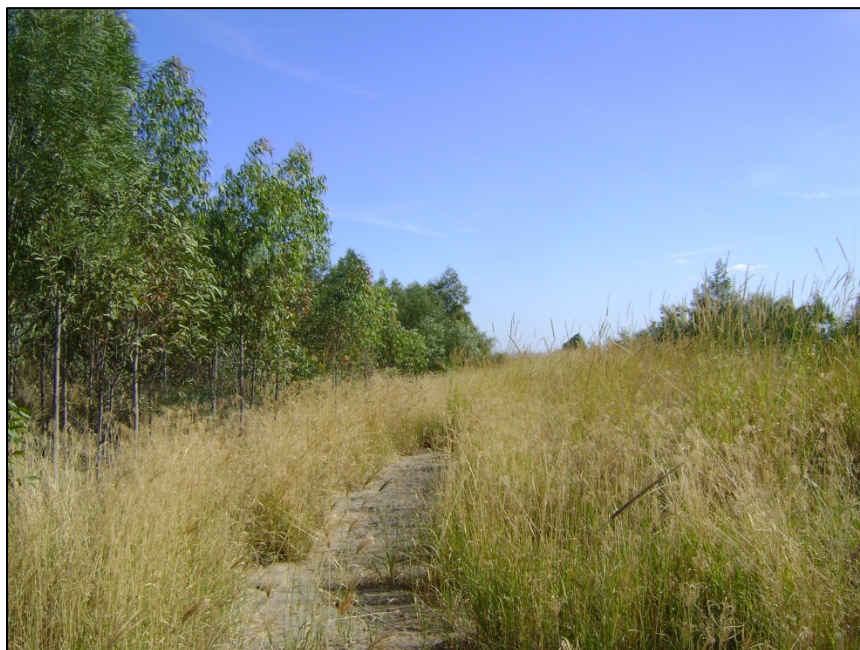
- Rehabilitated areas are planted with a combination of pasture and native trees (refer to **Figure 63**). Native trees are typically planted via direct seeding in plots, situated at strategic locations throughout the shaped landform. MCC is currently planting an increased percentage of trees to allow development of wildlife corridors between Skelletar Ridge and Bells Mountain. Overall percentage of trees across the entire site will be over 50%.

Figure 63 - CONTOUR BANK AND TREE SEED PLOTS

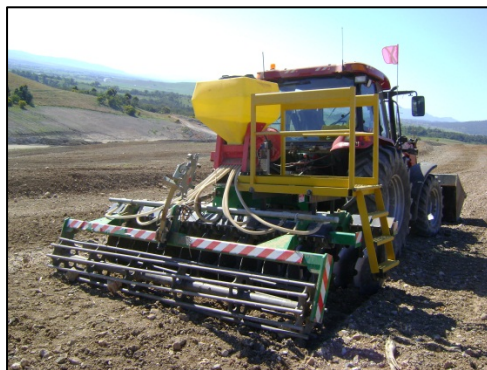
The tree seed mix, applied at 8 kg/ha, contains a combination of pre-treated Acacia and Eucalypt species. This mix is then blended with a seasonal grass species (3-5 kg/ha) as a cover crop and bran as a bulking agent. The seed is then applied by an air assisted seeding implement attached to the back of a 90hp tractor as shown in **Figure 64**.

Figure 64 - Air Assisted Planter for Tree Seeding

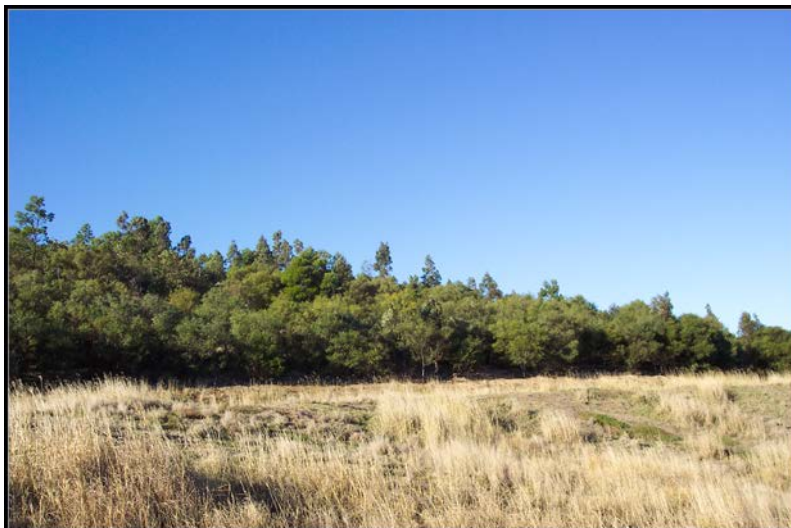
MCC intends to link existing remnant vegetation in Bells Mountain and Skelletar Ridge areas north and south of the lease area by planting corridors of native vegetation across the lease area creating a viable wildlife corridor. This strategy was developed in the Land Management Plan and is based on the Department of Primary Industries Synoptic Plan. Sections of the corridor are currently in place across the No.2 Open Cut and infill tree plantings will be conducted to complete a continuous corridor, refer to **Figure 65** for a photograph of a typical corridor planting at MCC. Rehabilitation planning for the No.1 Open Cut includes the incorporation of native vegetation areas to continue the corridor from the No.2 Open Cut.

Figure 65 - EXISTING WILDLIFE CORRIDOR AREA AT MCC

Forested areas are an important component of mine site rehabilitation, refer to **Figure 65**. Trees provide a stable long term landform and add to the visual amenity of the surrounding area. Trees also provide the necessary habitat for the reconstruction of valuable ecosystems

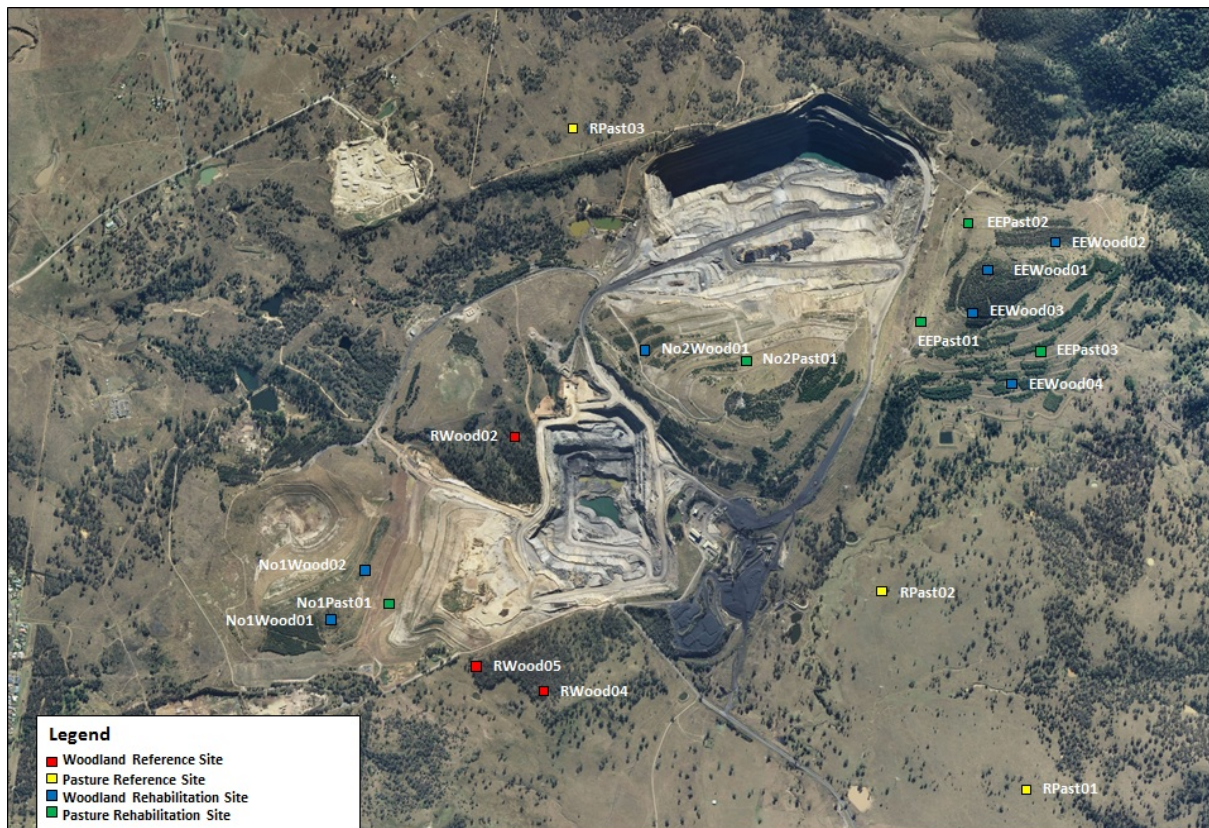
In November 2008, MCC commenced a detailed program of rehabilitation monitoring which would assist in demonstrating some of the key indicators/criteria required for mine closure. In assessing a self-sustainable ecosystem, the program provides a mechanism to identify positive recovery trends and rapid detection of rehabilitation failure, along with detailed remedial action as required. This program includes both Reference and Rehabilitation Monitoring sites as indicated on the location map in **Figure 67**.

Figure 67 - LOCATION OF 2013 REHABILITATION AND REFERENCE MONITORING SITES

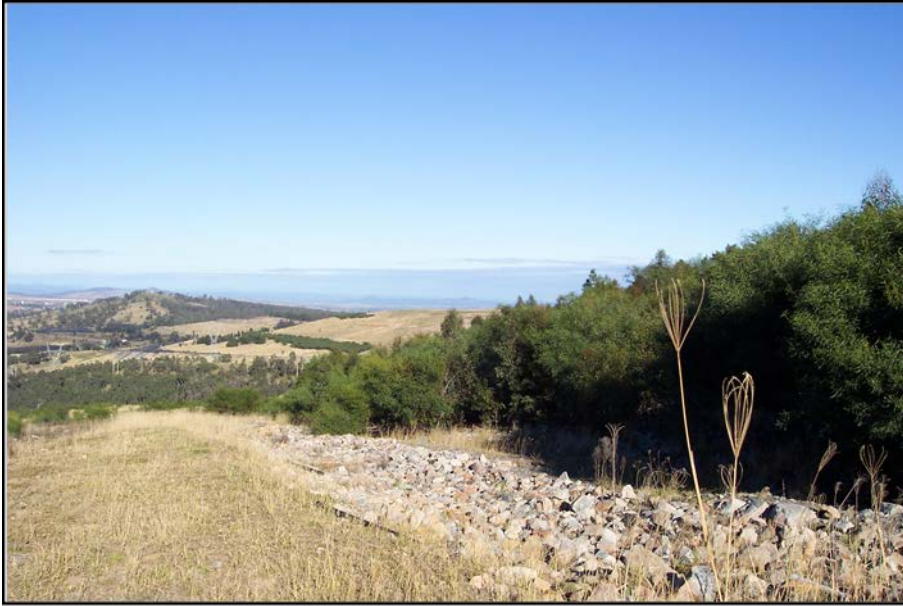
Habitat reinstatement areas across the mine site are at various stages of development. The majority of tree areas on the mine site are healthy and in some areas quite vigorous growth has occurred (refer to **Figure 68**).

Figure 68 - TYPICAL TREE PLOT DISPLAYING VIGOROUS GROWTH
