MUSWELLBROOK COAL COMPANY

2017 ANNUAL ENVIRONMENTAL MANAGEMENT REPORT

Name of Mine: **Muswellbrook Coal**

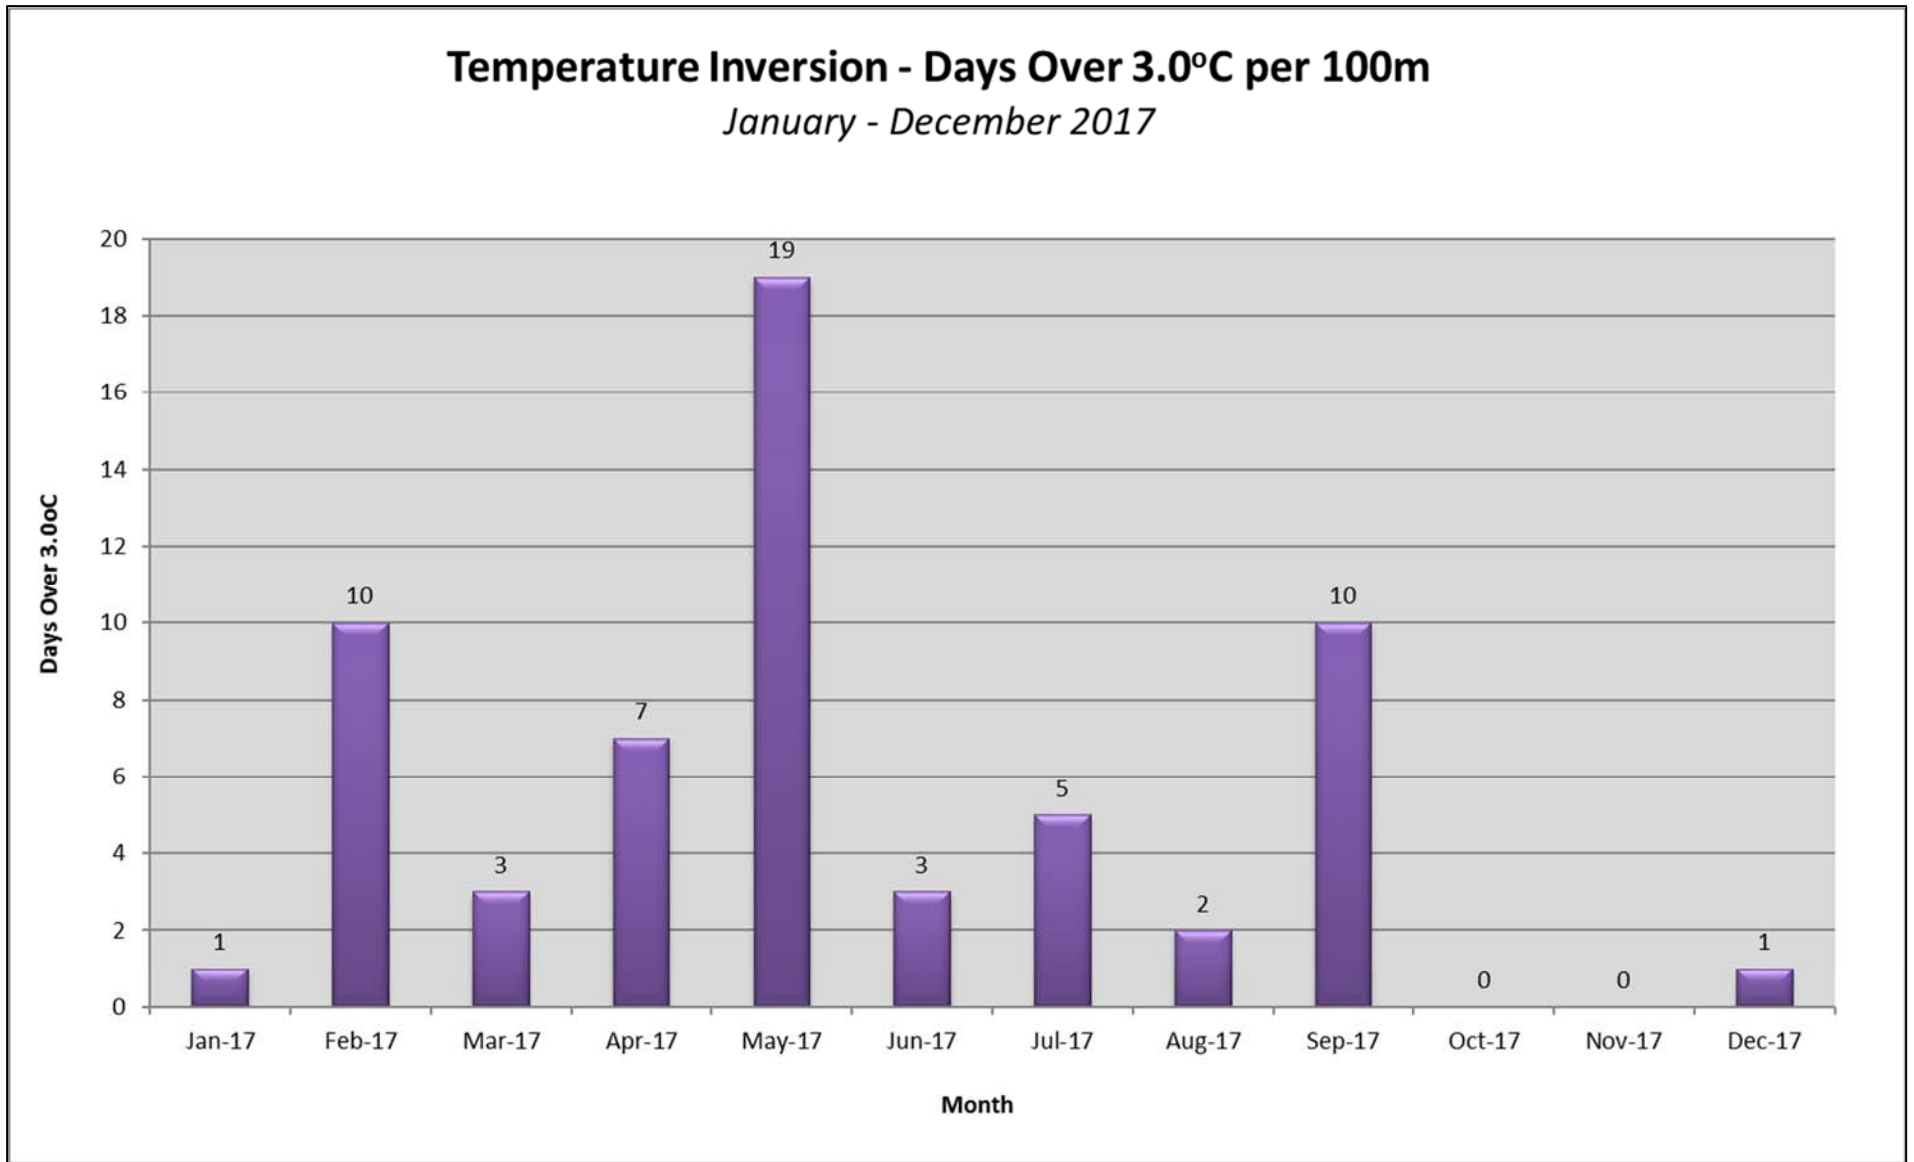
Figure 5: Temperature Inversion Graph

Inversion strength is measured between two different meteorological sites around MCC at two different elevations. The recorded temperatures are used to calculate the temperature differential per 100 metres (inversion strength). Temperatures normally decrease with increase in height above the ground. A temperature inversion is a temperature increase with height. Meteorological conditions, such as temperature inversion, may significantly increase noise levels by focusing sound-wave propagation paths at a single point. Inversions over 3°C per 100m are considered to be strong and occur primarily during the evening to early morning in the cooler months.

Over the reporting period, inversions were monitored and the daily maximum recorded. The days in each month recording an inversion level of 3°C/100m or greater (strong inversion) are displayed in **Figure 5**. A strong inversion was recorded on 61 days during the reporting period with May 2017 having the highest number of days with 19 days above 3°C/100m.

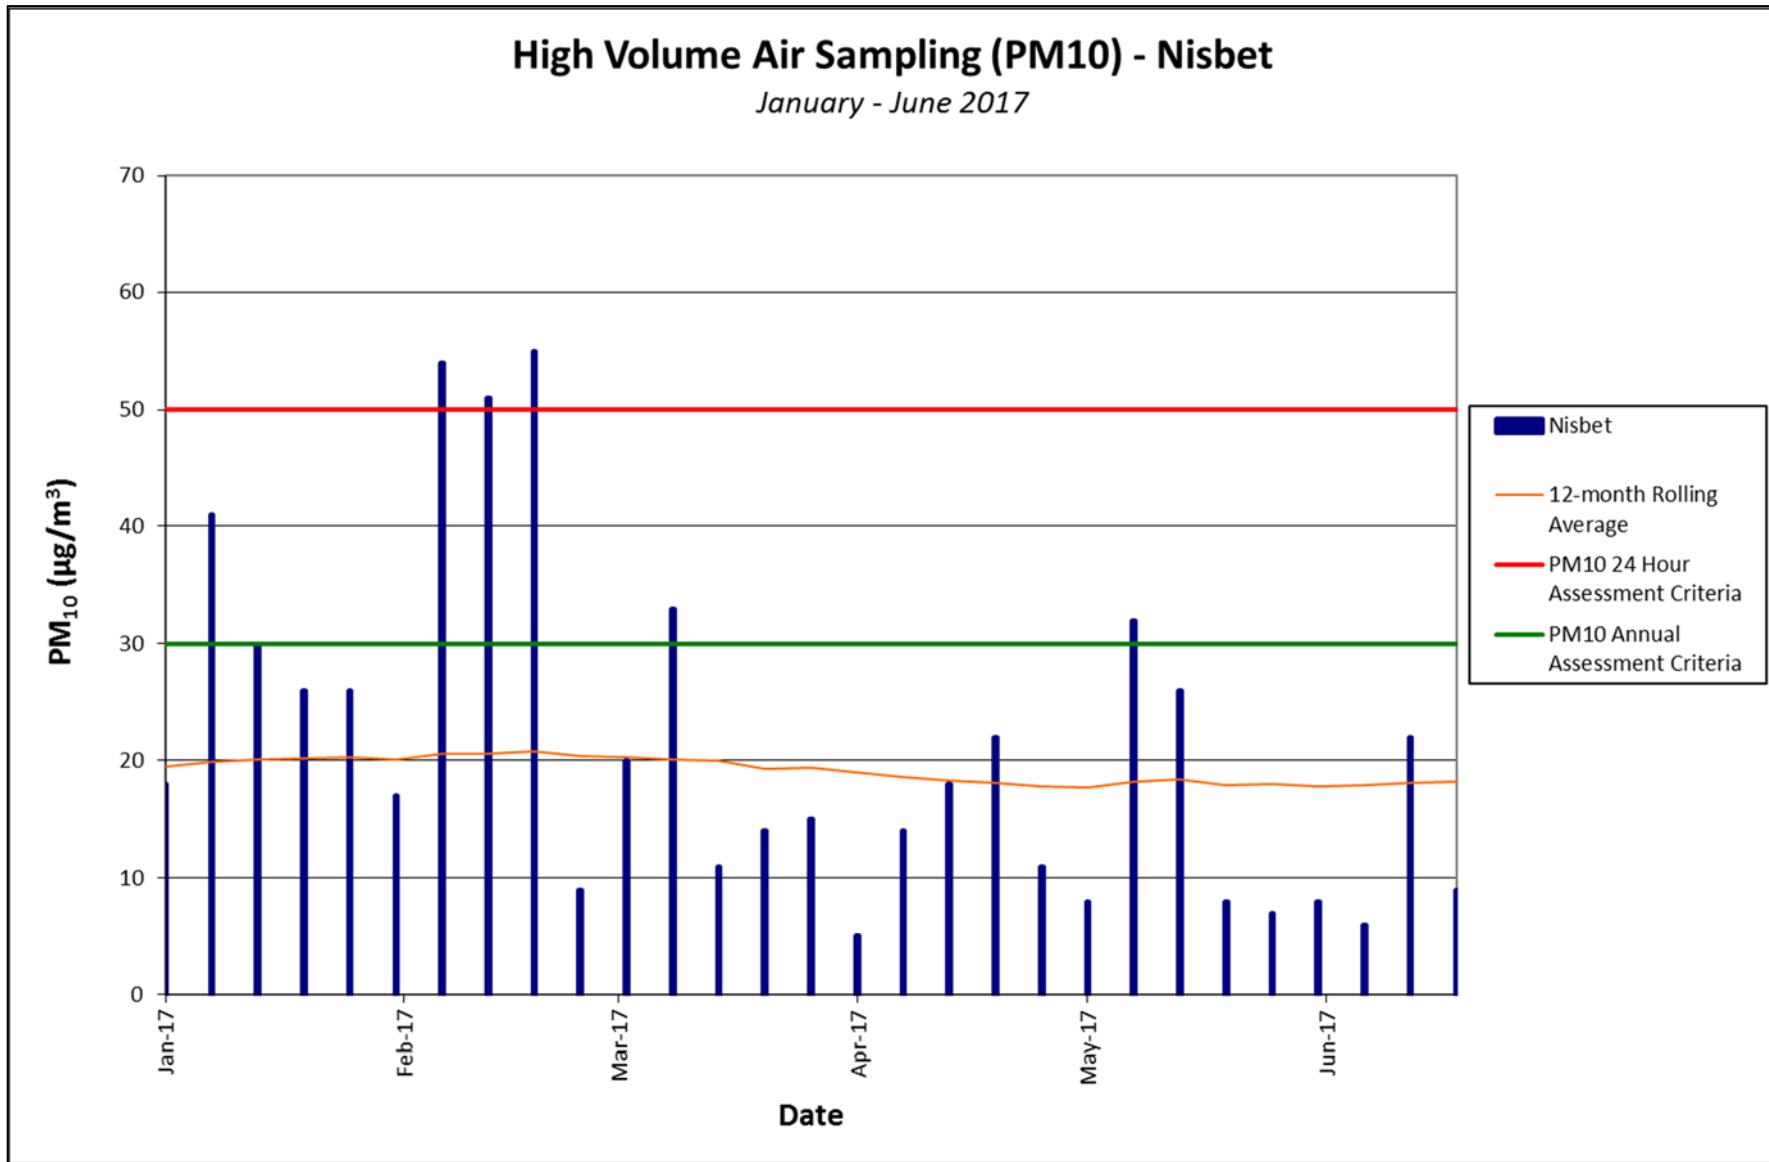
Figure 18: PM₁₀ HVAS Results

In addition to the real-time PM₁₀ units a PM₁₀ HVAS unit has been established with the location of this site shown in **Figure 6**. This unit operates on a 6-day cycle and is not real-time like the other PM₁₀ units. This unit was decommissioned in July 2017. There were three days during the reporting period where the 24 hour PM₁₀ result was above the 24-hour criteria of 50µg/m³. These occurred on 11 February 2017, 17 February 2017 and 23 February 2017. These high results were a result of smoke from bushfires burning in the local area. The annual average PM₁₀ did not exceed the 30µg/m³ annual criteria during the reporting period. The rolling annual average PM₁₀ HVAS recorded over the reporting period was 18.2µg/m³ with the results being displayed in **Figure 18** and **Table 27**.

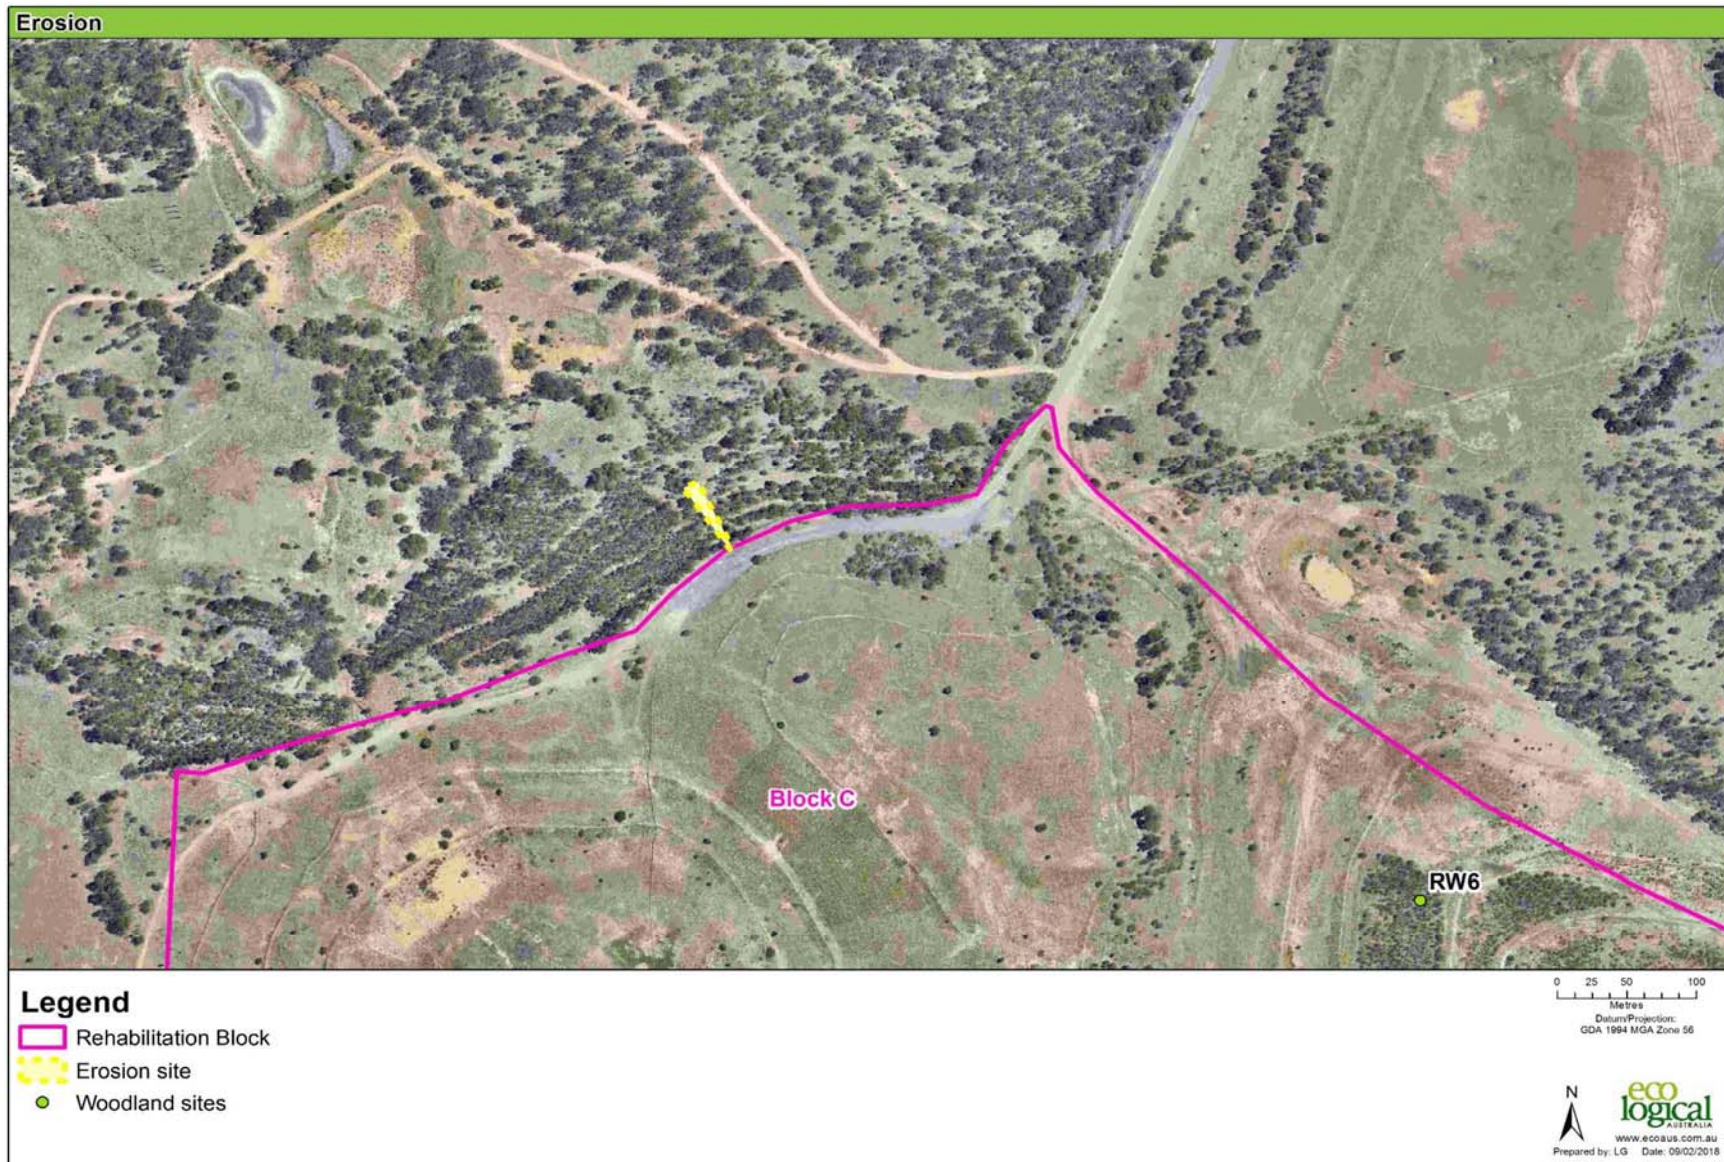
Figure 76: Erosion Sites

Generally, across the rehabilitation sites limited erosion was encountered. The majority of sites had good vegetative cover and maintaining this cover will limit further erosion from occurring. No major settlement or subsidence areas were identified; however, one fairly advanced erosion gully was identified.

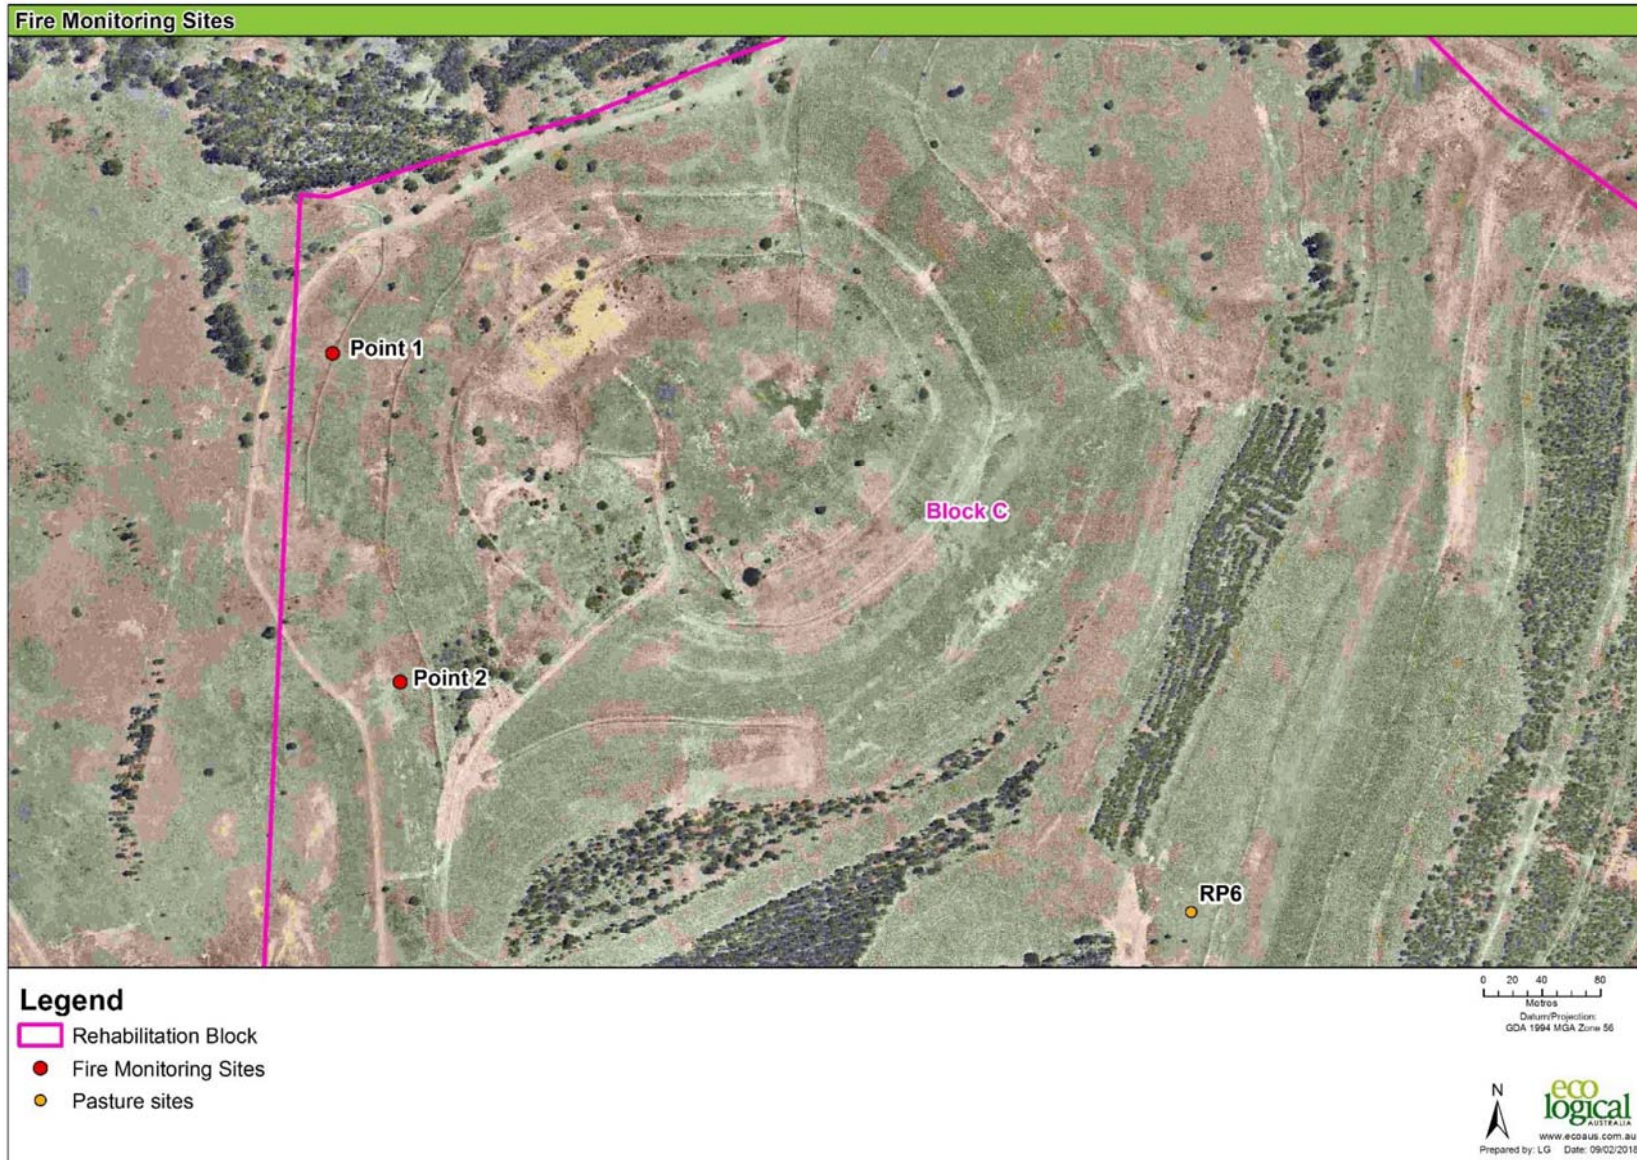
Figure 77: Fire Affected Monitoring Sites

An unplanned fire occurred on the 14 December 2015 within the western and south-western section of Block C. Two monitoring points have been set up to monitor the area in order to document the resilience of rehabilitation to impacts of fire. These points were recorded using GPS and at these locations photos were taken from north, east, south and west directions (**Figure 77**). The condition of the area was recorded, including noting species regenerating and any weed species becoming established. In subsequent years these monitoring points can be revisited with photos taken over time showing the recovery of species. It is noted that no photos of the site were taken prior to the burn occurring so no data is available for the location pre-burn.
