MUSWELLBROOK COAL COMPANY

**ANNUAL ENVIRONMENTAL
MANAGEMENT REPORT**

Name of Mine: **Muswellbrook Coal**

AEMR Commencement Date: **1 January 2020**
AEMR End Date: **31 December 2020**

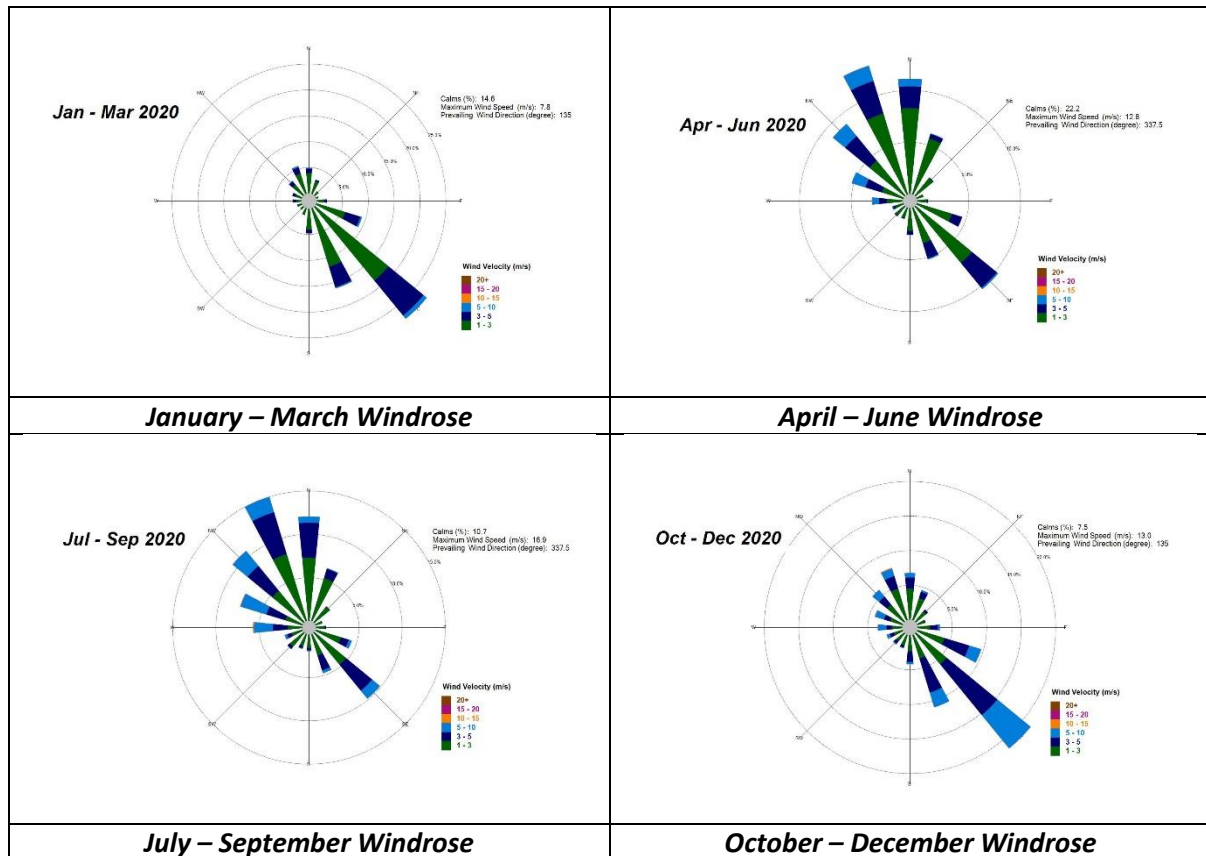
Figure 2: Quarterly Windroses

Quarterly wind roses are provided in **Figure 2**. These results are generally consistent with the predominant wind patterns in the Hunter Valley.

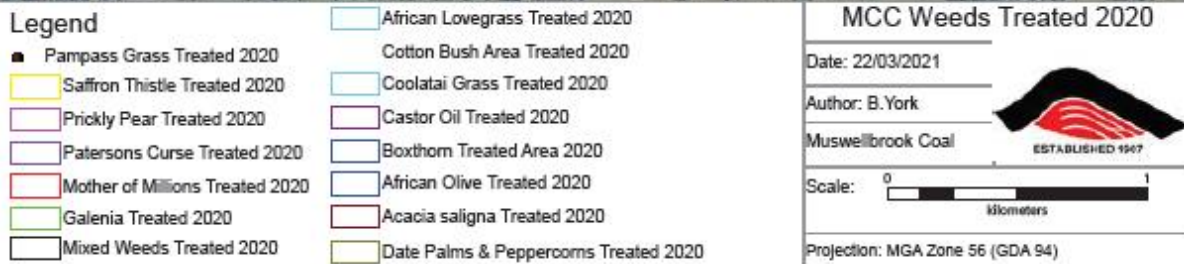
Figure 22: Weed Control Areas

The areas that were targeted during the reporting period are shown in **Figure 22**.

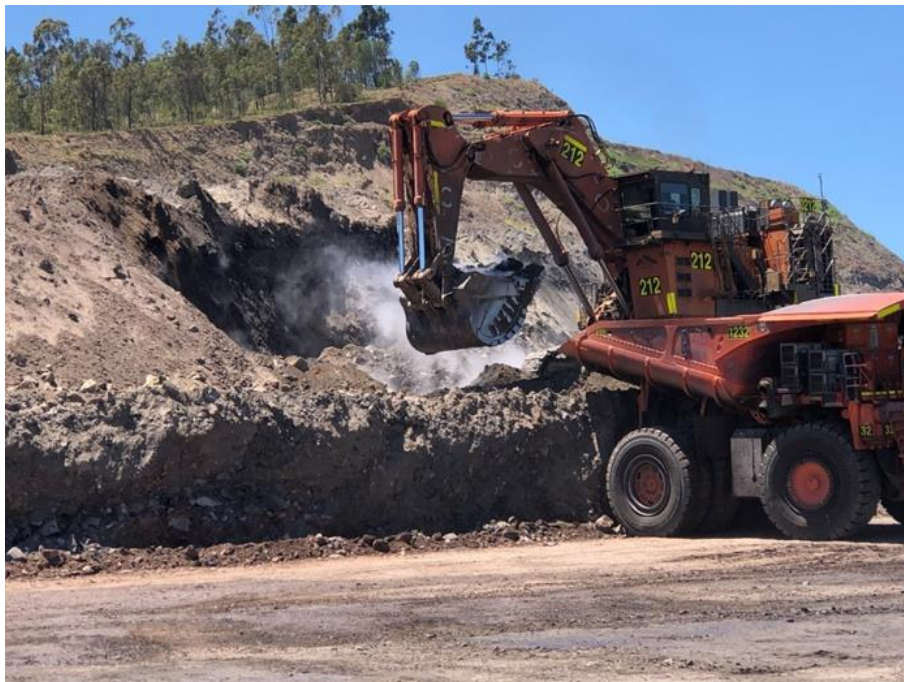
Figure 33: Photo of Spontaneous Combustion in previously dumped overburden

- isolated “pockets” of spontaneous combustion in previously dumped overburden adjacent to the No.2 Open Cut area have been quickly identified, mined out and dumped in the required dump area (Figure 33).

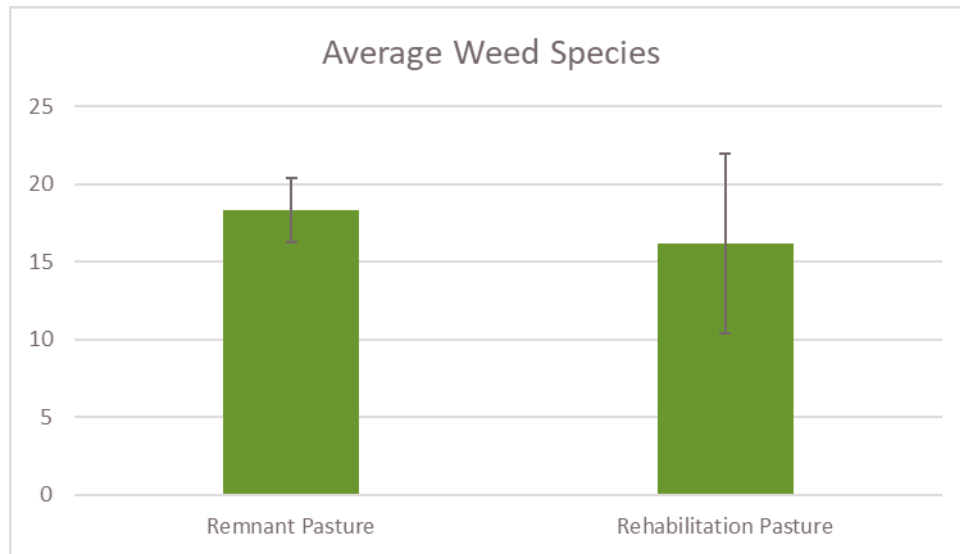
Figure 47: Comparison Between Remnant and Rehabilitation Pasture Sites for Average Weed Species Richness

The average number of weed species has been compared between remnant and rehabilitation pasture sites (**Figure 47**). The average weed species present at both remnant and rehabilitation pasture sites was very similar, with remnant pasture sites comprising 18 weed species and rehabilitation pasture sites comprising 16 species.
