MUSWELLBROOK COAL COMPANY

2021
ANNUAL ENVIRONMENTAL
MANAGEMENT REPORT

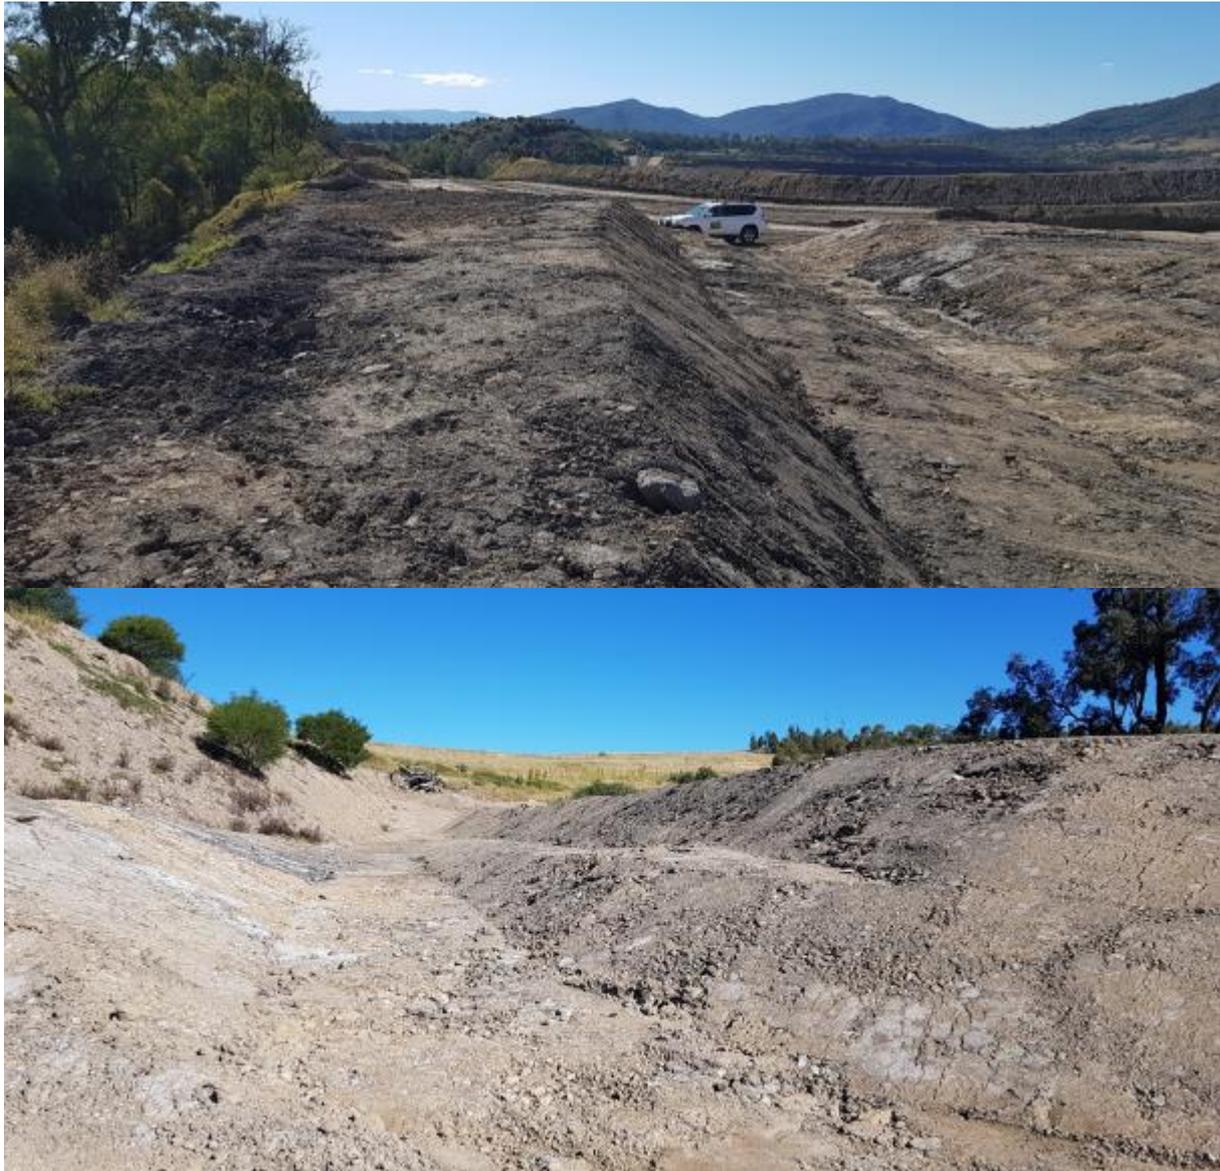
Figure 1: Photos showing improved drainage

- Response to Recommendation 3 – Earthworks have been completed at the head of the gully to prevent future erosion by improving the windrow width and redirecting water onto Open Cut 1 (**Figure 1** below). The area where water was pooling at the side of the mine access road has been built up to prevent pooling and facilitate drainage towards the pit. This work will be inspected after the next significant rainfall event to confirm that water is no longer pooling against the windrow at the head of the gully.

As noted during the inspection 21 April 2021, remediation works to retrieve the sediment deposited in the drainage line of the non-disturbance area would be likely to cause more damage. The focus will therefore be on preventing reoccurrence. The sediment deposited in the gully is showing signs of stability, with much of the drainage line exhibiting groundcover vegetation except for a short section above the dam at the bottom of the drainage line. MCC will desilt the dam at the bottom of the drainage line in the non-disturbance area to provide capacity for future rainfall runoff flows.

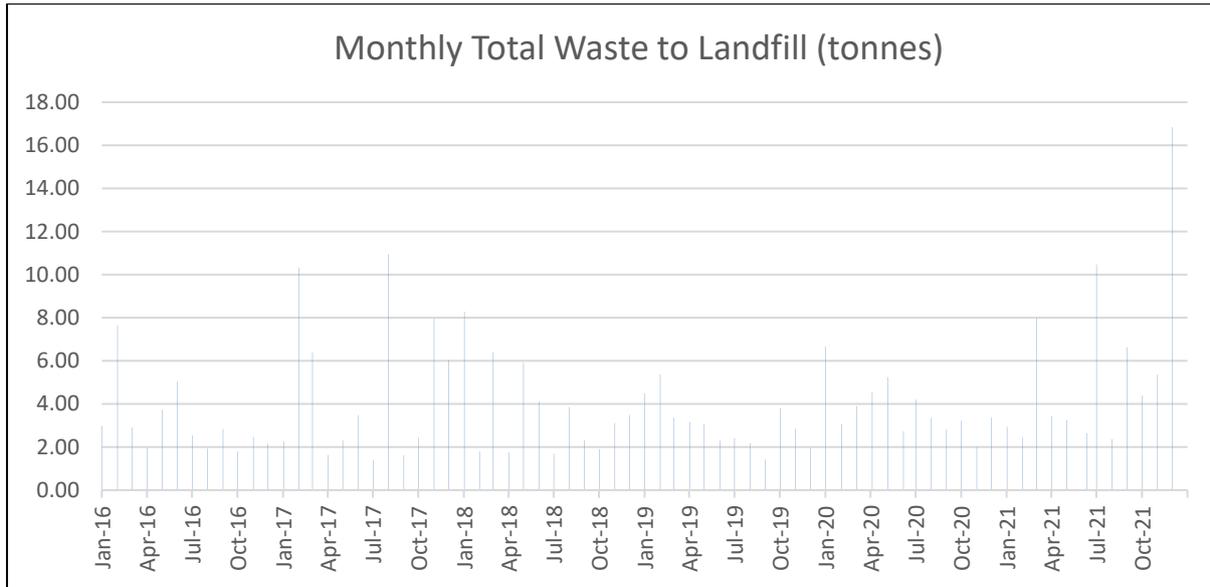
Figure 3: Monthly Total Waste to Landfill (tonnes) 2016-2021

Figure 3 shows the monthly total waste to landfill in tonnes between 2016 and 2021.

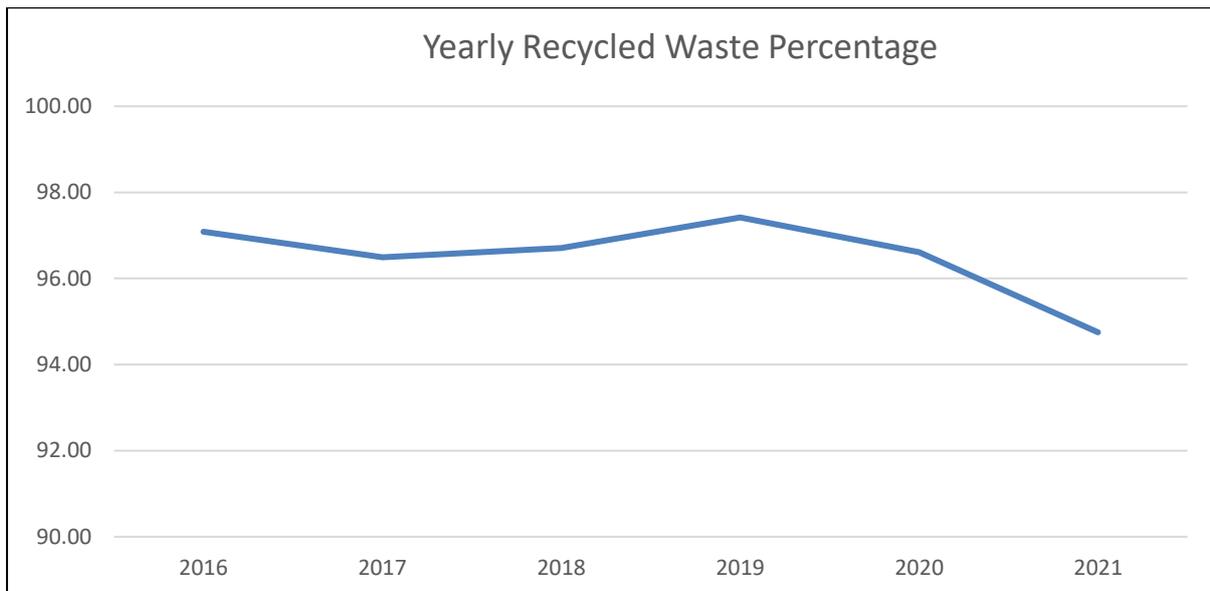
Figure 4: Waste Percentage Recycled 2016-2021

Figure 4 shows the percentage of total waste recycled from 2016 to 2021. This percentage dropped during the reporting period due to increased general waste from site clean ups but remains high at over 94% of the total waste produced.

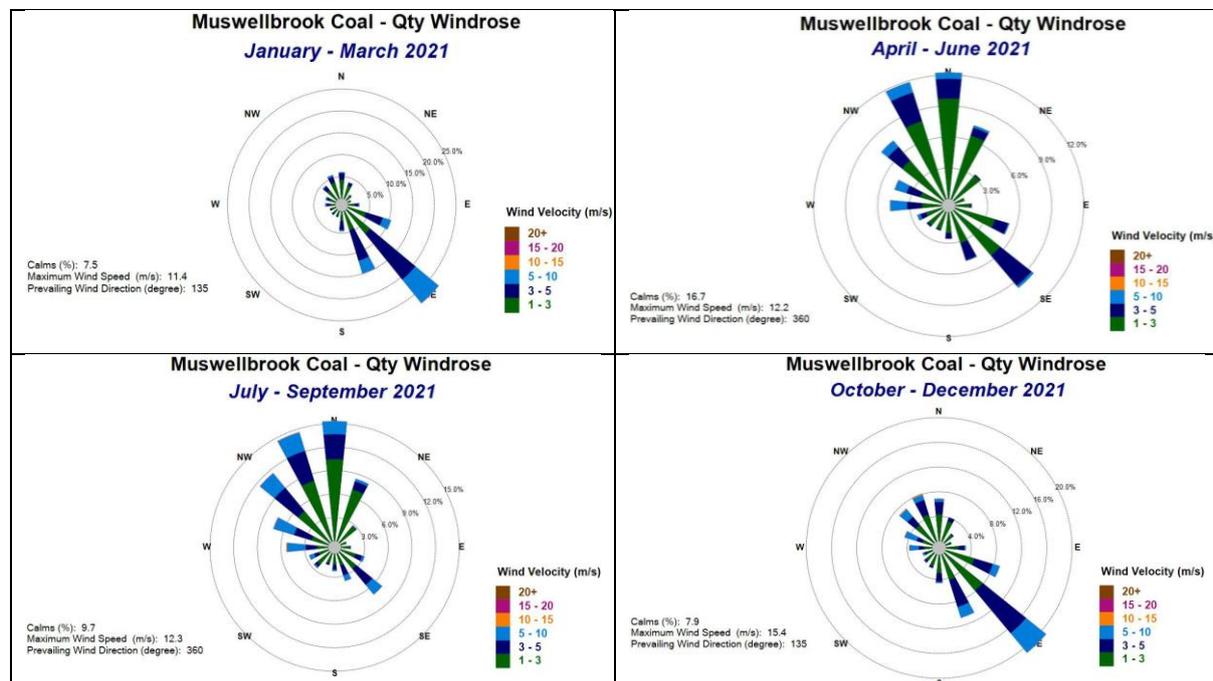
Figure 5: Quarterly Windroses

Quarterly wind roses are provided in **Figure 5**. These results are generally consistent with the predominant wind patterns in the Hunter Valley.

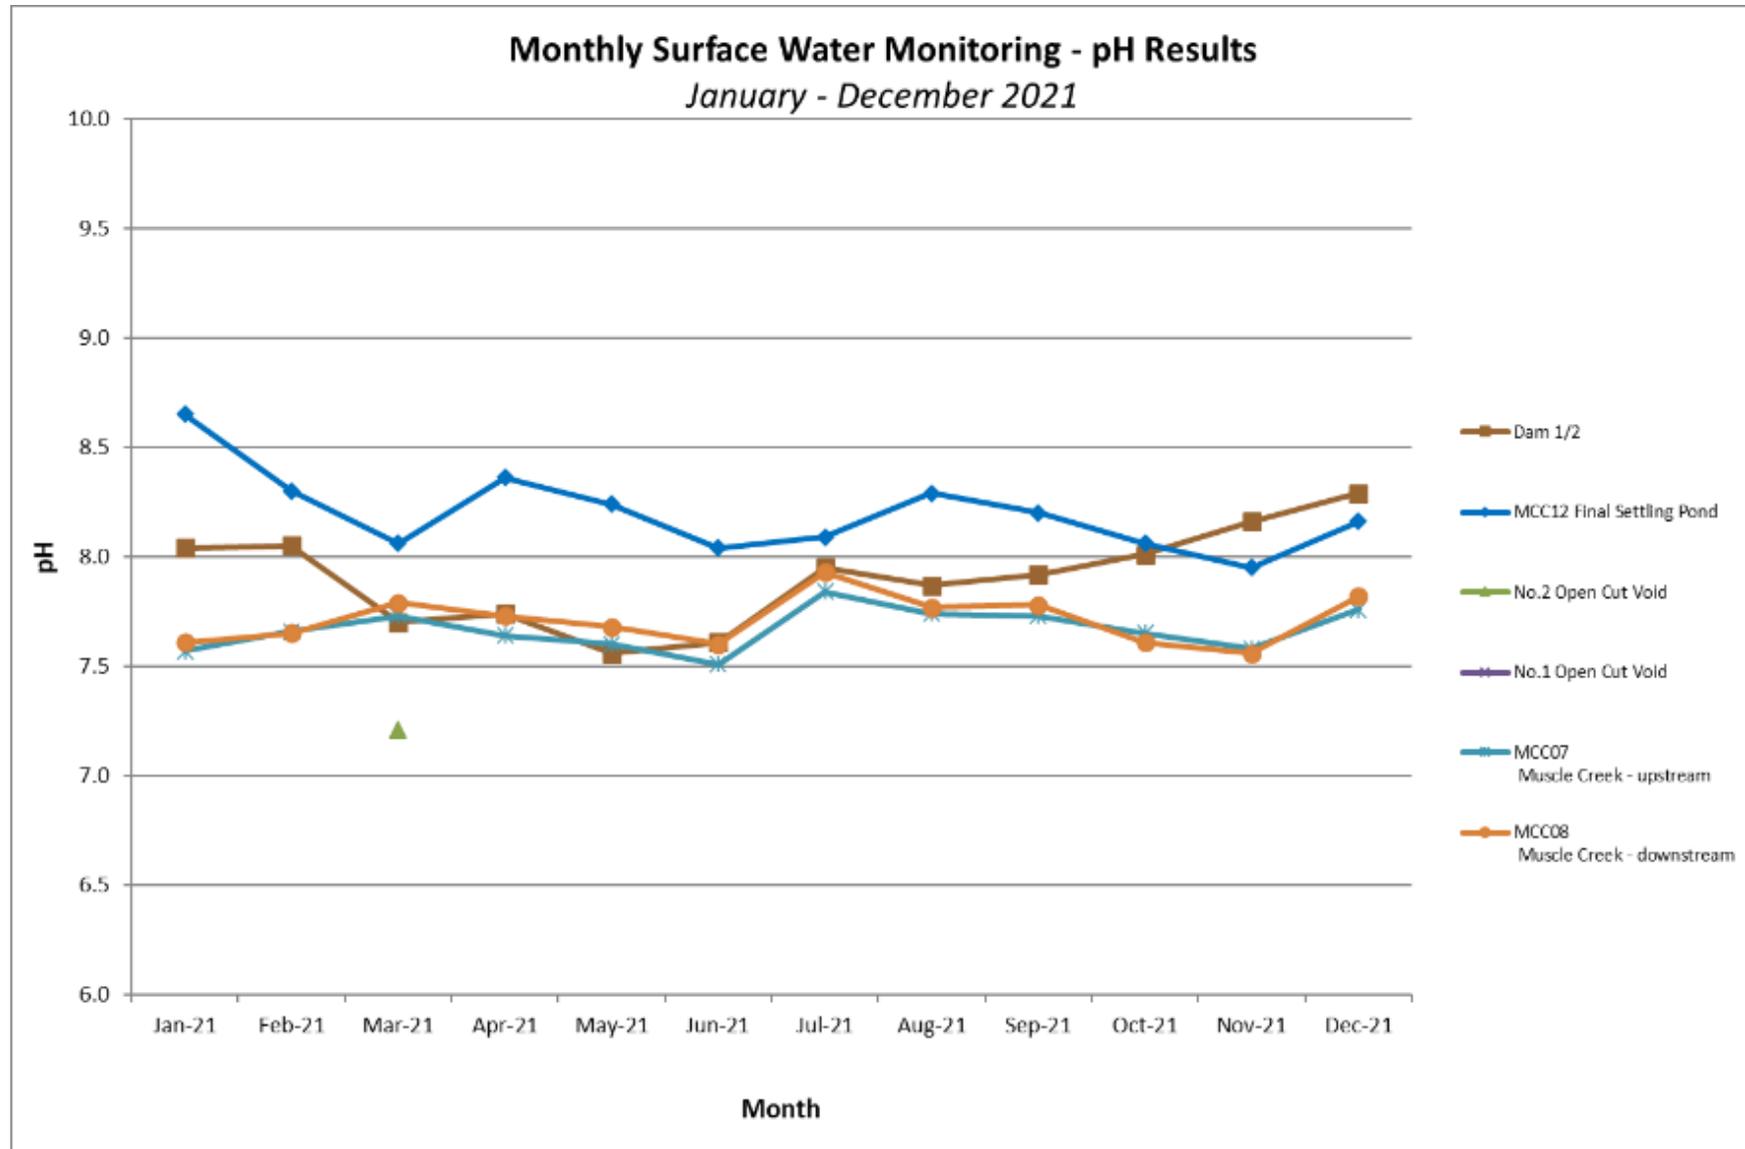
Figure 13: Monthly Surface Water Monitoring Results – pH

The pH levels at surface water monitoring sites were generally within the recommended ecosystem pH levels of 6.5–9.5 throughout the reporting period (**Figure 13** and **Figure 14**). As shown in **Figure 15**, the results from this reporting period are consistent with the results from previous reporting periods. There are no predictions to compare these results to.

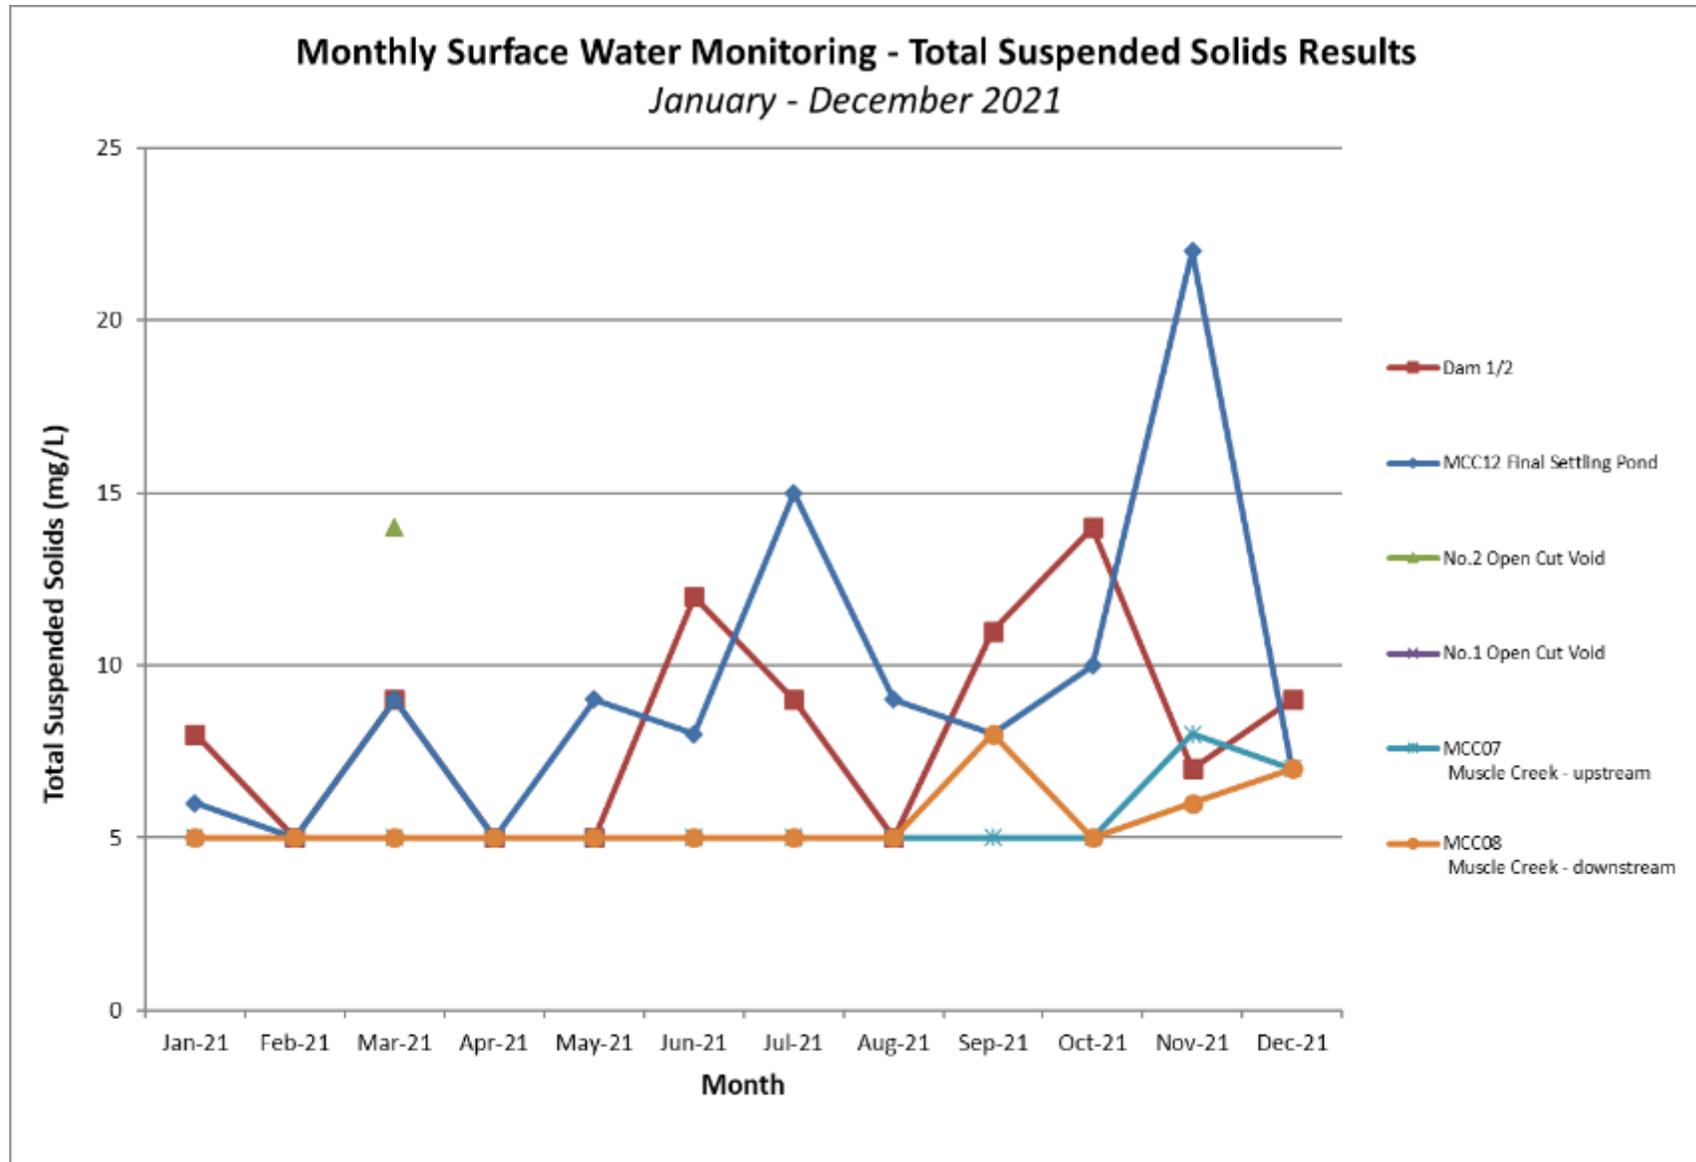
Figure 19: Monthly Surface Water Results – Total Suspended Solids

The results from this reporting period are shown in **Figure 19** and **Figure 20**. As shown in **Figure 21** the results from this reporting period are consistent with the results from previous reporting periods. TSS results can be highly variable with disturbance from desilting works and runoff from heavy rainfall causing short-term increases before conditions return to normal. There are no predictions to compare these results to.

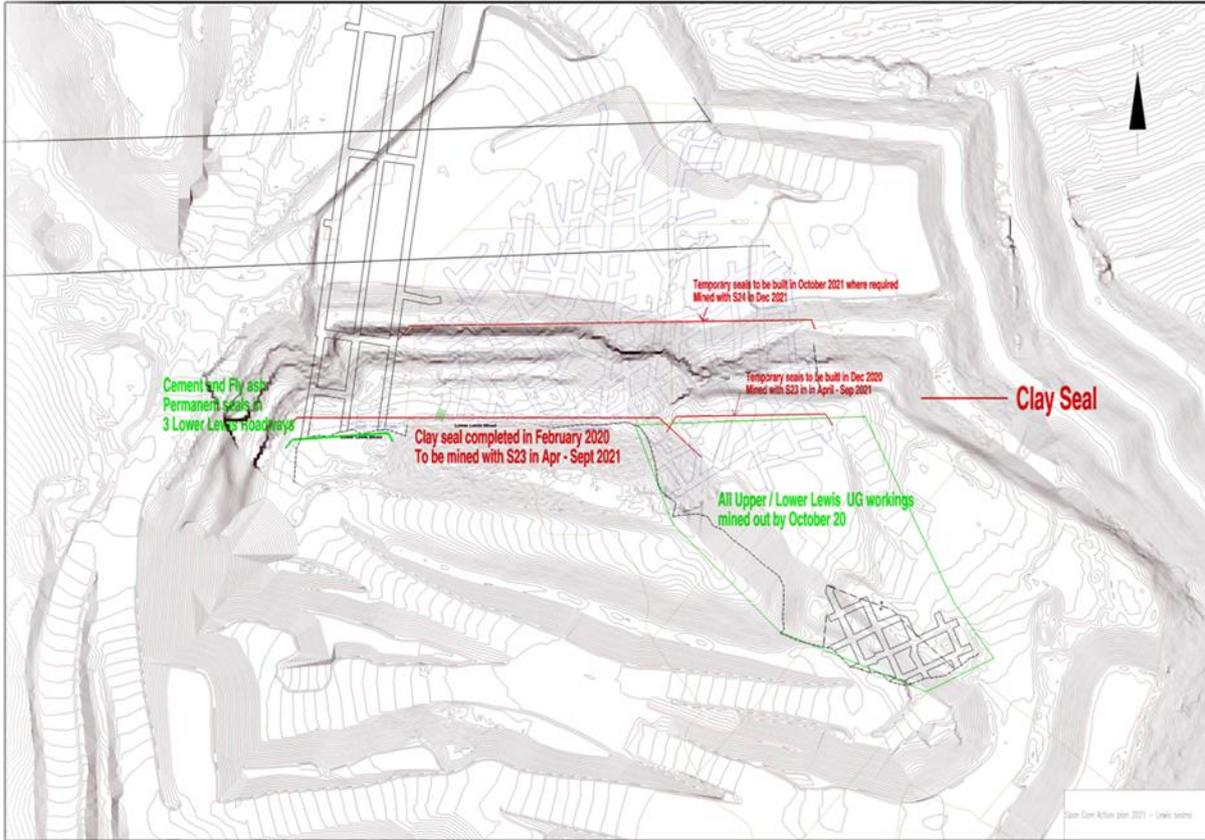
Figure 38: Proposed and Actual sealing in Lewis Workings

The planned sealing activities for this reporting period are shown in **Figure 38** to **Figure 39**.

The sealing activities for the reporting period happened as per the plan.

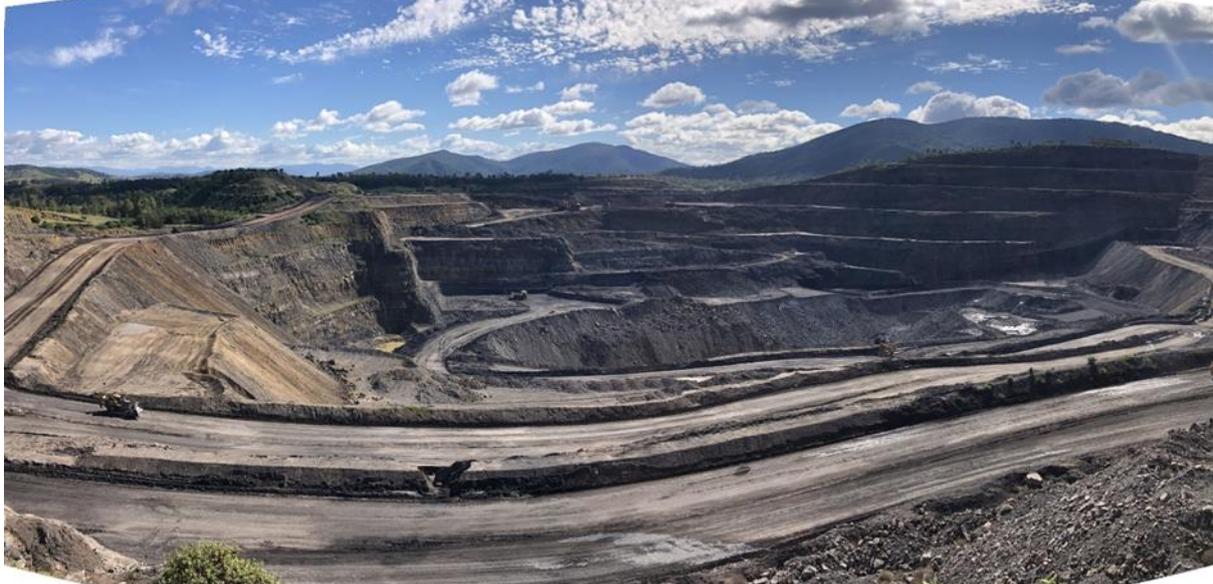
- Spontaneous combustion control and, where it was present, management of spontaneous combustion in overburden dumps was excellent. While this was assisted at times by higher rainfall, the control “on the ground” provided excellent results.
- The control and management of higher temperature coal was also very well managed with stockpile residence time kept very low to minimise spontaneous combustion.
- The use of fragmented rill material, together with additional water kept spontaneous combustion to a minimum even during the mining of the coal seams.
- The detailed planning, rescheduling and execution of mining to ensure that all underground workings in the old St Heliers Colliery are mined has shown the commitment of all personnel.

Figure 40: Photo of Open Cut 1 showing effective Spontaneous Combustion Management

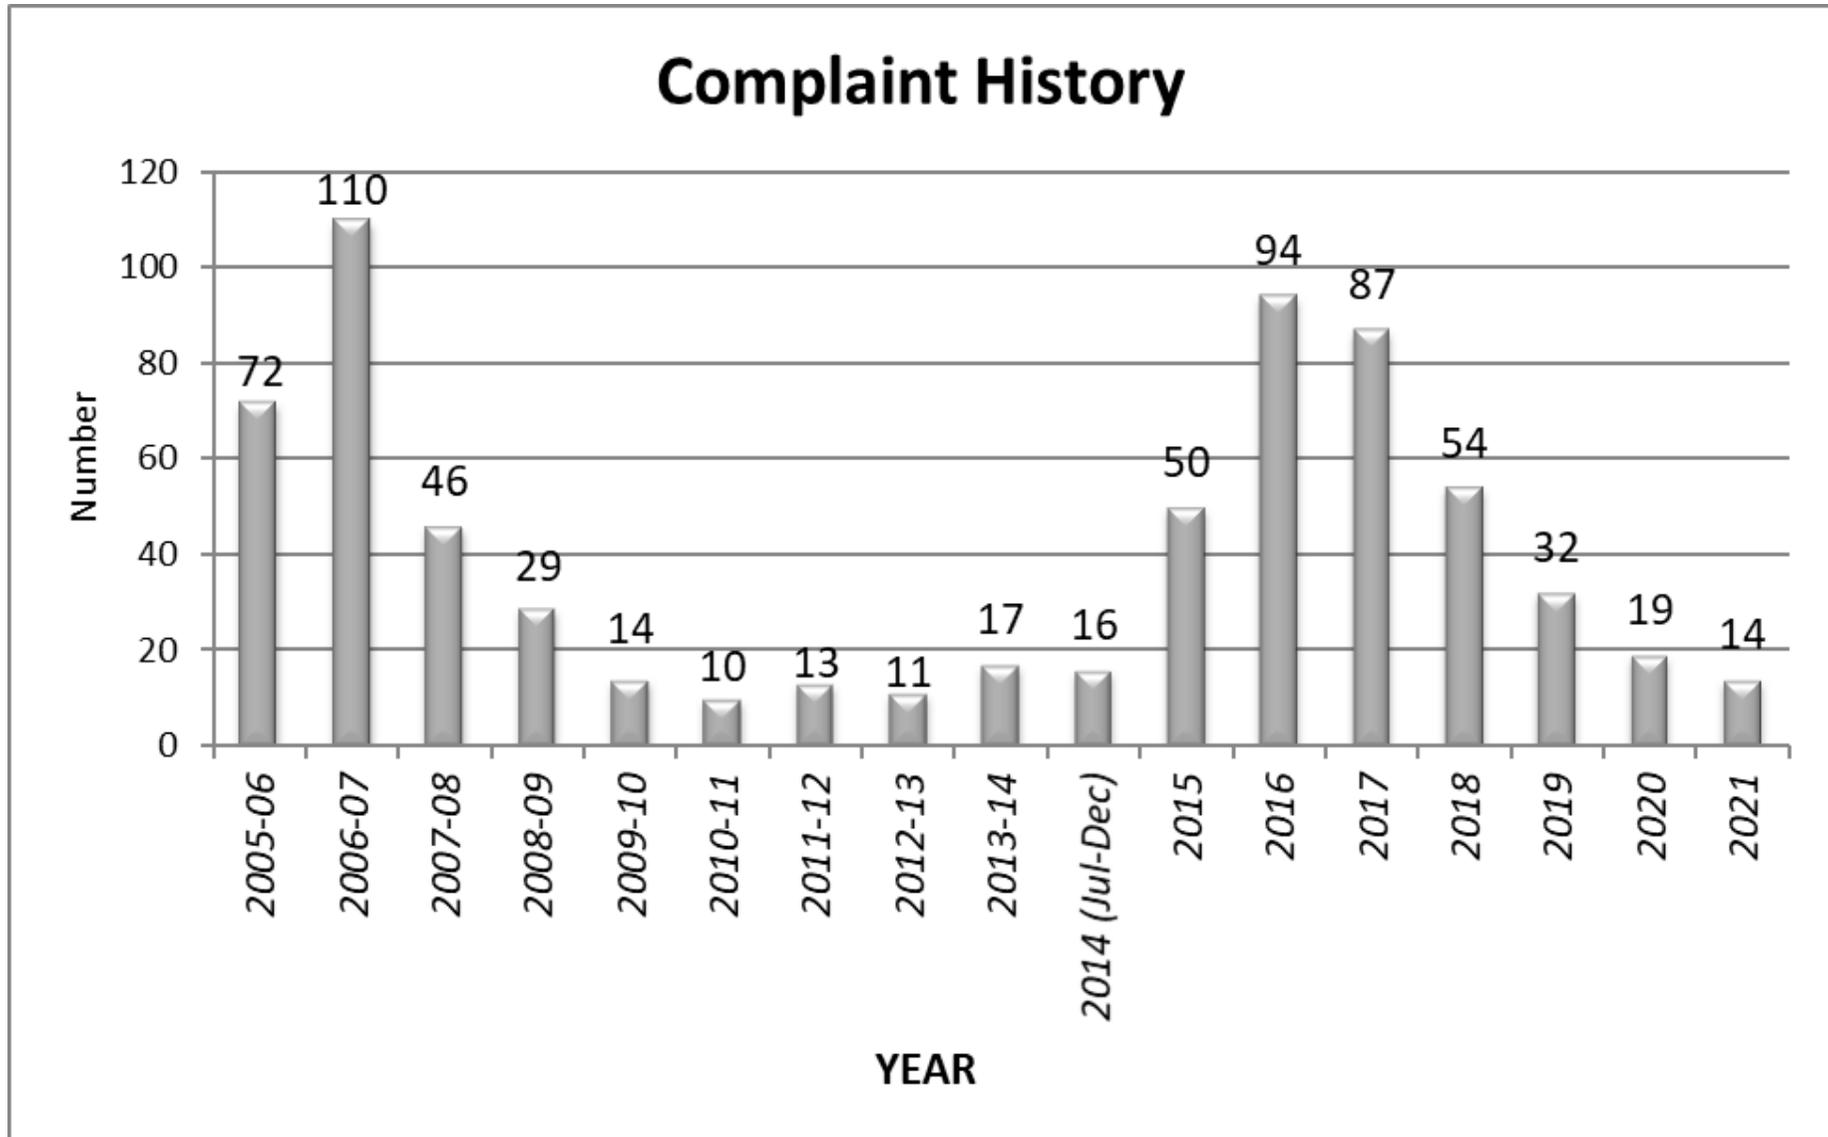
Figure 42: Complaint History

In comparison to 2020, there has been a decrease in the number of complaints received during this reporting period. The complaint history chart is shown in **Figure 42**. In comparison to the last reporting period, there has been a significant decrease in the number of odour related complaints (7 for this reporting period compared to 13 for the previous reporting period).

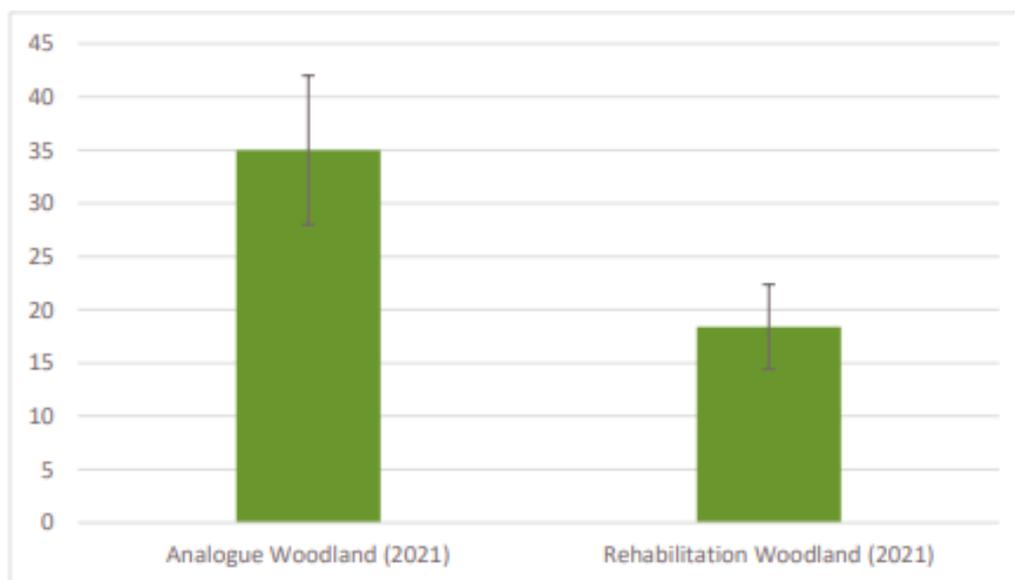
Figure 44: Comparison of Average Native Species Richness at Woodland Sites

The species richness measured at each woodland monitoring site this reporting period is represented in **Figure 44**. The average number of native species present within the rehabilitation woodland sites is just above half (18) that of native species present across the analogue woodland sites (35).

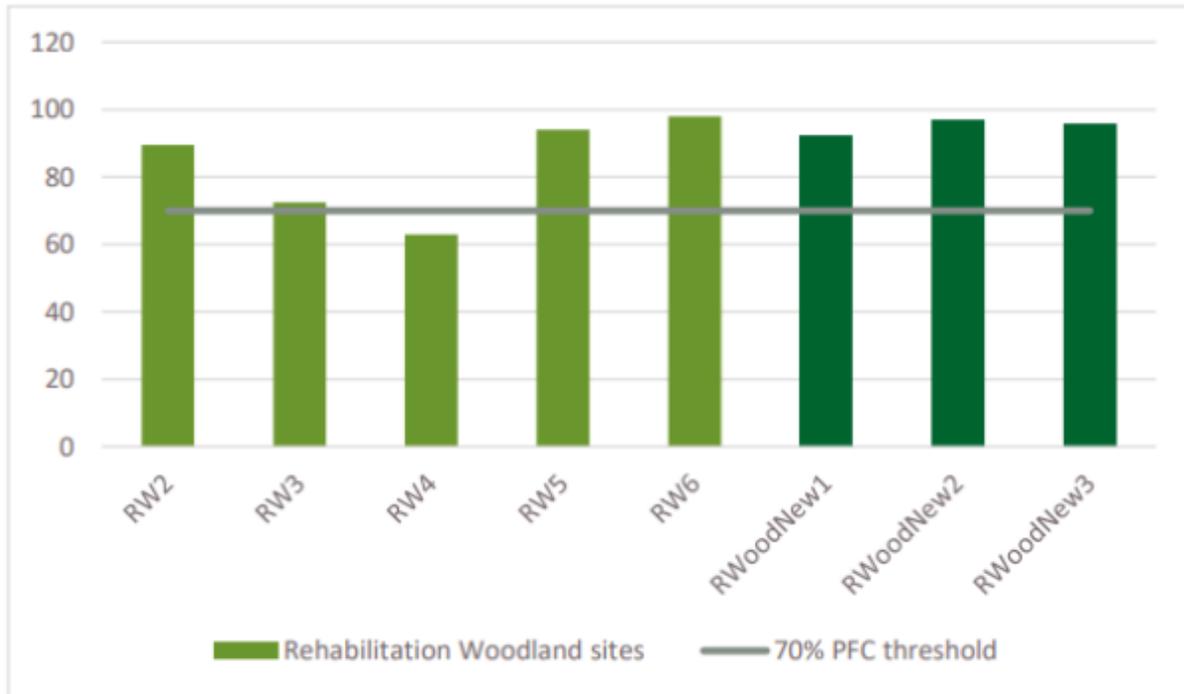
Figure 45: Total Projected Foliage Cover at Rehabilitation Woodland Sites

The total Projected Foliage Cover (PFC) at each of the rehabilitation woodland sites has been calculated and compared against the Ecosystem and Land Use Establishment Phase completion criteria (>70%) presented in **Figure 45**. Only RW4 was below the completion criteria requirement in 2021. The total PFC recorded at rehabilitation sites ranged from 98% (at RW6) to 63% (at RW4). In comparison the total PFC recorded at analogue woodland sites ranged from 97% (at RWoodNew2) to 92.5% (at RWoodNew1).

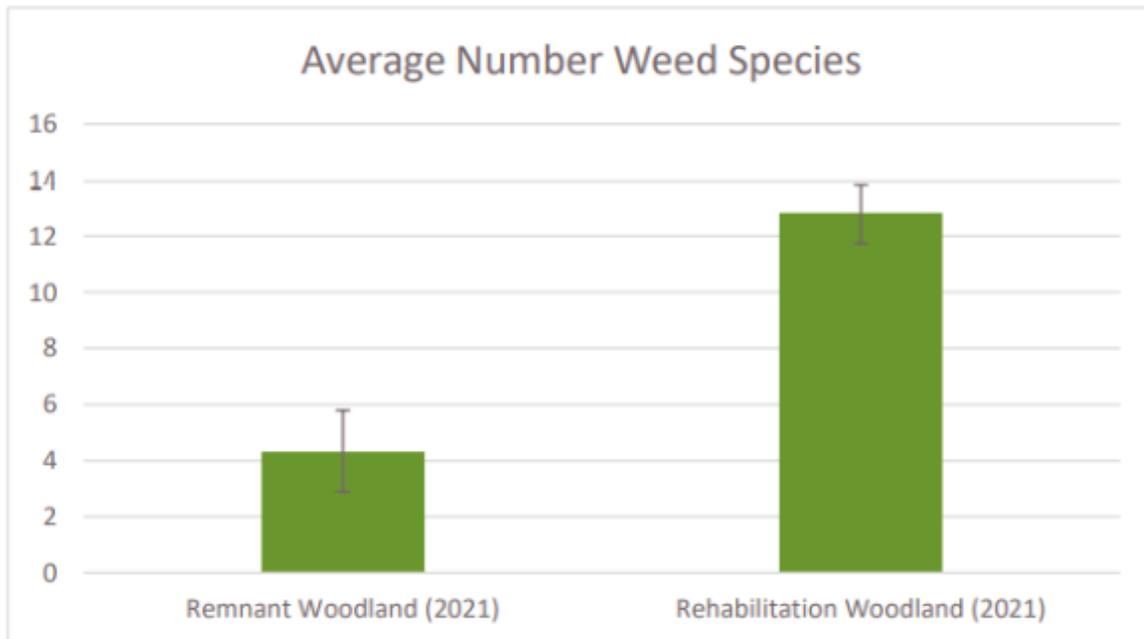
Figure 48: Comparison of Average Number of Weed Species at Woodland Sites

The average weed species present at rehabilitation woodland sites was three times higher than at analogue woodland sites. Rehabilitation woodland sites comprised an average of 13 weed species and analogue woodland sites comprised an average of four weed species. (Figure 48).

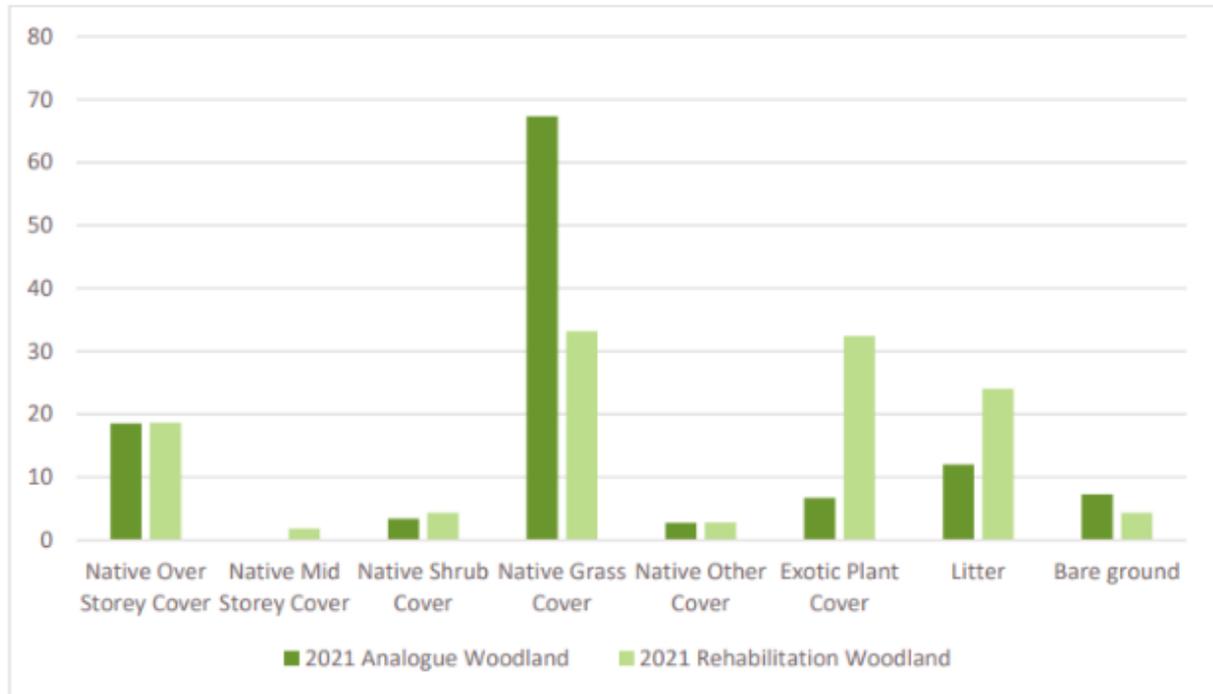
Figure 49: Biometric Data Averages

The analogue and rehabilitation woodland sites had comparable average over-storey cover, shrub cover and native 'other' cover, and rehabilitation woodland sites had almost double the amount of litter cover and slightly less bare ground than analogue Woodland sites. The high ground cover is valuable for erosion protection. However, the native grass cover percentages at analogue sites was double that of Rehabilitation sites and analogue woodland sites also had considerably less exotic cover at almost four times less than rehabilitation sites.

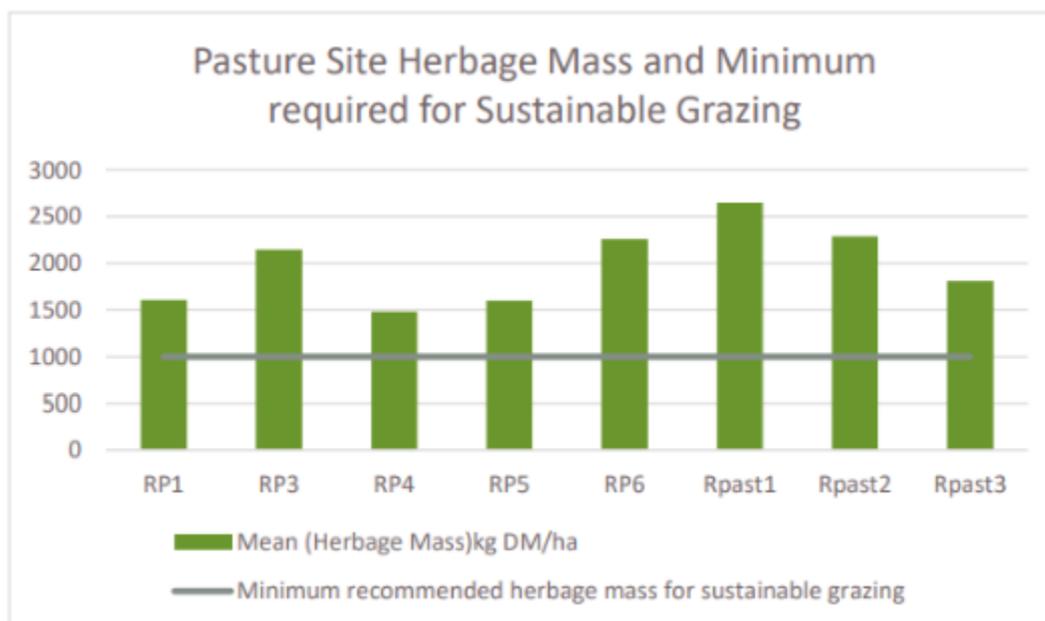
Figure 50: Pasture Site Herbage Mass (kg DM/ha) and Minimum Required for Sustainable Grazing

The herbage mass for each of the analogue and rehabilitation sites is presented in **Figure 50** below and shows that all analogue and rehabilitation sites are above the minimum required for sustainable grazing.

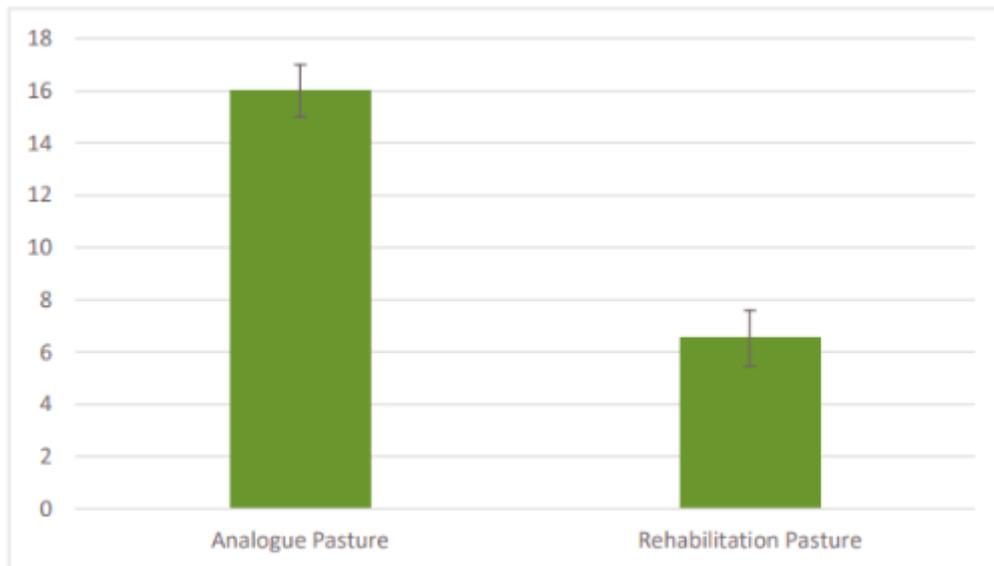
Figure 52: Comparison Between Analogue and Rehabilitation Pasture Sites for Average Native/Desirable Species

The average number of native/desirable pasture species has been compared between analogue and rehabilitation pasture sites (Figure 52). The average number of native/desirable species present within the rehabilitation pasture sites for this reporting period is just under half (7) that of native/desirable species present across the analogue pasture sites (16).

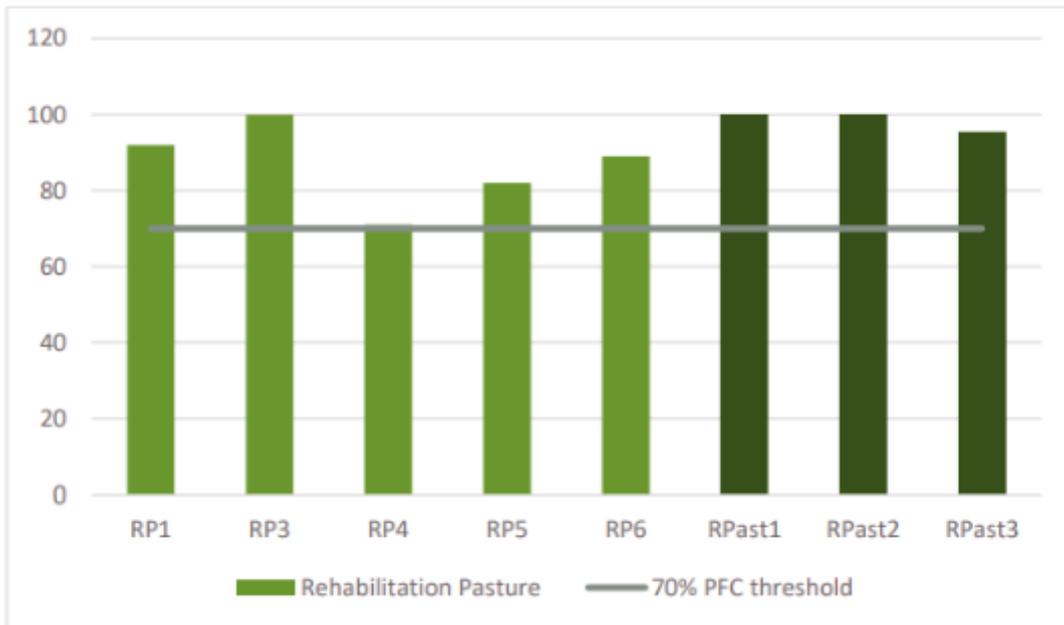
Figure 53: Total Projected Foliage Cover at Analogue and Rehabilitation Pasture Sites in 2021

The total Projected Foliage Cover (PFC) at each of the rehabilitation pasture sites has been calculated and compared against the Ecosystem and Land Use Establishment Phase completion criteria from the MOP (>70%) Figure 53. The data shows that PFC was comparable between rehabilitation sites RP1,

RP3, RP5 and RP6 and the analogue pasture sites. The results from RP4 were below the average, however they met the 70% PFC completion criterion.

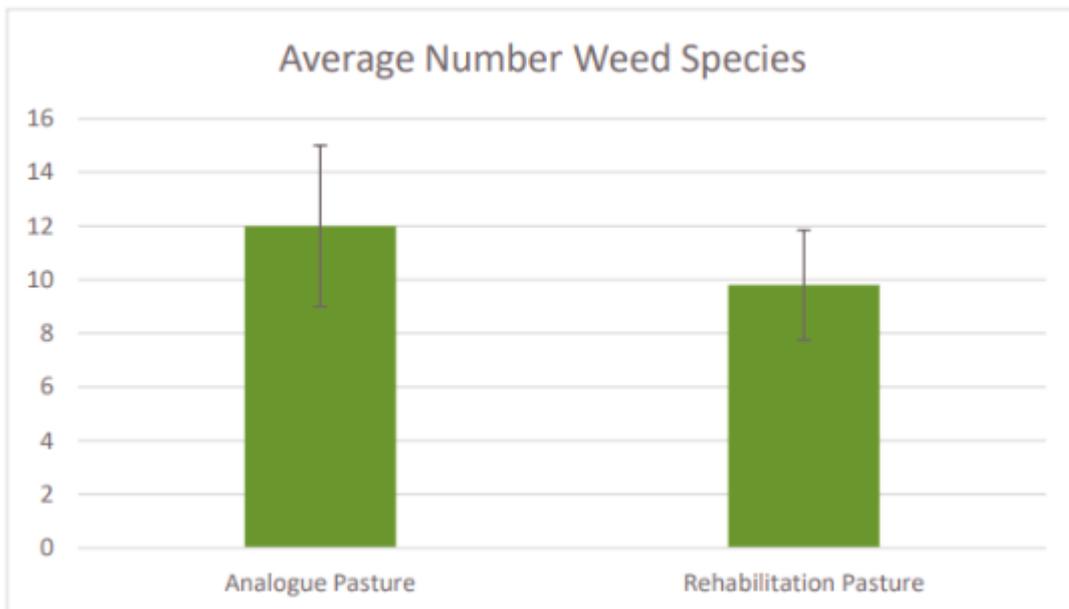
Figure 54: Comparison Between Analogue and Rehabilitation Pasture Sites for Average Weed Species Richness

The average number of weed species has been compared between analogue and rehabilitation pasture sites (**Figure 54**). The average weed species present at both analogue and rehabilitation pasture sites was similar with analogue pasture sites comprising 12 weed species and rehabilitation pasture sites comprising 10 species.

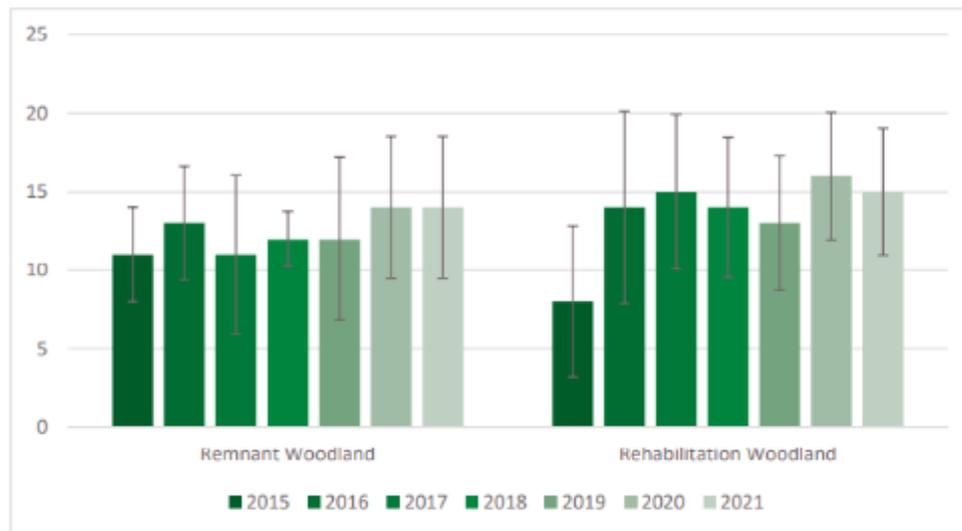
Figure 56: Bird Species Identified at Analogue and Rehabilitation Sites from 2015-2021

Bird species were identified with a comparison between analogue and rehabilitation woodland sites and across the 2015 to 2021 monitoring periods is shown in **Figure 56**. The results show that average bird species numbers recorded at rehabilitation sites have been greater than at analogue woodland sites in the last six years of monitoring. Fifteen or more species have been recorded in three of the seven years at the rehabilitation woodland sites, whereas no more than 14 species have been recorded in any year at the analogue woodland sites.
