Boggabri Coal Operations Pty Ltd
Boggabri Coal Mine
2019 Annual Review
31 March 2020

Annual Review Title Block	
Name of Operation	Boggabri Coal Mine
Name of Operator	Boggabri Coal Operations Pty Ltd
Development Consent/Project Approval #	09_0182
Name of Holder of Project Approval	Boggabri Coal Pty Limited (now trading as Boggabri Coal Operations Pty Limited)
Mining Lease #	CL 368
Name of holder of mining lease	Boggabri Coal Pty Limited (now trading as Boggabri Coal Operations Pty Limited)
Water Licence #	see Table 2-2 below for details
Name of holder of water access licences	Boggabri Coal Pty Limited (now trading as Boggabri Coal Operations Pty Limited)
MOP Commencement Date	1 January 2020
MOP Completion Date	31 December 2024
Annual Review Commencement Date	1 January 2019
Annual Review Completion Date	31 December 2019
I, Anthony Margetts, certify that this audit report is a true and accurate record of the compliance status of Boggabri Coal Mine for the period 1 January 2019 to 31 December 2019 and that I am authorised to make this statement on behalf of Boggabri Coal Operations Pty Limited.

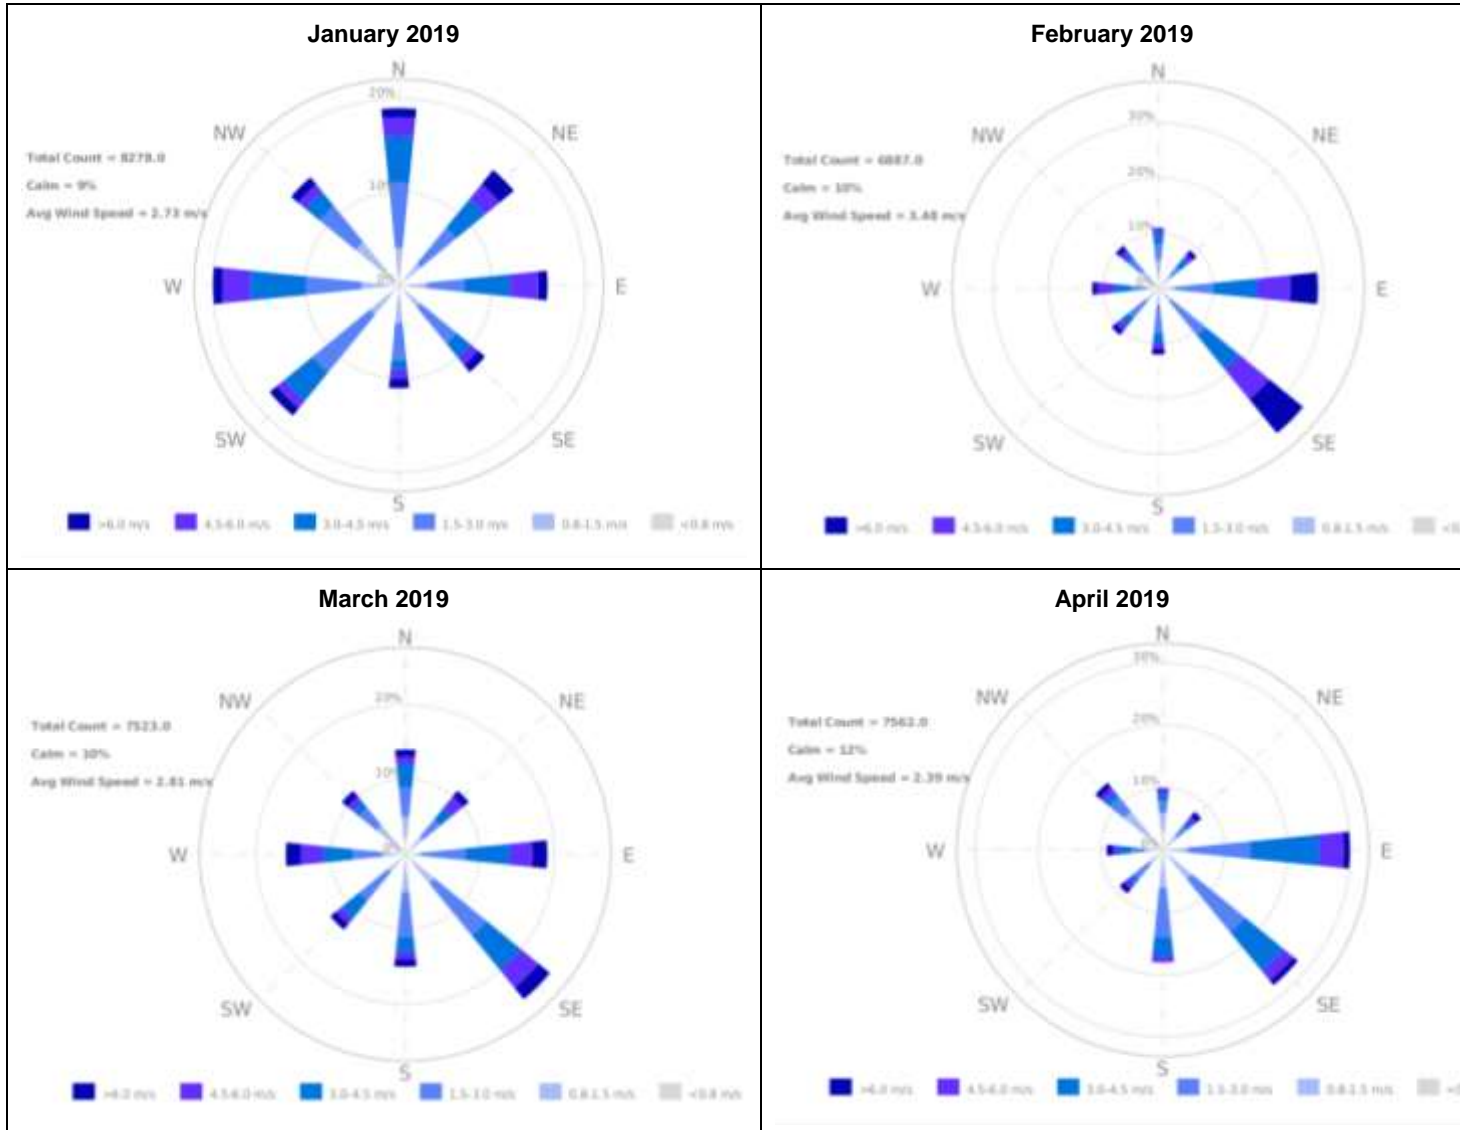
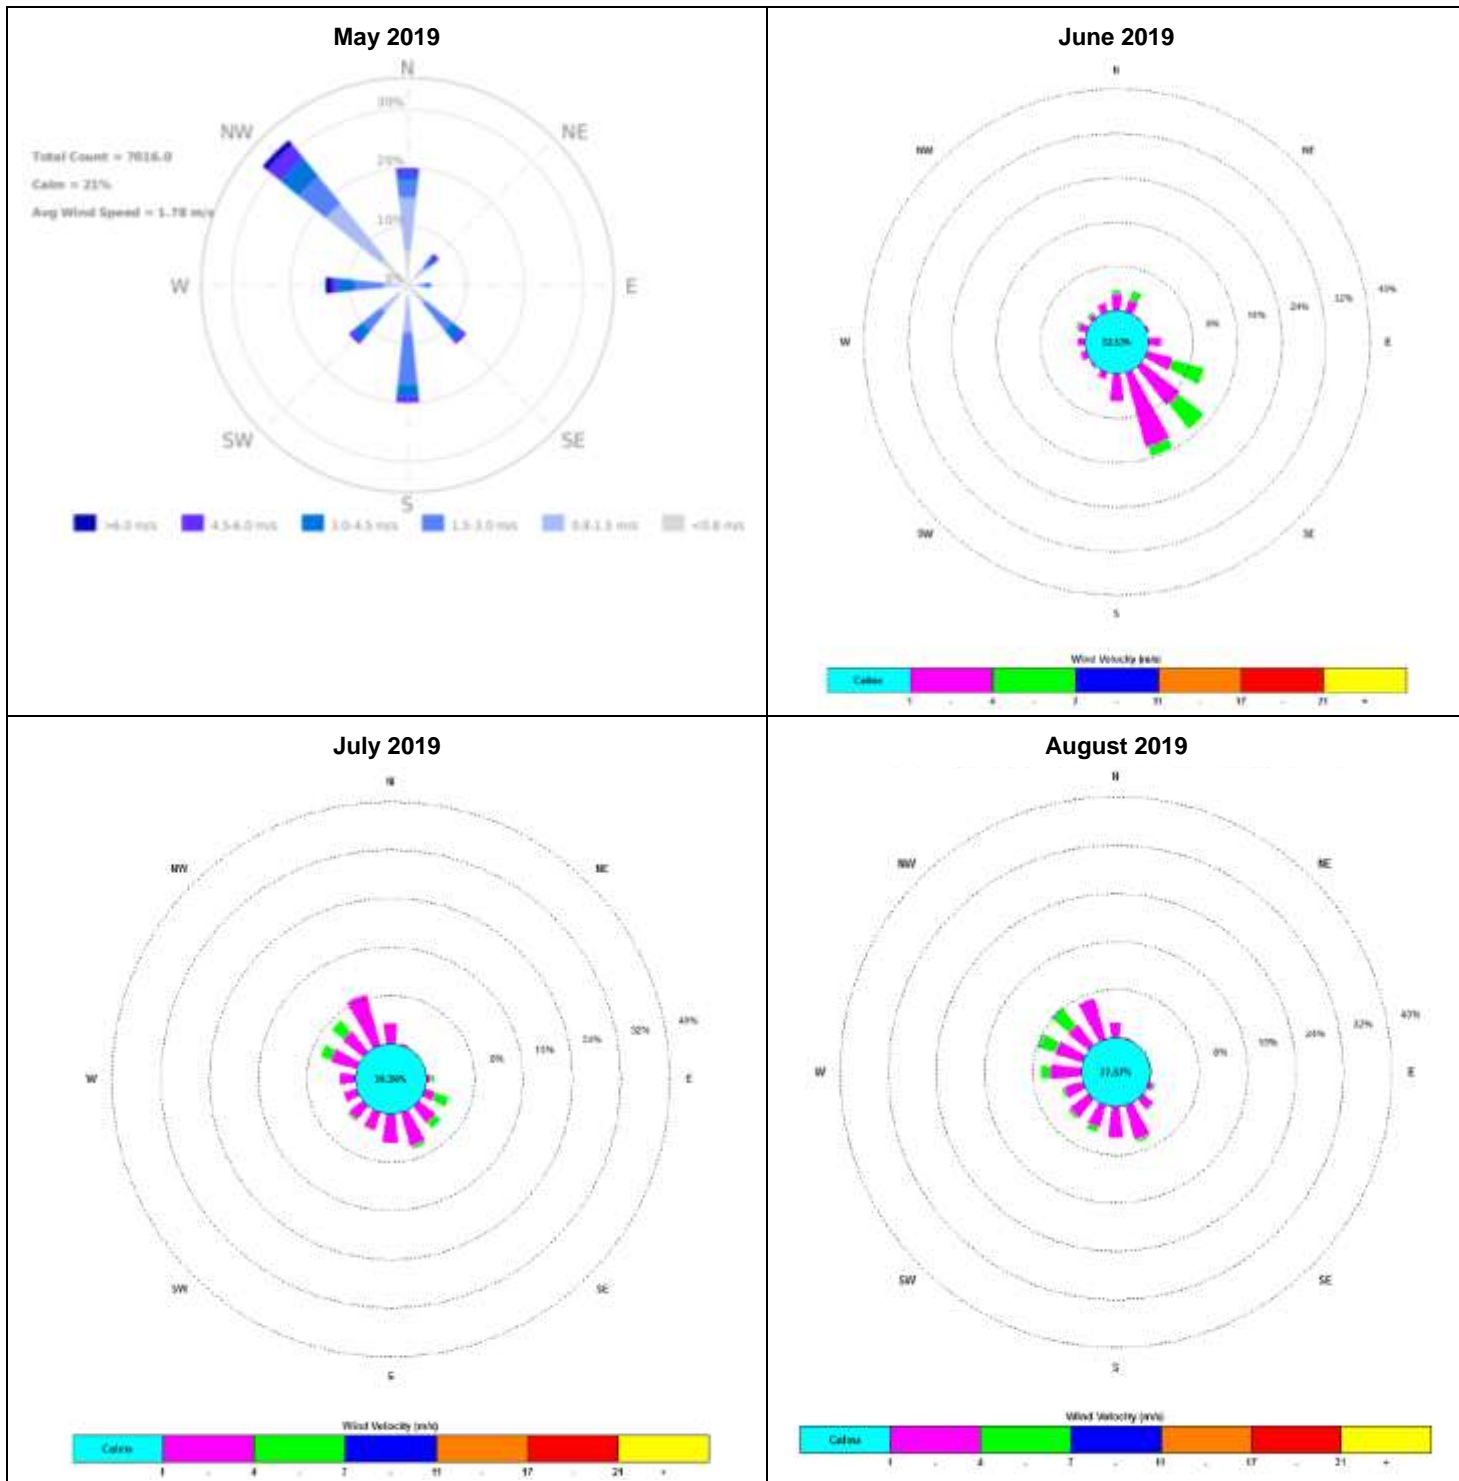
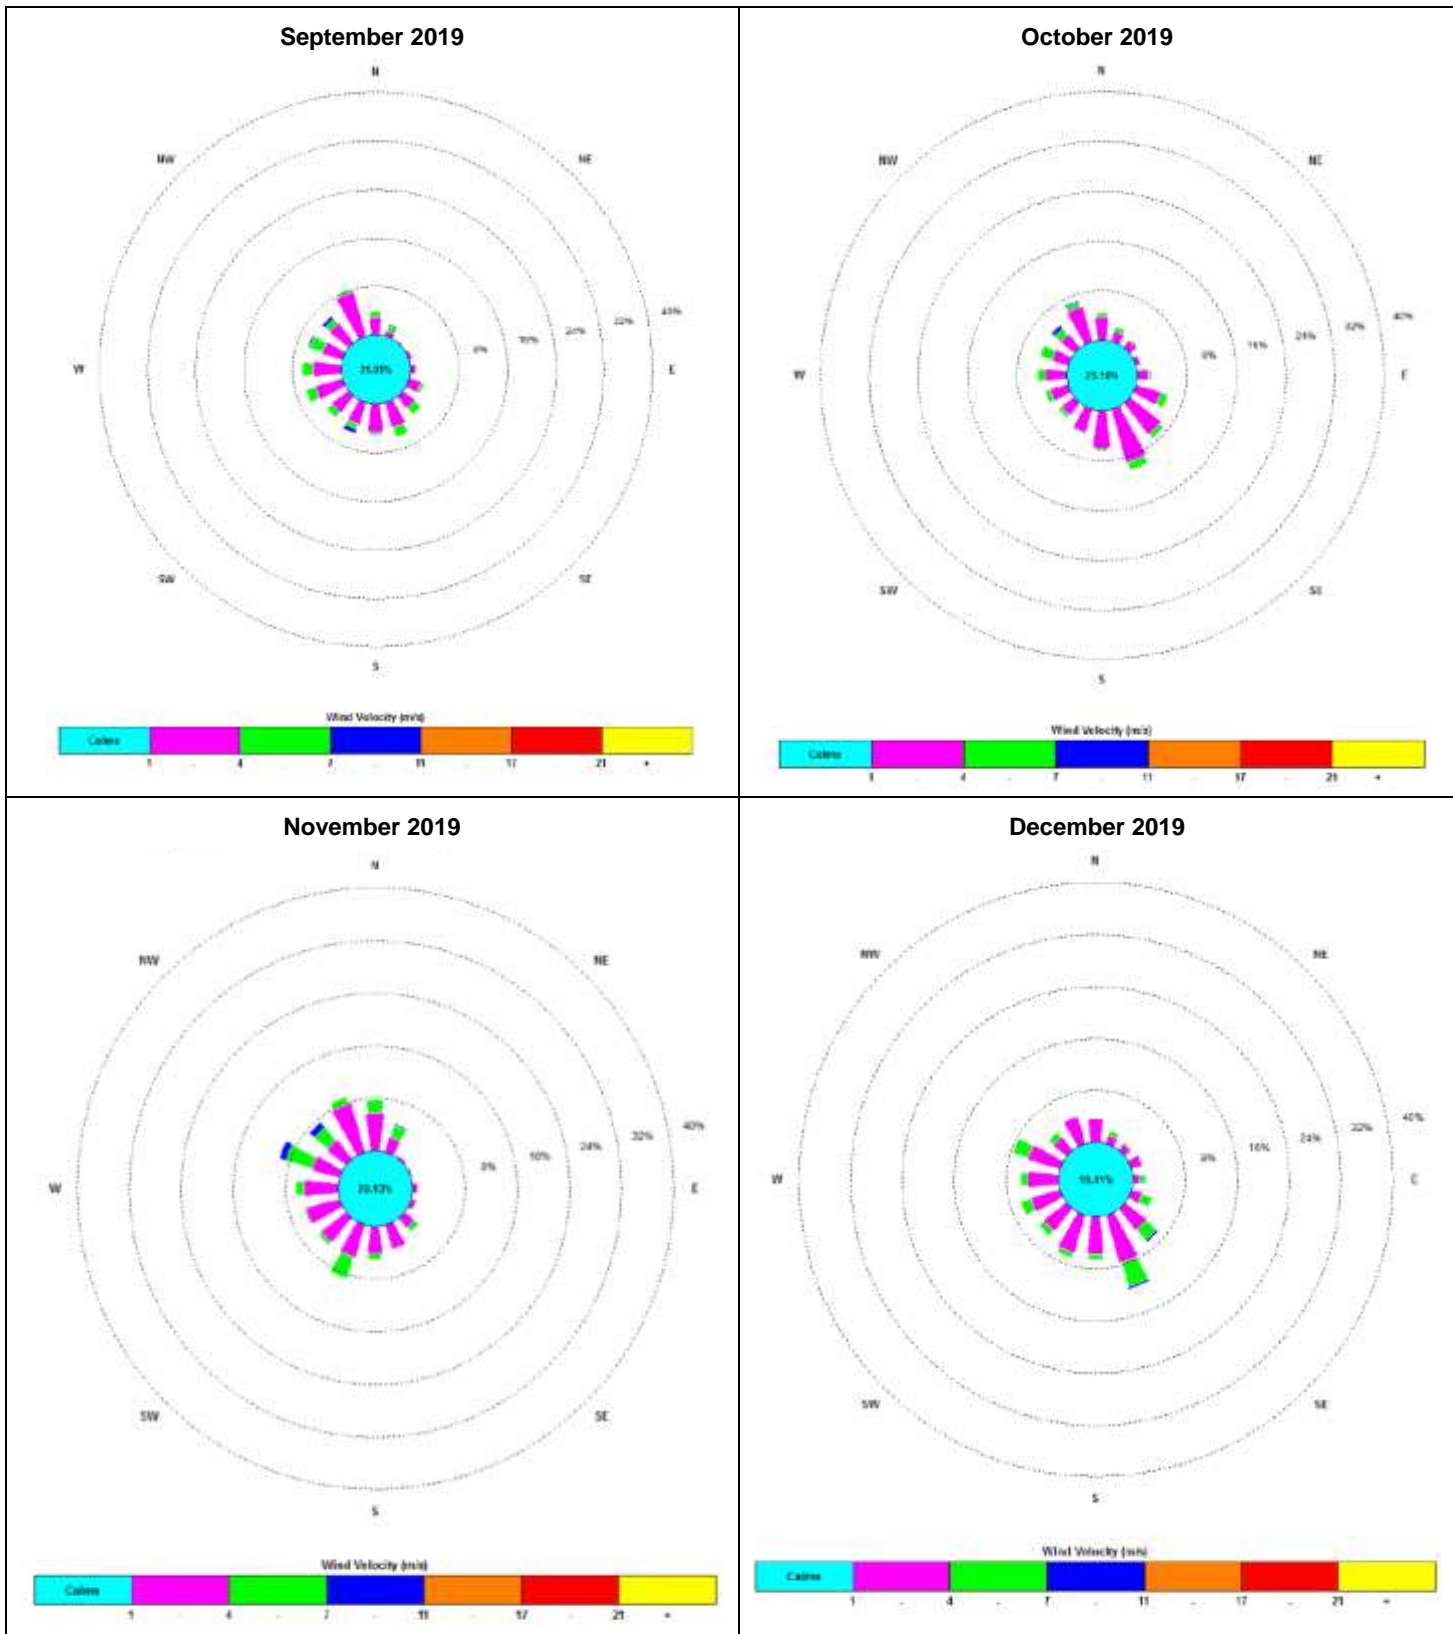
The prevailing wind conditions during this reporting period were relatively consistent with the historical data as presented in the 2010 EA. Average wind speeds were lower in all months except February, March, April and June than the previous reporting period.

The MET data identified that average monthly wind speed generally did not exceed 3 m/s, except in February where the average monthly wind speed was 3.48 m/s.

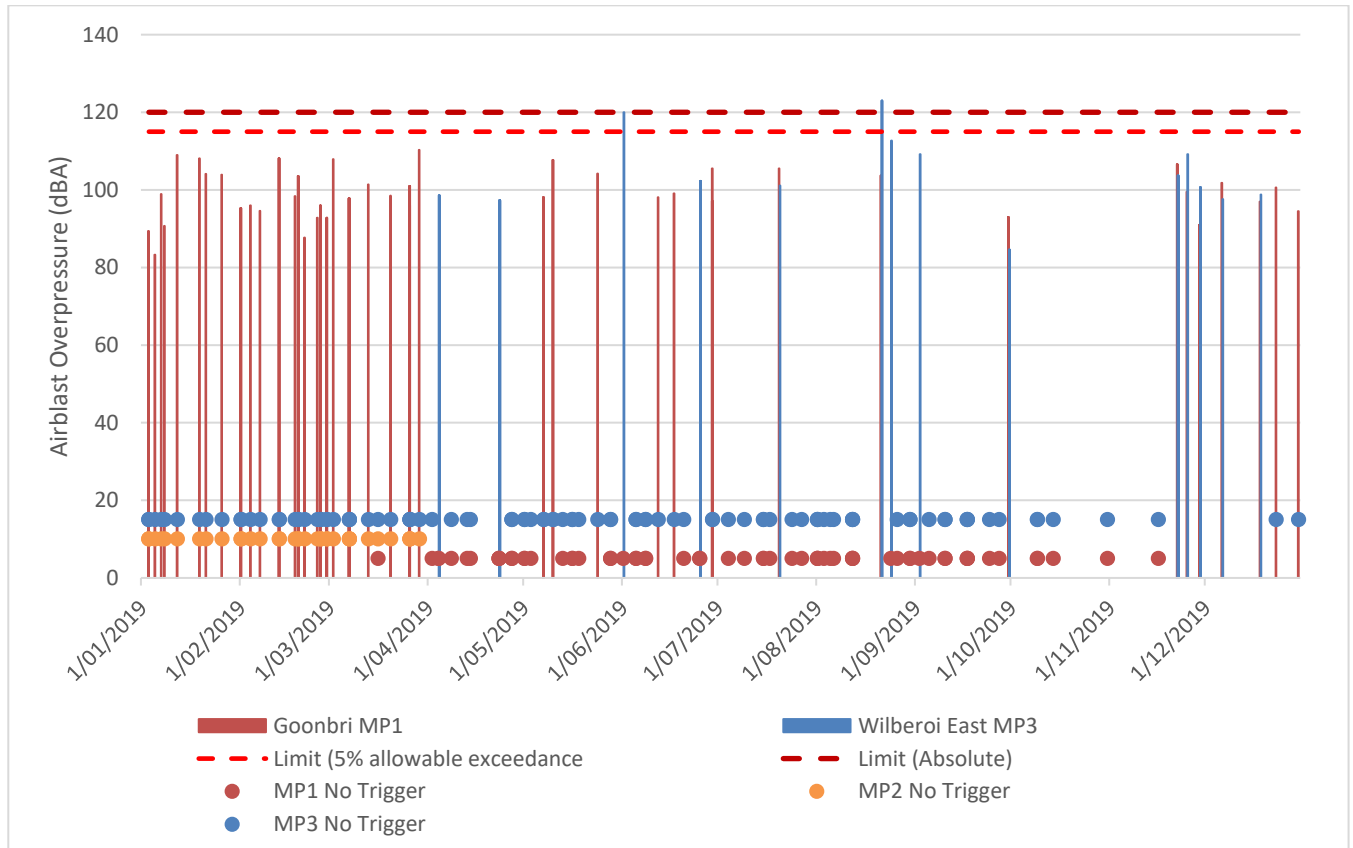
Figure 4-11 Blast Overpressure Results

The monitoring results indicate that one blast exceeded 115 dB(A) overpressure limits (5% allowable exceedance applies) at mine owned property, which did not trigger a non-compliance with the PA as they occurred within the 5% allowable exceedance. One blast exceeded 120 dB(A) overpressure limit at Wilberoi East on 21 August. Analysis of meteorological data at BCM during the period of this blast event was conducted by Todoroski Air Sciences (2019). This exceedance was attributed to a short term fluctuation in the upper air wind conditions that could not have been reasonably foreseen. The exceedance was reported to DPIE on 28 August. BCOPL was issued with a warning letter from DPIE on 18 October 2019 for not reporting the blast overpressure exceedance within seven days of the incident.

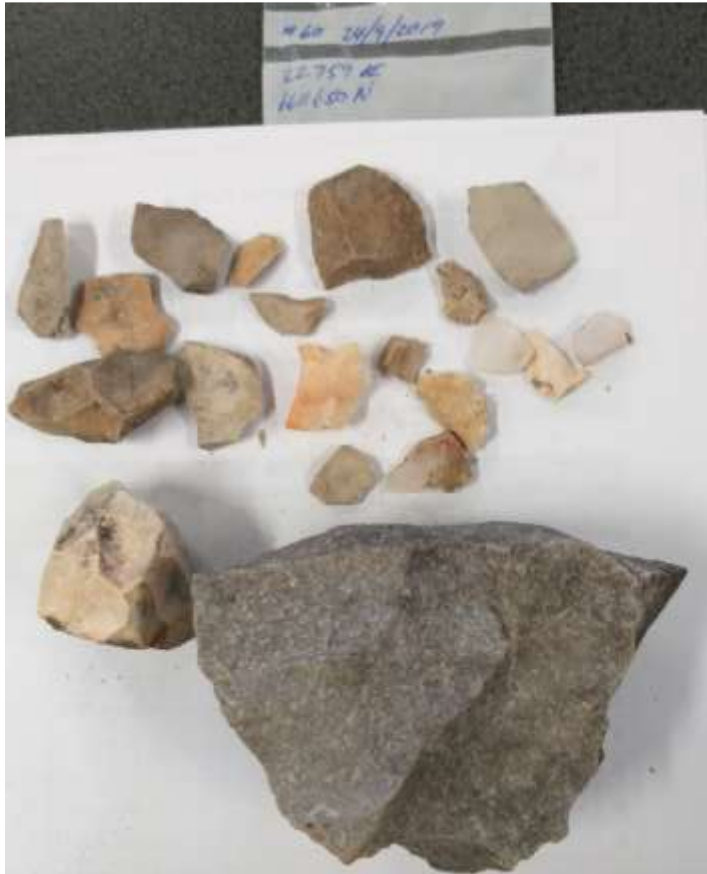
Figure 4-19 Artefacts collected from BC34

Salvage works were also undertaken at BC 34 during the reporting period. BC 34 is an extensive artefact scatter in an area of historic disturbance. The salvage works recovered 69 surface artefacts.

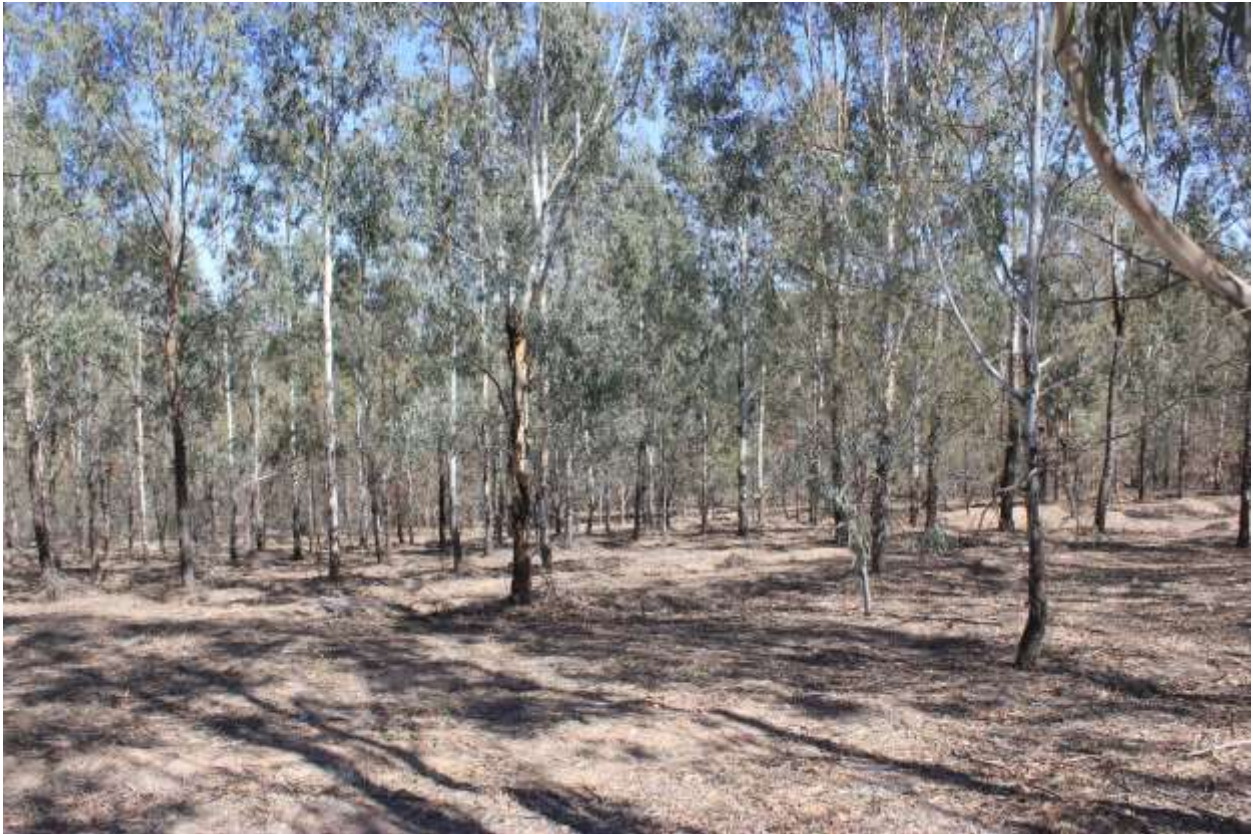
Figure 8-2 2008 Rehabilitation Area (11 years old)

Photographs of the monitoring sites for 2008, 2010, and 2018 rehabilitation areas are provided in Figure 8-2, Figure 8-3 and Figure 8-4 respectively.
