Muswellbrook Coal Company Limited

Spontaneous Combustion Report

For: Environmental Protection Licence 656

Reporting Period:	**March 2020**
Authority Holder:	**Muswellbrook Coal Company Limited**
Report Date:	**29 April 2020**
Approved by:	**Julie Thomas** **Environmental Superintendent**

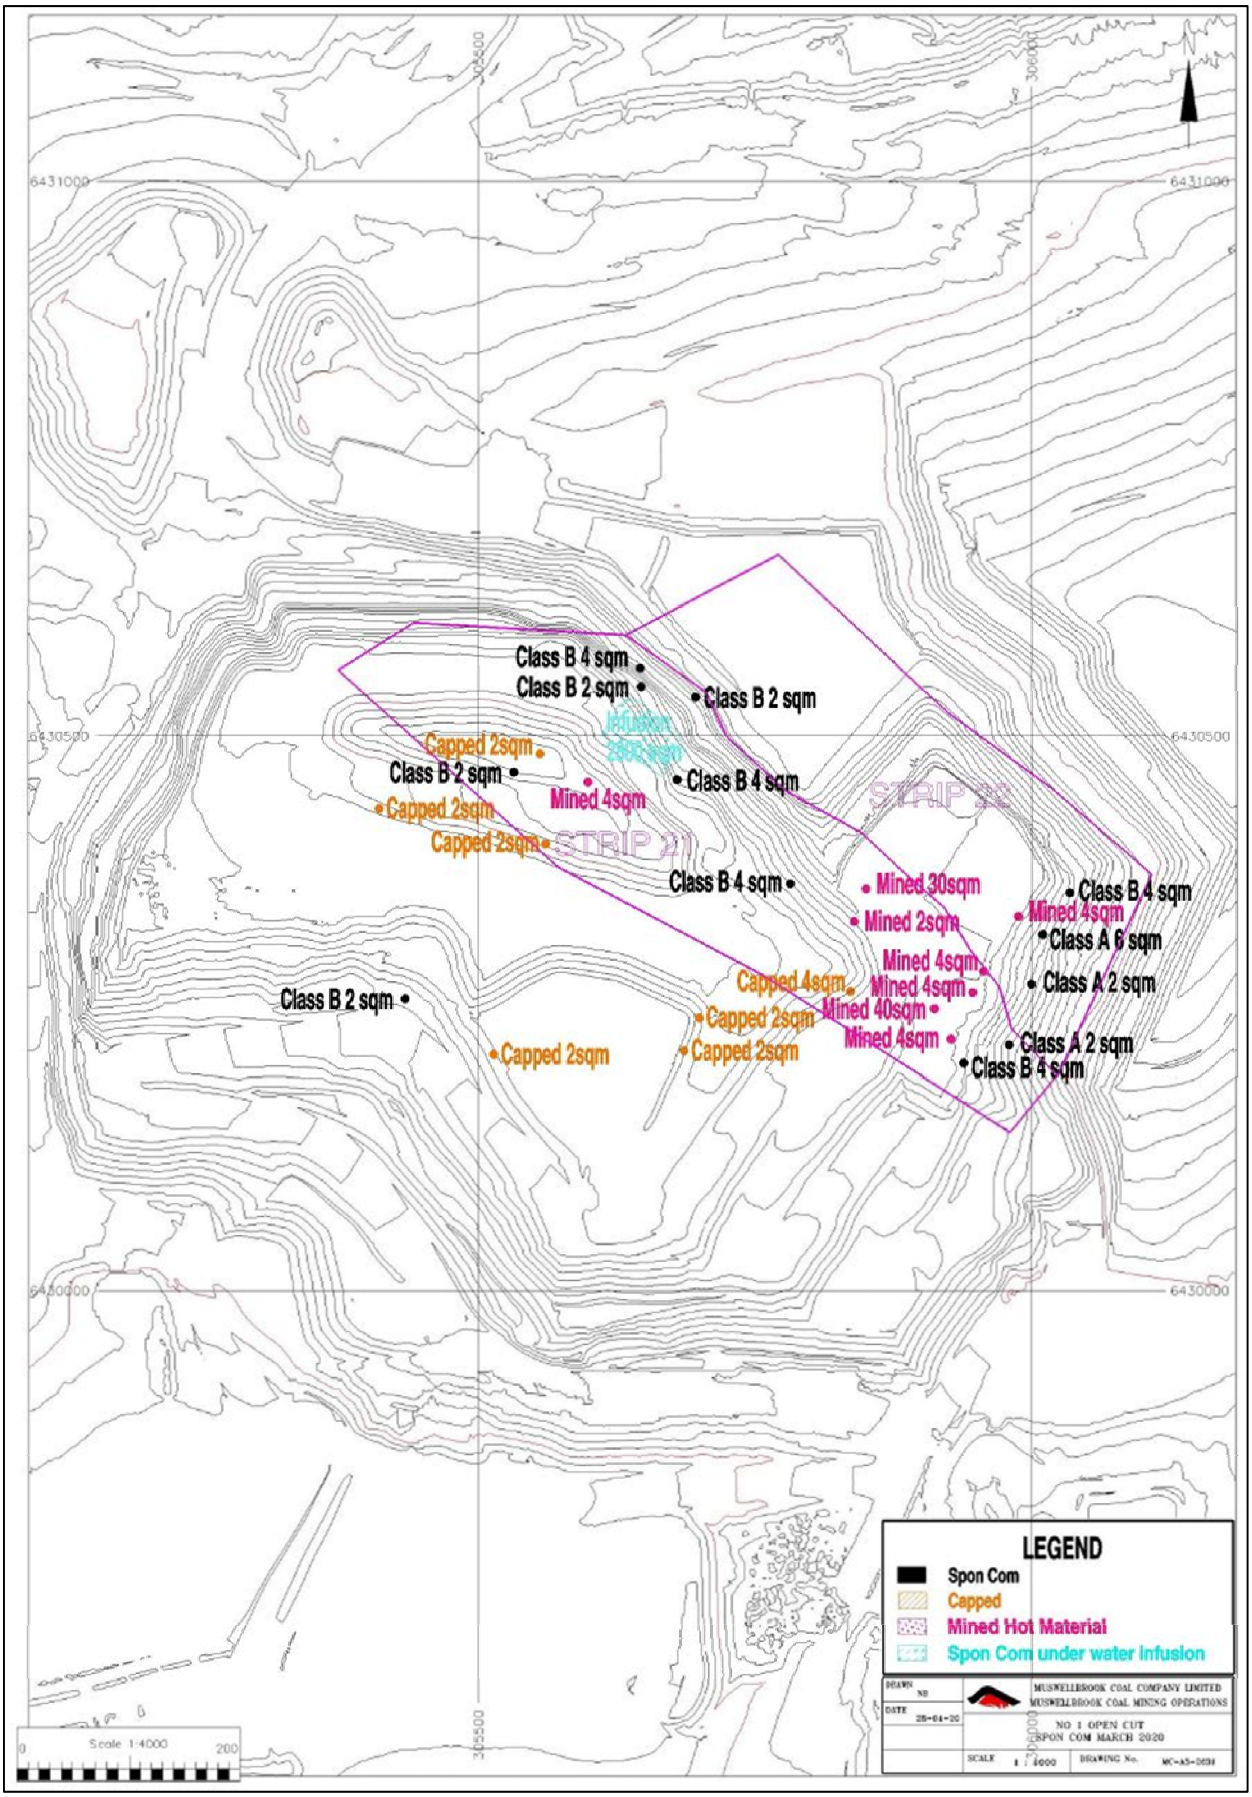
Figure 1: Location of Spontaneous Combustion Outbreaks in Open Cut 1

The classification system for spontaneous combustion outbreaks is provided in **Table 2**. A summary of the areas affected by spontaneous combustion and the areas controlled and treated during the reporting period is provided in **Table 3**. The locations of these areas can be seen in **Figure 1** to **Figure 2**.

Site Map Location	Classification (A-C)	Affected Area Without Active Control *(m^2)*	Active Controls Completed	Area Controlled *(m^2)*
Open Cut 1	A B	10* 28*	Mining Capping Infusion	94** 14** 2,800**
Open Cut 2	N/A	0*	None Required	0**
SUMMARY				
Total Area Affected		38*		
Total Area Controlled		108**

Date	Water Sprays	Water Carts Assisting	Capping	Hot Material Removal	Comments
01/03/20	-	OC1	-	-	
02/03/20	-	OC1	-	-	
03/03/20	-	OC1	-	-	
04/03/20	-	OC1	-	-	
05/03/20	-	-	-	-	Wet weather
06/03/20	-	OC1	S22	-	
07/03/20	-	OC1	-	S21	
08/03/20	-	S22	-	S22 & RL155	
09/03/20	-	OC1	S21	S22 & RL155

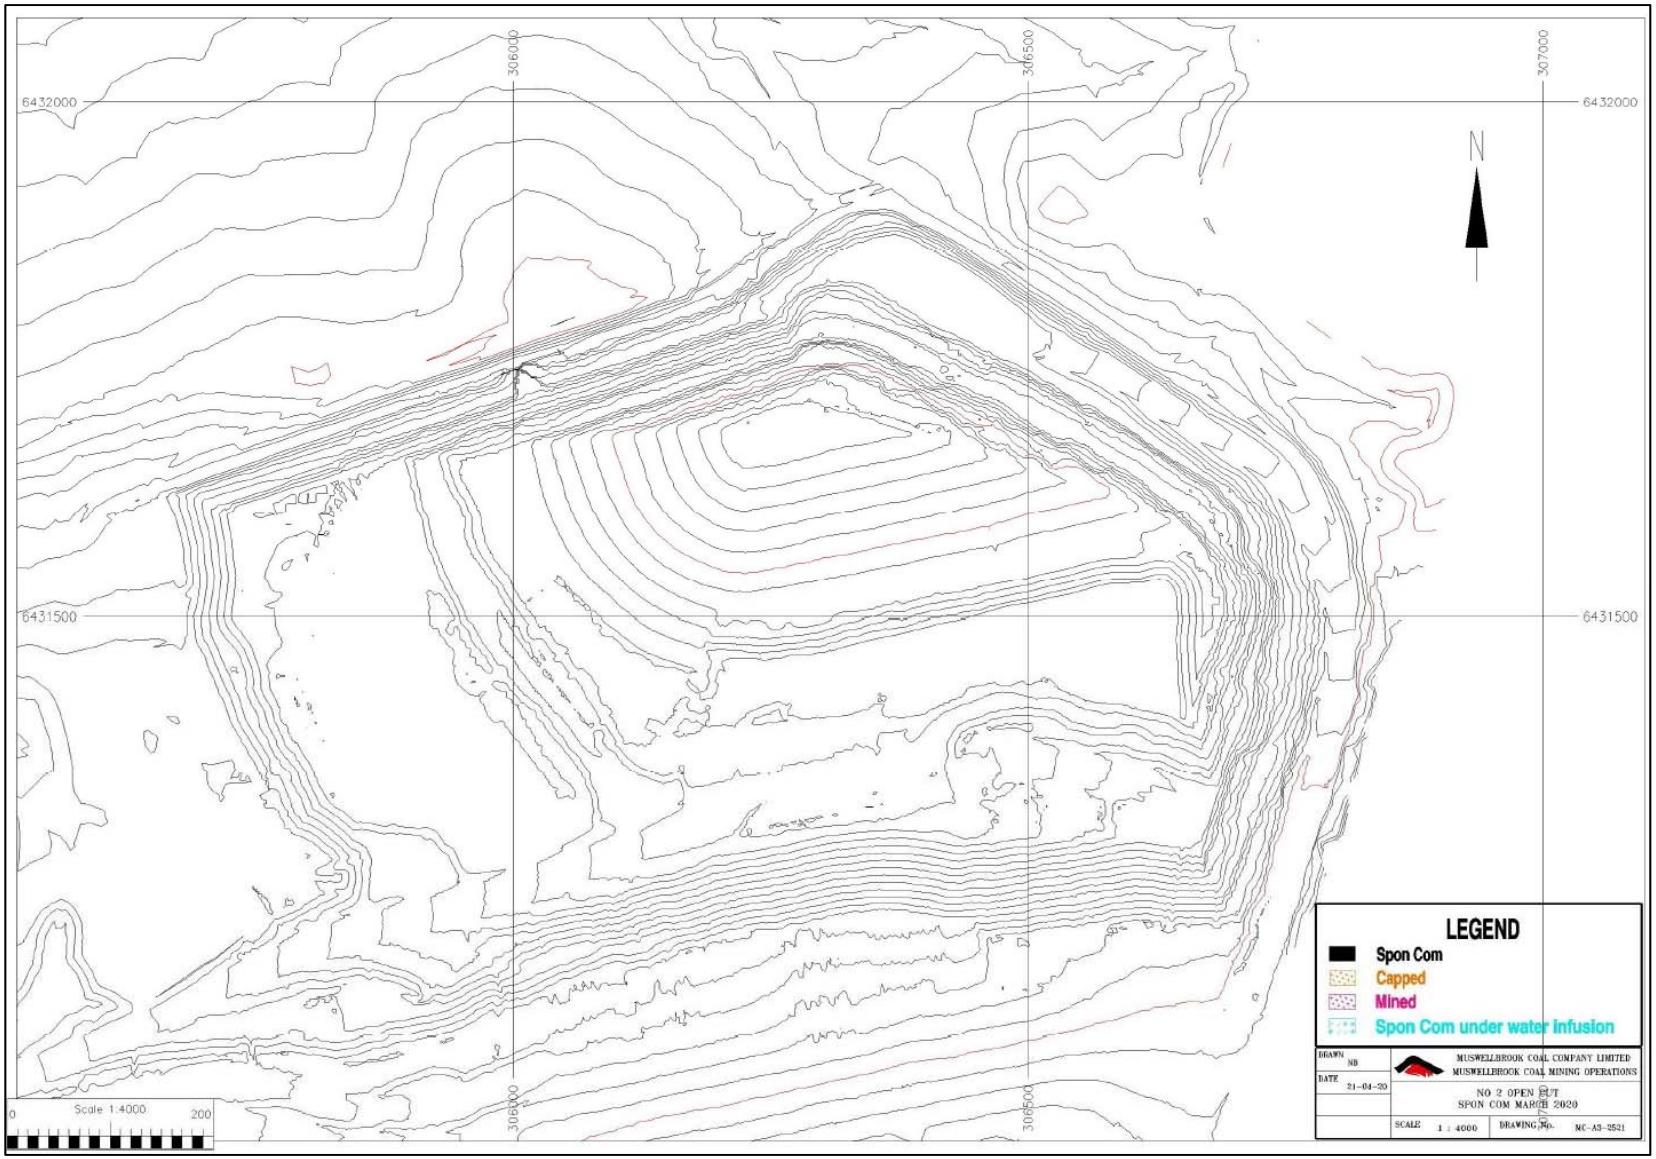
Figure 2: Location of Spontaneous Combustion Outbreaks in Open Cut 2

No spontaneous combustion outbreaks were observed in Open Cut 2 throughout March 2020. Therefore, no active controls were implemented in Open Cut 2.

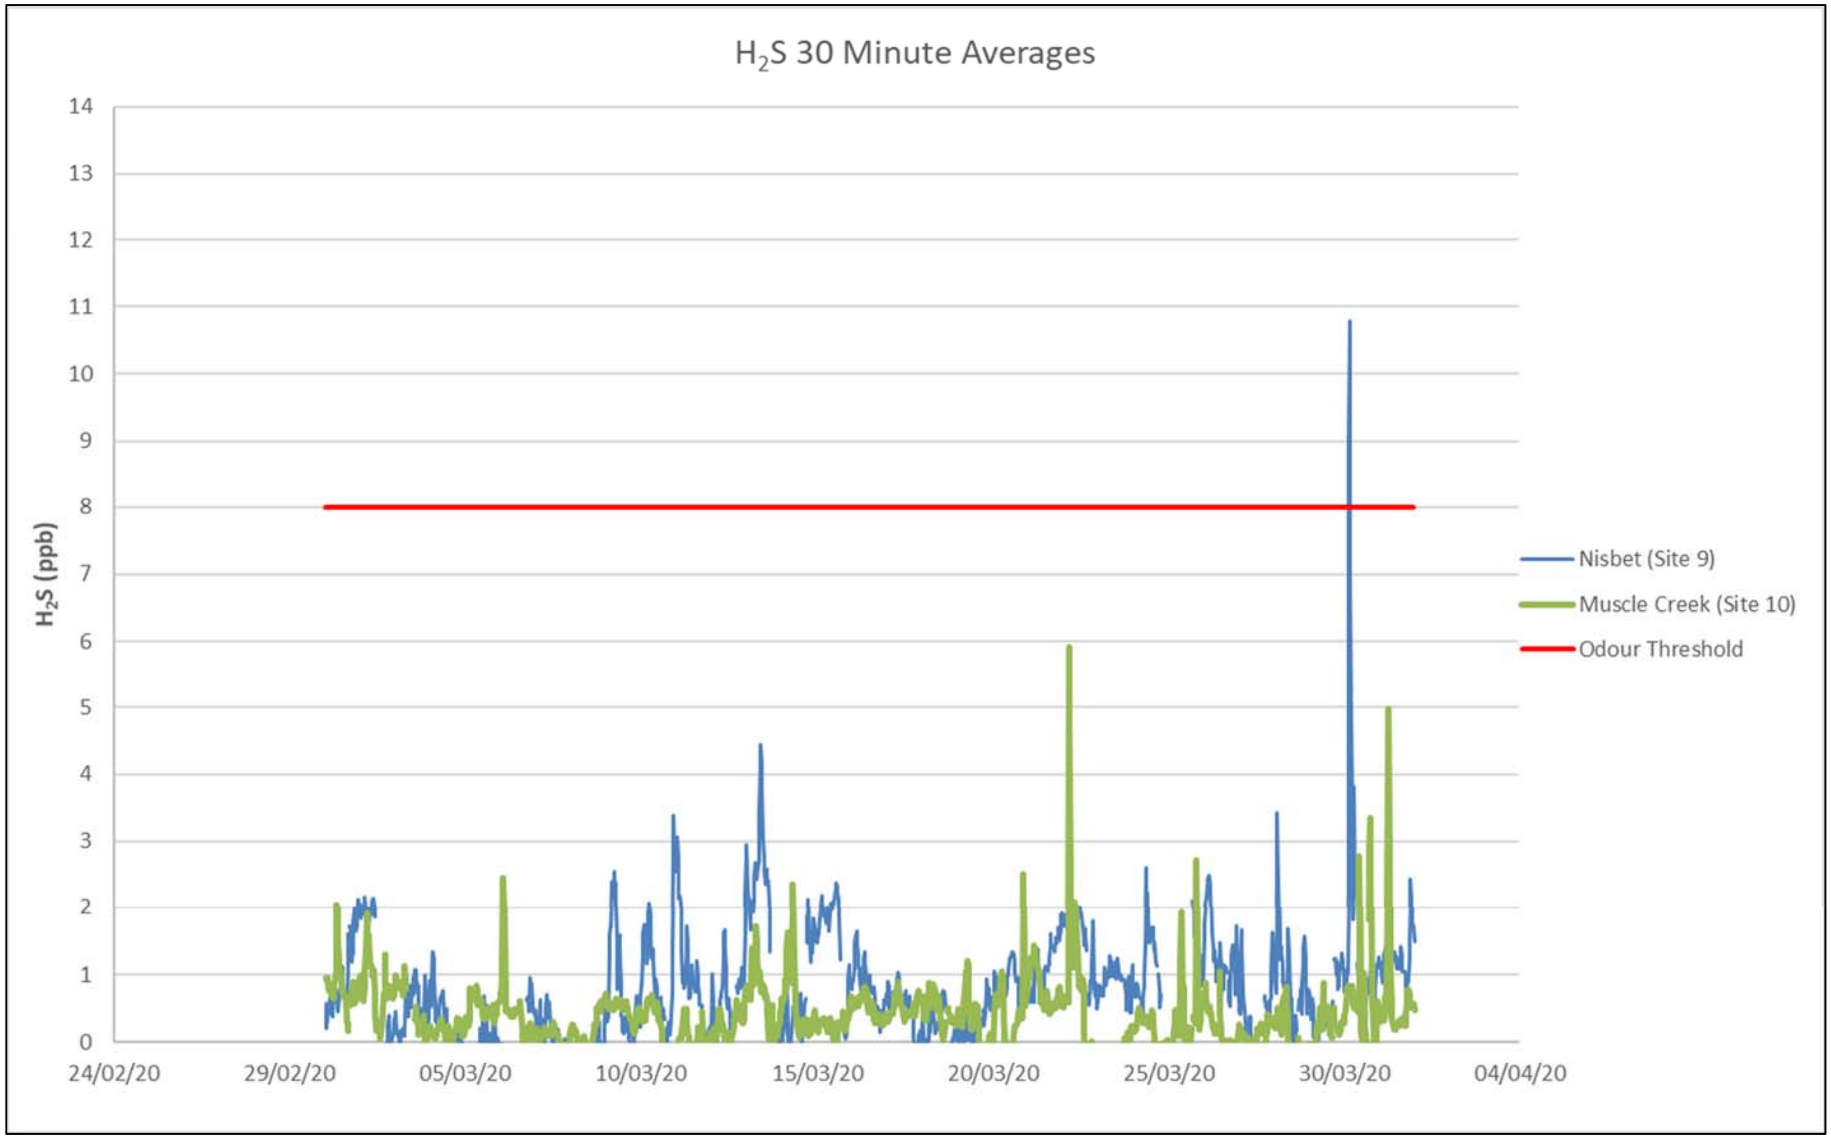
Figure 3: Hydrogen Sulphide 30 Minute Results

The gas monitoring results are displayed graphically in **Figure 3** to **Figure 7.** As noted in these graphs, there were no results above the health impact assessment criteria for the reporting period. There was only one result in the reporting period where H_2S was above the odour threshold. This occurred on 30th March 2020 at 04:30am at Nisbet (Site 9).

Date and Time of Alarm	Location of Alarm	Weather Conditions at Time of Alarm	Response to Alarm	Classification of Spontaneous Combustion
30/03/2020 4:30am	Nisbet	Wind speed = 0 m/s	Spontaneous combustion management was being undertaken including clay capping and water carts cooling areas.	Combination of Class A and B.
