Muswellbrook Coal Company Limited

Spontaneous Combustion Report

For: Environmental Protection Licence 656

Reporting Period:	**September 2020**
Authority Holder:	**Muswellbrook Coal Company Limited**
Report Date:	**26 October 2020**
Approved by:	**Julie Thomas** **Environmental Superintendent**

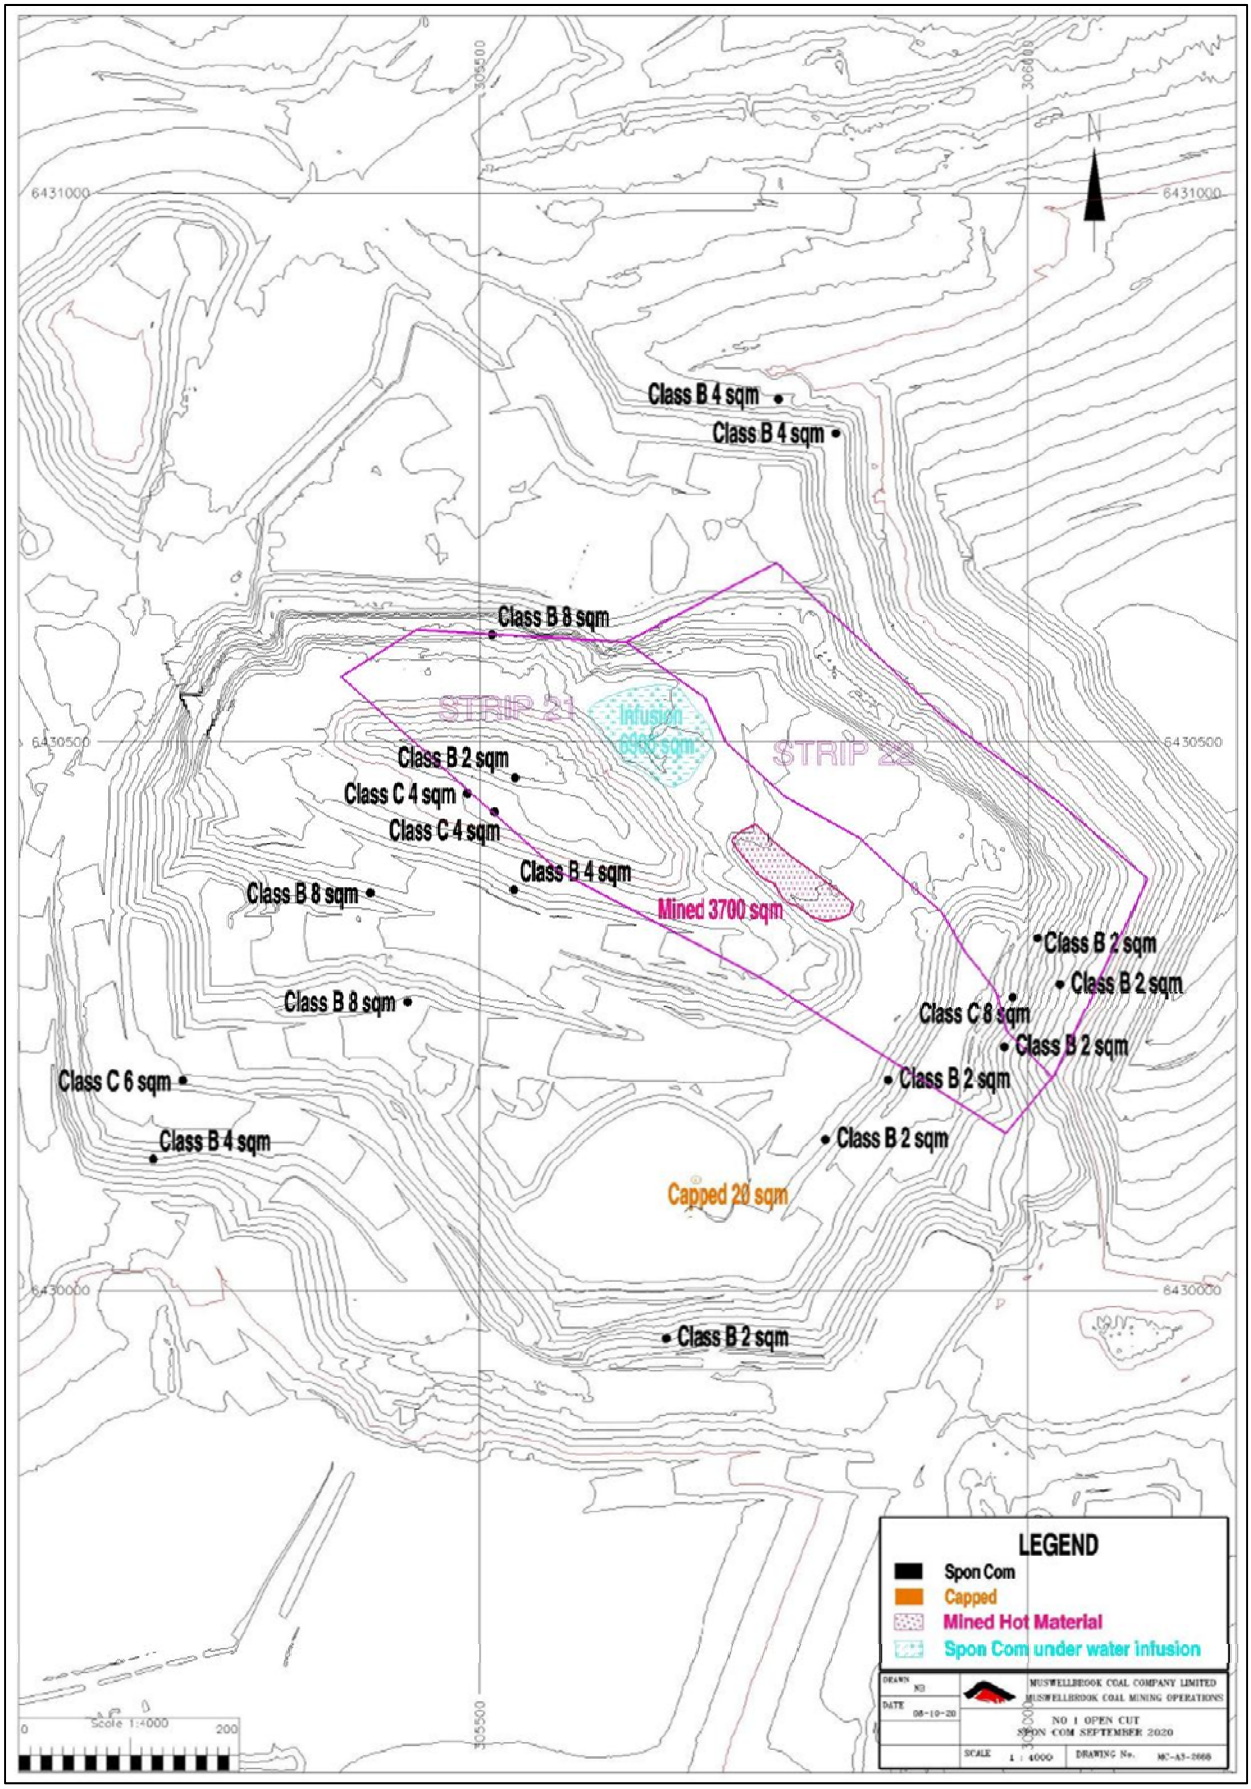
Site Map Location	Classification (A-C)	Affected Area Without Active Control *(m^2)*	Active Controls Completed	Area Controlled *(m^2)*
Open Cut 1	A B C	0* 50* 22*	Mining Capping Infusion	3,700** 20** 6,900**
Open Cut 2	N/A	0*	None Required	0**
SUMMARY				
Total Area Affected		72*		
Total Area Controlled		10,620**

Figure 1: Location of Spontaneous Combustion Outbreaks in Open Cut 1

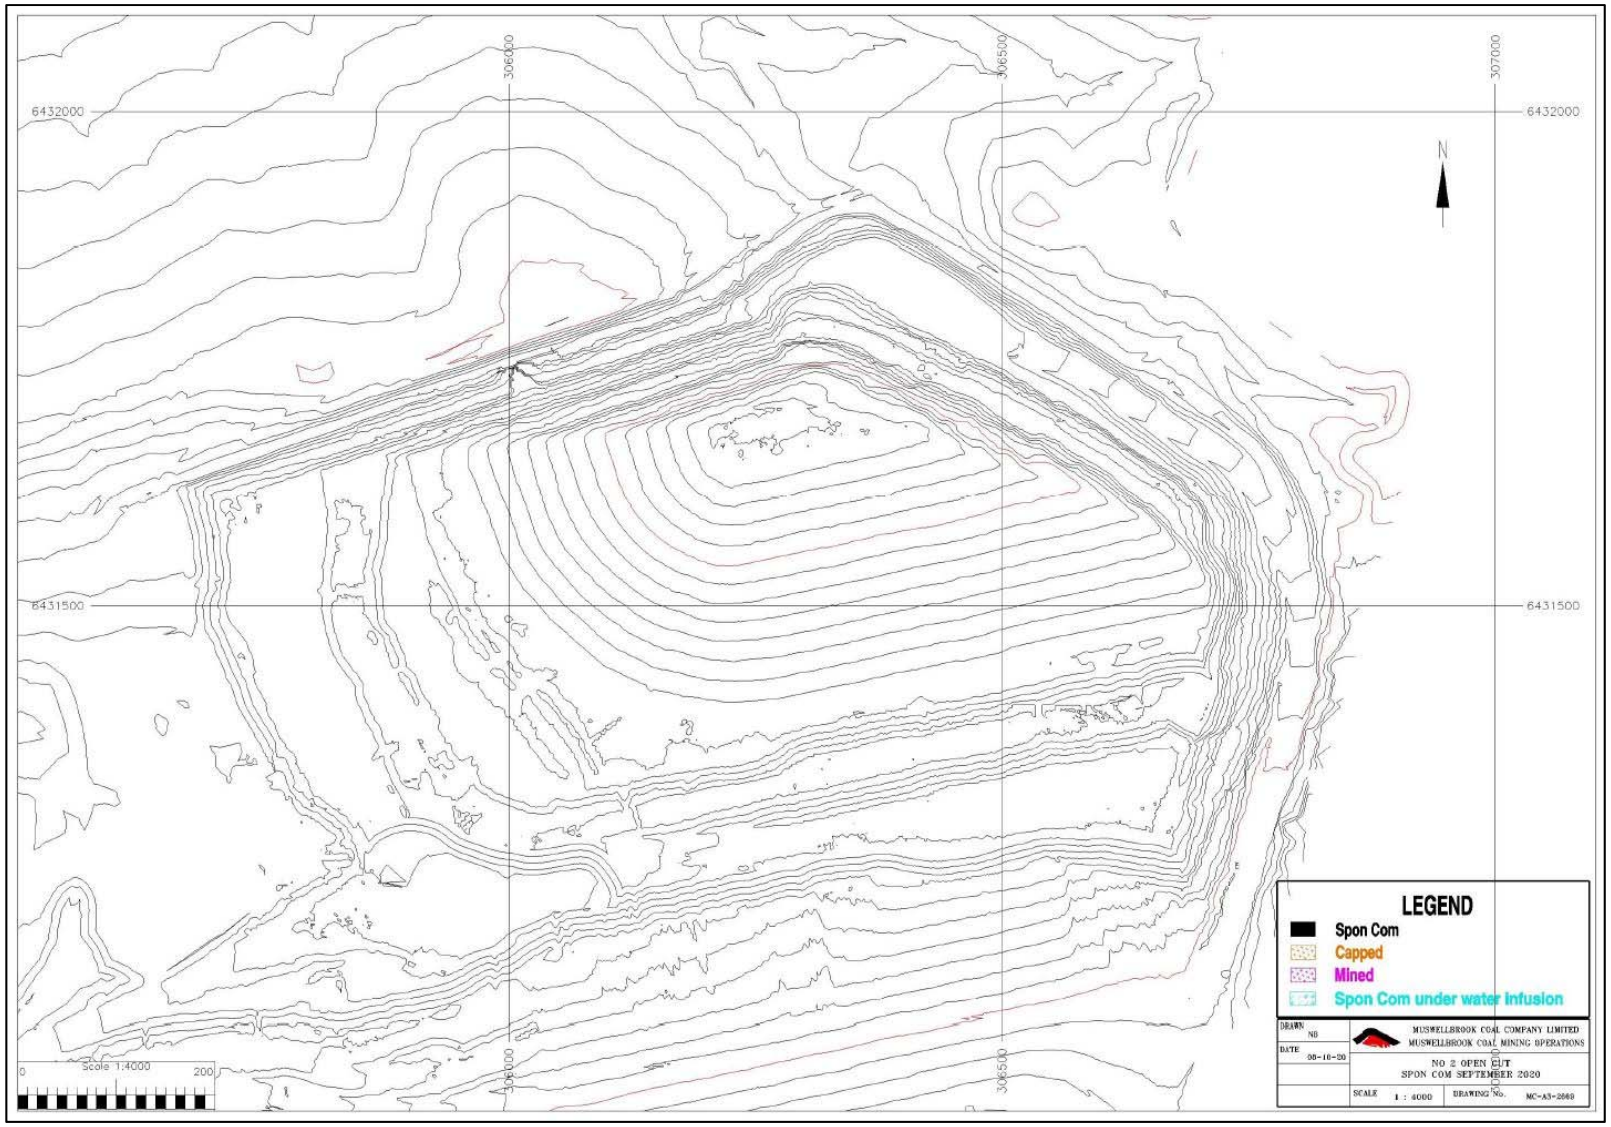
No spontaneous combustion outbreaks were observed in Open Cut 2 throughout September 2020. Therefore, no active controls were implemented in Open Cut 2.

Figure 2: Location of Spontaneous Combustion Outbreaks in Open Cut 2
