Ref: 171356/29239

#### RE: JANUARY 2021 NOISE MONITORING RESULTS – MUSWELLBROOK COAL MINE

This letter report presents the results of noise compliance monitoring, commencing at about 10.00 pm on Monday 25<sup>th</sup> of January, 2021, for the Muswellbrook Coal Company (MCC) mine at Muscle Creek Road, Muswellbrook. The monitoring was undertaken as per the requirements of D.A. 205/2002 and detailed in the Noise Management Plan (NMP) for the mine.

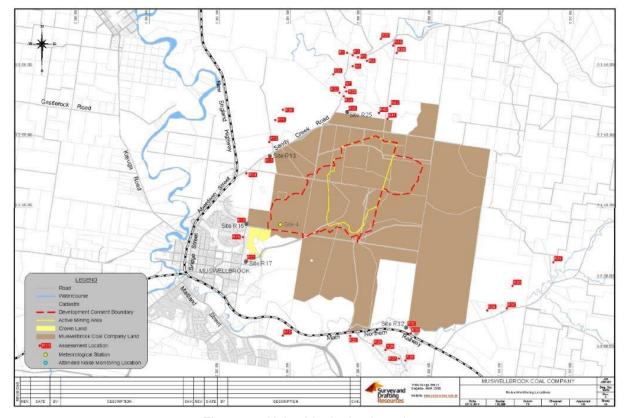
Figure 1 – Noise Monitoring Locations

The attended noise monitoring locations are detailed in Table 1 and shown in Figure 1.

Noise criteria for all assessment locations shown in Figure 1 are detailed in Appendix I to this report.
